Residential Inspection Report

13867 Firefall Court , Colorado Springs, Colorado 80921

September 07, 2023 09:30 am

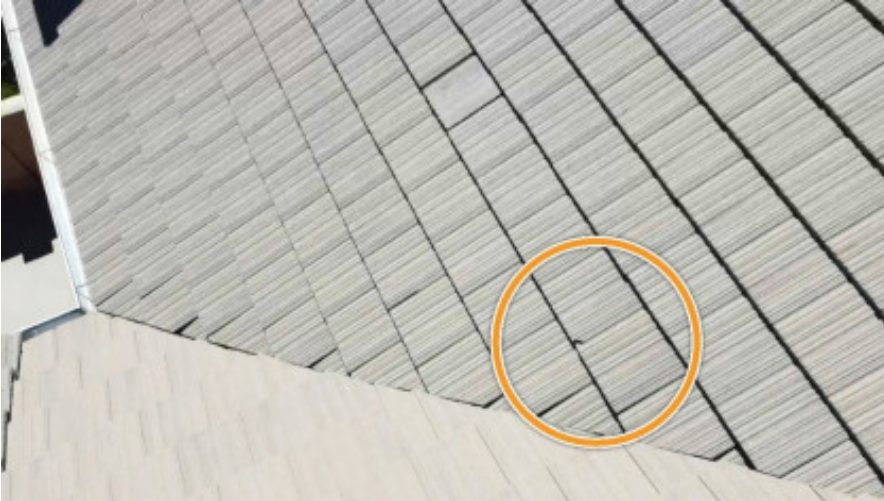
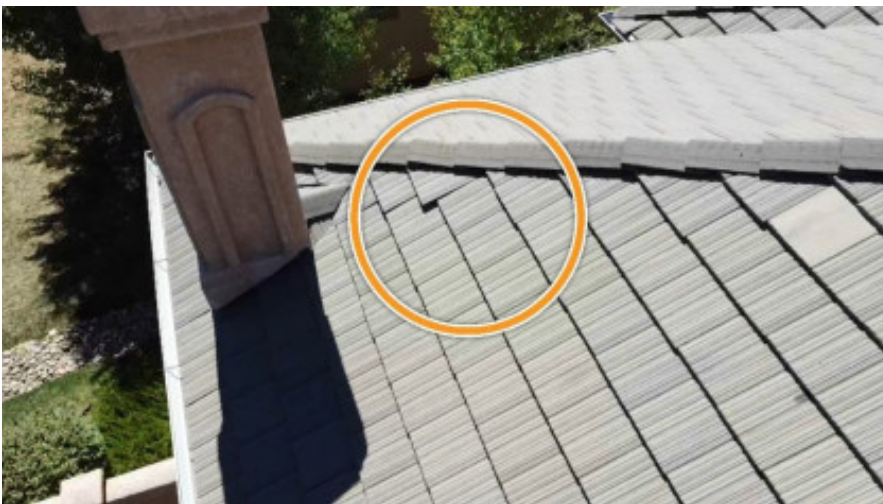
DEFICIENCY 2.1

Chipped and Loose Tiles

Estimated Severity : ■ Minor/Maintenance

The roof had some chipped and loose tiles. I recommend a qualified roof contractor repair or replace to prevent moisture intrusion.

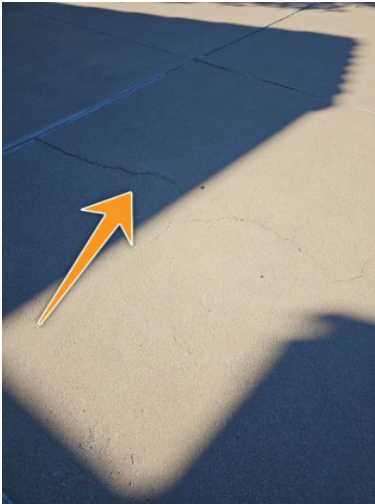
DEFICIENCY 3.1

Cracking/Settling - Minor - Walkways Patios Driveways

Estimated Severity : Minor/Maintenance

I observed some minor cracks in the cement. This is very typical due to soil movement. I would consider these cracks cosmetic, but I do recommend using a sealant to prevent water intrusion. Monitor and maintain as necessary.

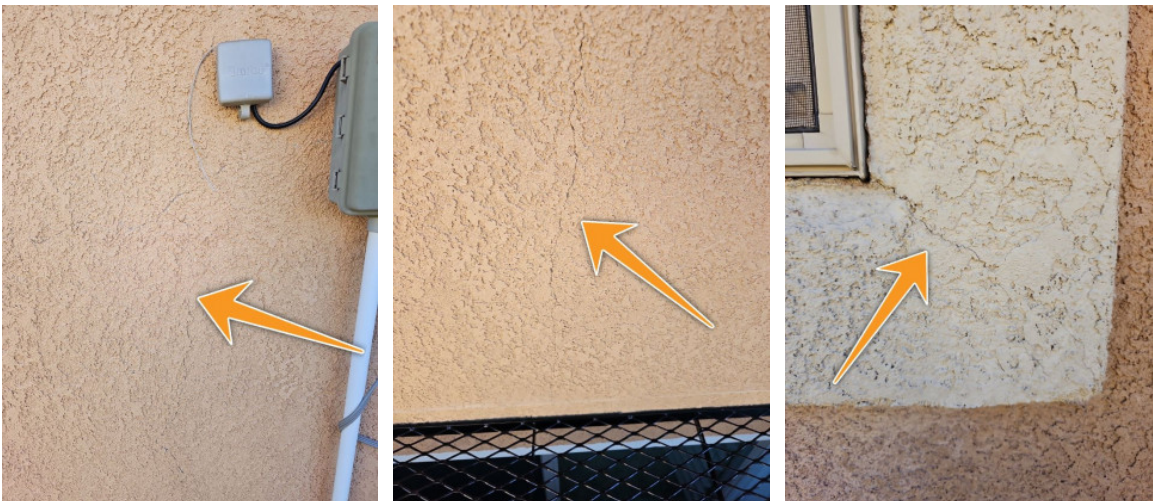
DEFICIENCY 3.2

Cracking Stucco - Minor

Estimated Severity : ■ Minor/Maintenance

The stucco siding showed cracking in one or more places. This is a result of temperature changes, and typical as homes age. I recommend patching, sealing, replacing, or monitoring areas of cracking depending on severity and siding material in question.

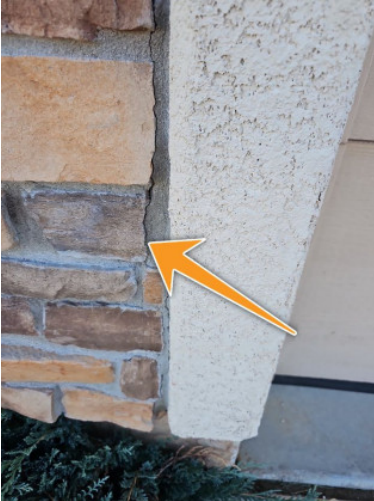
DEFICIENCY 3.3

Cracking in stone veneer

Estimated Severity : ■ Repair

At the time of inspection, some cracking was noted in the stone veneer. This is not a structural component of the home. Recommend performing any necessary maintenance for the upkeep of the stone exterior..

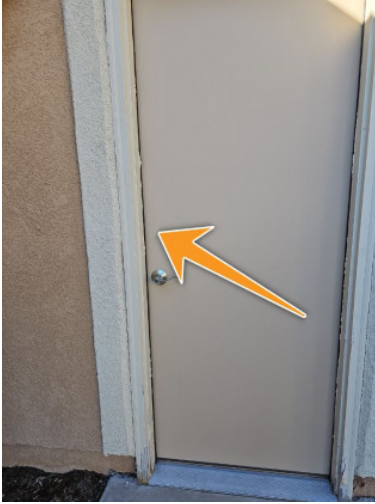
DEFICIENCY 3.5

No deadbolt - Exterior Doors

Estimated Severity : ■ Repair

No dead bolt on the exterior door. I recommend installing for safety on all exterior doors.

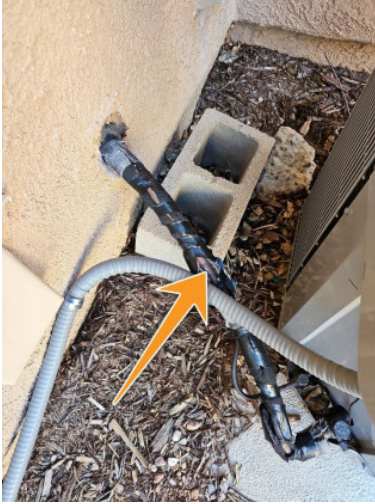
DEFICIENCY 8.1

Insulation Damaged/Missing - AC Condenser

Estimated Severity : ■ Minor/Maintenance

Recommend fully insulating coolant line for the AC condenser.

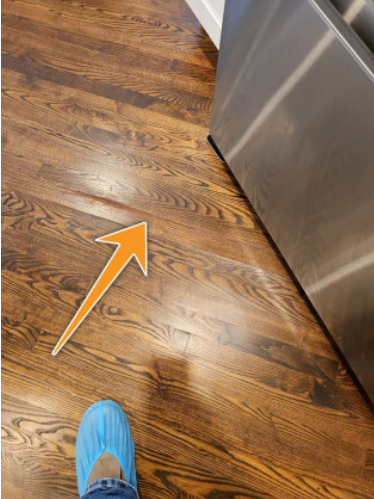
DEFICIENCY 10.5

Moisture Damage - Flooring

Estimated Severity : ■ □□ Repair

When inspecting the home's flooring, one or more areas had visible moisture damage. I recommend a qualified flooring contractor evaluate & repair areas of moisture.

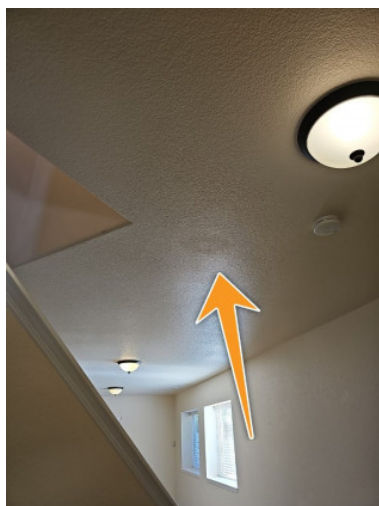
DEFICIENCY 10.8

Patching - Ceiling

Estimated Severity : ■ □□ Repair

There appears to be some visible patching in the ceiling. Recommend asking the seller history as to why the patching was needed.

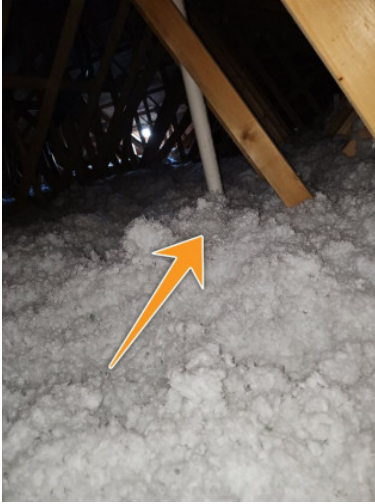
DEFICIENCY 12.1

Aged Insulation - Attic

Estimated Severity : ☐☐ Repair

Due to the age of the Insulation, and most likely the original install of the home, I recommend a insulation specialist to verify the quality and condition of the insulation. Overtime, insulation settles and compresses. I recommend further evaluation to determine if newer insulation is necessary to improve the efficiency of your home.
