# Top Choice Inspectors

## Residential Inspection Report

13867 Firefall Court , Colorado Springs, Colorado 80921

September 07, 2023 09:30 am

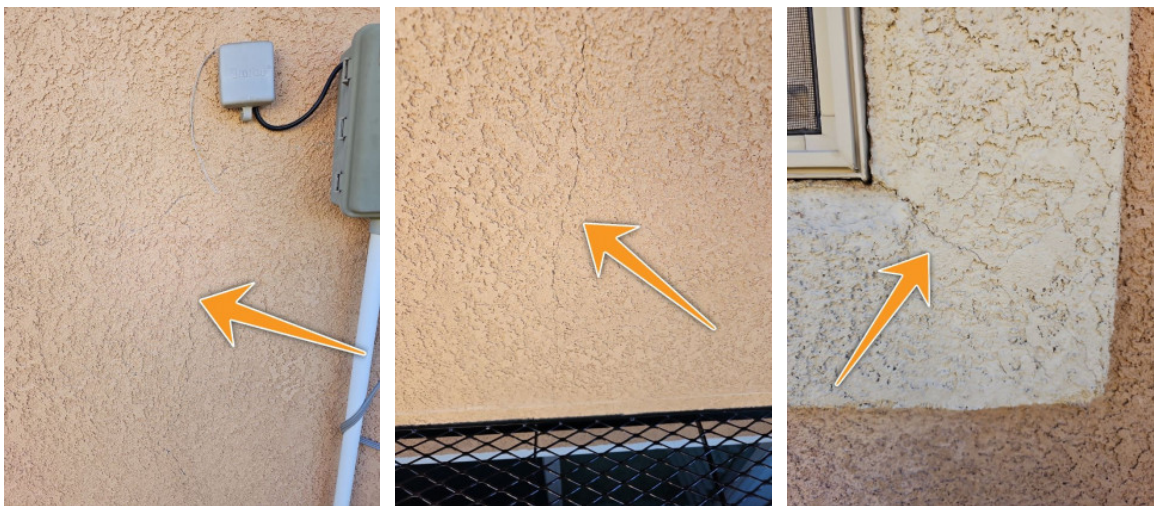
### DEFICIENCY 3.2

Cracking Stucco - Minor

Estimated Severity : ■ Minor/Maintenance

The stucco siding showed cracking in one or more places. This is a result of temperature changes, and typical as homes age. I recommend patching, sealing, replacing, or monitoring areas of cracking depending on severity and siding material in question.

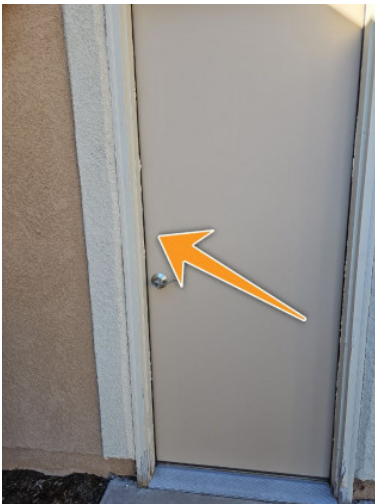
### DEFICIENCY 3.5

No deadbolt - Exterior Doors

Estimated Severity : ■   Repair

No dead bolt on the exterior door. I recommend installing for safety on all exterior doors.

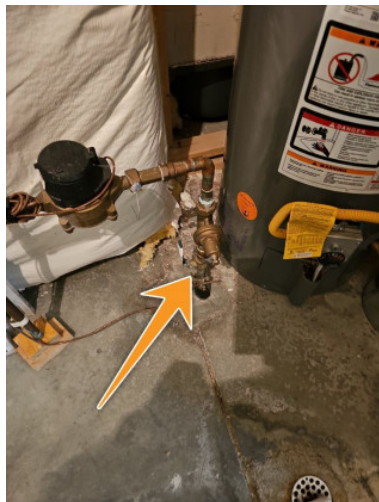
## CUSTOM 9.1

Main Water Shut-Off

This valve turns the water off to the whole house.

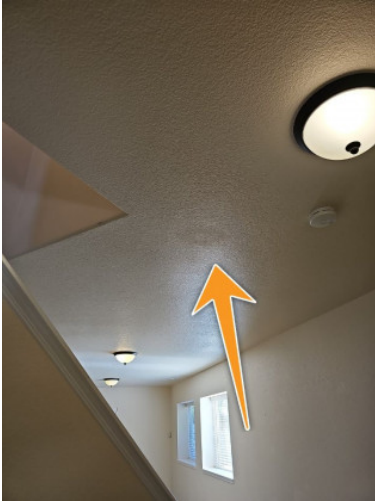
## DEFICIENCY 10.8

Patching - Ceiling

Estimated Severity : ■ □□ Repair

There appears to be some visible patching in the ceiling. Recommend asking the seller history as to why the patching was needed.

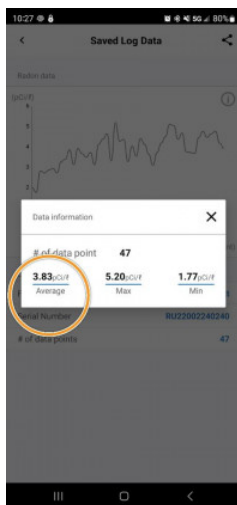
### CUSTOM 14.1

Basement Bedroom, 48 hrs, 10, 3.83
