# Precision Property Inspections

## Precision Residential

123 Sample Drive, Anytown, USA 54321

September 12, 2025 01:30 pm

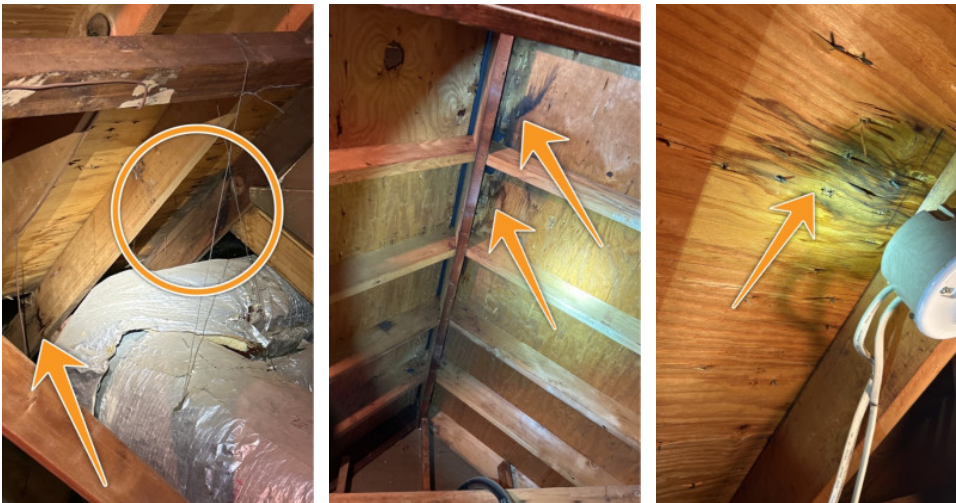
#### DEFICIENCY 2.1

Water Stains Noted - Dry At Inspection

Monitor: Water staining noted. The area was dry at the time of inspection. Consult the owner for further information regarding past leakage, repairs, and warranty information. Consult a qualified roofer for additional evaluation and repairs as needed.

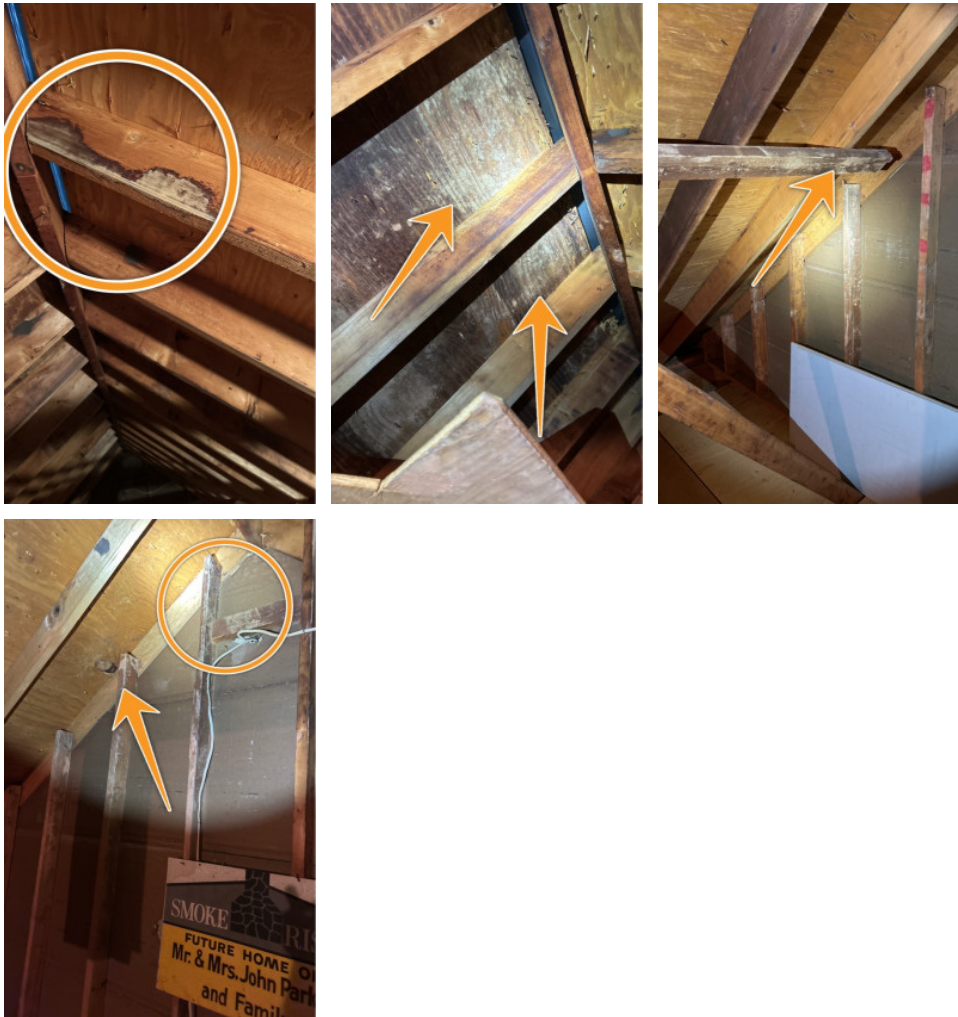
## DEFICIENCY 2.2

Microbial Growth Noted In Attic

Repair: Microbial growth was noted on attic components, likely due to a combination of high humidity and lack of ventilation. Attempt to clean and increase ventilation. Consult a mold remediation specialist for evaluation and mitigation if needed.

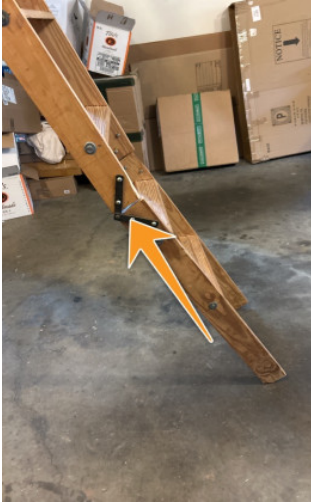
## DEFICIENCY 2.3

Adjust Pull-Down Stairs

Repair, Safety Issue: The pull-down stairs to the attic need to be adjusted so that the stair is in a straight line when fully extended (see manufacturer's recommendations printed on label). This will relieve unnecessary pressure on the connections at the folding sections. The stairs should be cut back at the floor to provide proper support.

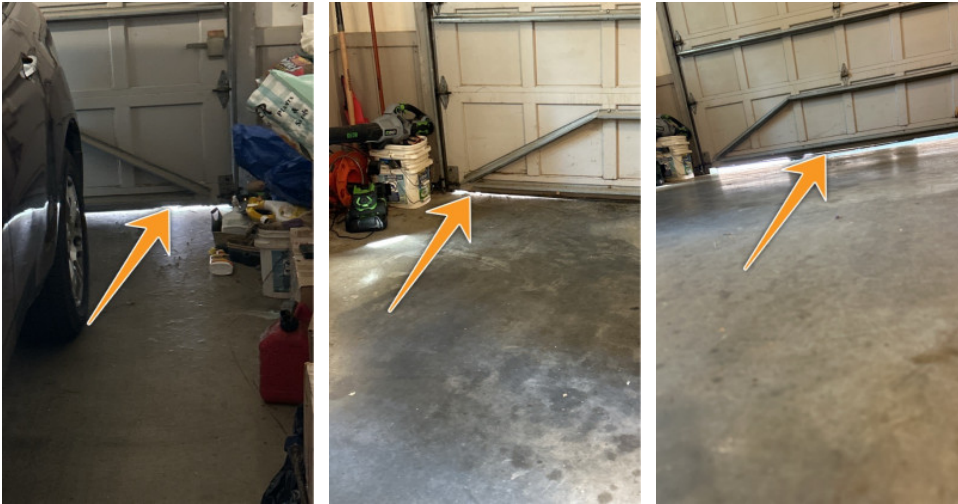
#### DEFICIENCY 3.2

Repair Weatherstripping

Repair: The garage door weatherstripping as noted is damaged and should be repaired to limit moisture and rodent intrusion into the garage.

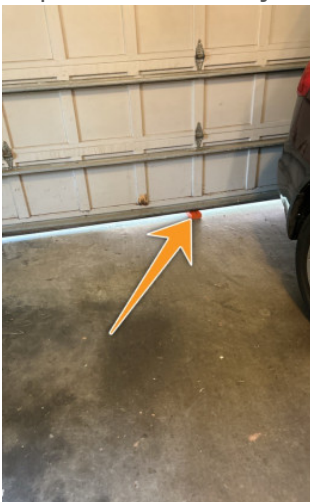
### DEFICIENCY 3.3

Impact Reverse Adjustment Needed

Repair, Safety Issue: The garage door opener did not automatically reverse using standard testing procedures as required by the National Safety Council (door must reverse upon hitting a 2x4 block of wood laid flat on the floor below the door). There is a risk of injury, particularly to children and pets, and damage to vehicles under this condition. The opener and door should be serviced and adjusted as needed by a qualified garage door service company.

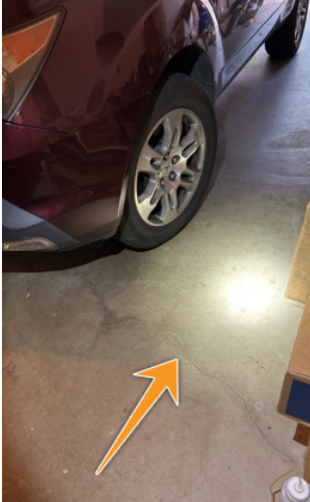
### DEFICIENCY 3.4

Routine Settlement Cracking (Garage)

Repair, Monitor: Cracks such as these fall within the range of normal settlement. Repair cosmetically and monitor for subsequent movement. Should further movement occur, consult a foundation contractor.

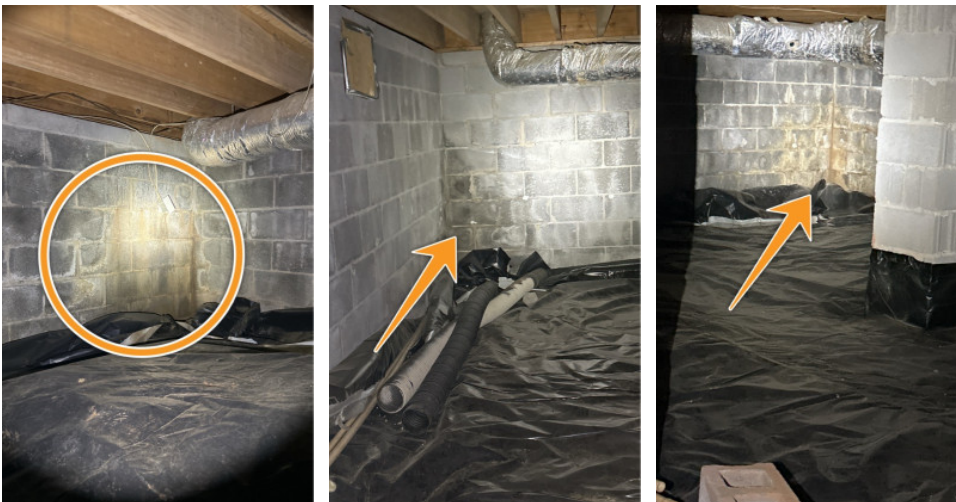
#### DEFICIENCY 4.1

Water Staining At Foundation

Repair, Monitor: Evidence of previous or active moisture penetration was observed in the

crawlspace, especially as noted. Wet basements and crawlspaces risk building damage from rot and insects and can cause interior microbial growth or mildew (a microbial growth assessment is not included in this inspection). Roof and lot drainage repairs or improvements should be addressed as a first step to controlling water intrusion into the crawlspace (see Exterior and/or Roofing Sections). This condition should then be monitored.

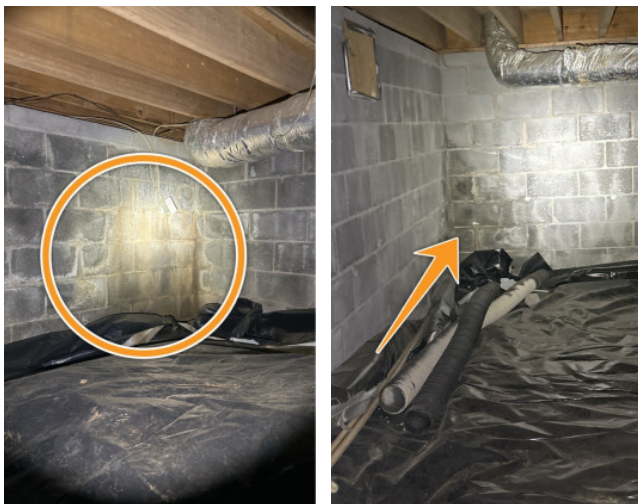
### DEFICIENCY 4.2

Efflorescence Noted At Foundation

Water pressure from the far side of the foundation is penetrating the wall and leaching salts from the masonry and mortar. The salts themselves are harmless but indicative of persistent moisture. Consult with a licensed water-proofing contractor for remediation as needed.

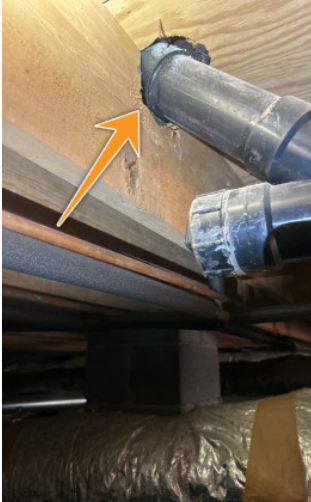
### DEFICIENCY 4.3

Floor Joist Overly Notched / Cracked

Repair: A floor joist was cracked / overly notched as noted. This weakens the joist and can cause floor settlement in the future.

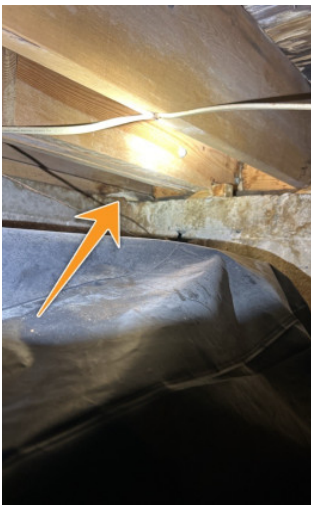
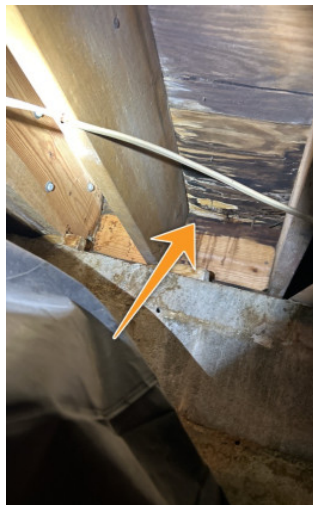
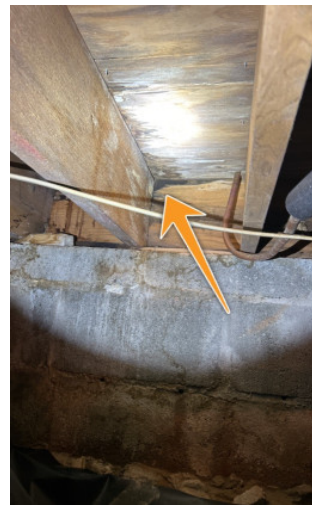
#### DEFICIENCY 4.4

Water Damage / Rot Noted - Repair

Repair: The floor structure as noted shows evidence of advanced water damage and rotting. Rot weakens the structure and can cause building settlement. Damaged wood should be repaired or replaced and the conditions that have promoted the rot should be corrected. Consult a qualified framing contractor for further evaluation and options for repair, as well as prevention of future damage.

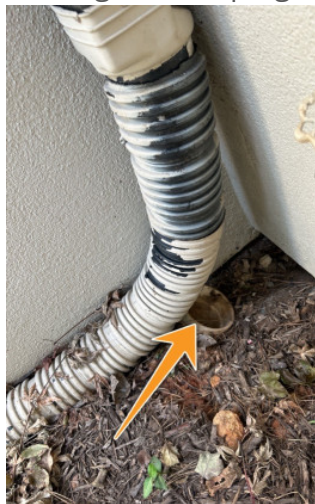
### DEFICIENCY 5.4

Underground Piping Disconnect From Downspout

Repair: Downspout connections to underground piping need to be secured as noted. The piping should be screwed to the downspout and sealed to prevent moisture leakage next to the foundation, a potential source of leaks into the interior. Make sure all piping is clear and free flowing. Ribbed (black corrugated) piping is more prone to become blocked with debris than smooth wall piping.

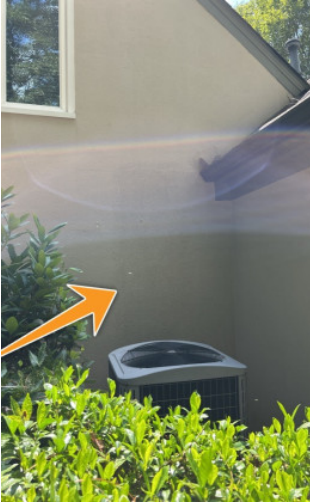
### DEFICIENCY 6.1

Previous Stucco Repairs Noted

Monitor: Previous repairs to the exterior EIFS veneer were noted, which align with interior drywall repairs and water damage in the crawlspace (see the Interior and Structural sections). Consult the seller for details on all repairs, as well as any documentation, warranties, etc., provided by the contractor who performed the work.

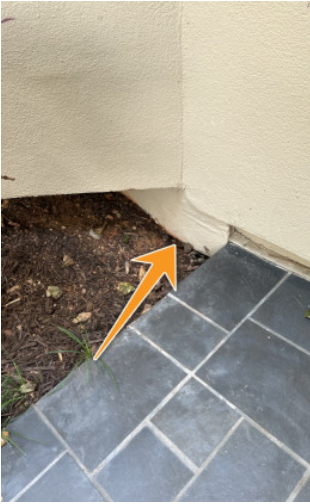
## DEFICIENCY 6.3

## EIFS Grade Contact

Repair: Synthetic stucco as noted is a weather sensitive material that should be kept well protected and sealed at all times. The bottom edge of this veneer appears to be in contact with the soil, which can be a source of moisture and insect infiltration. All foam board should be cut back to provide at least 6" clearance with the soil and the exposed edges properly sealed. All joints with woodwork should be properly caulked. All windows, doors, chimneys and intersecting roofs should be properly flashed. Consult with a professional stucco contractor adept in repairing these systems.

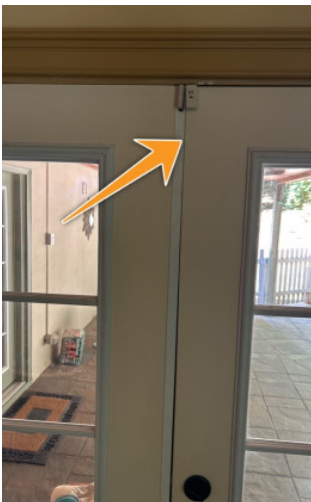
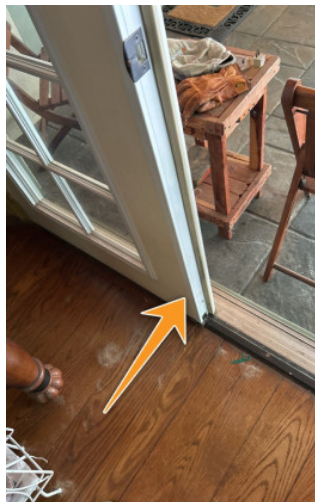
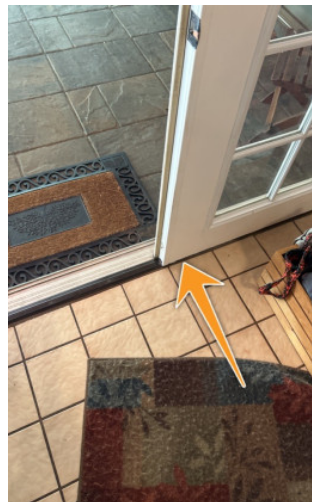
### DEFICIENCY 6.4

Adjust Exterior Door

Improve: Exterior doors should be adjusted to close and fit properly as noted for ease of operation and to limit outside air and moisture infiltration.

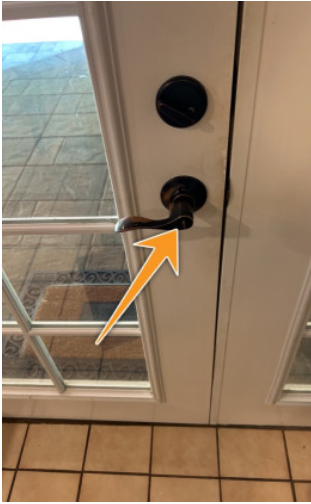
## DEFICIENCY 6.5

#### Service Door Locks

Improve: Exterior door locks that are difficult to operate as noted should be oiled and serviced for proper locking of the doors. Consider changing the locks altogether for proper operation and to reduce future maintenance.

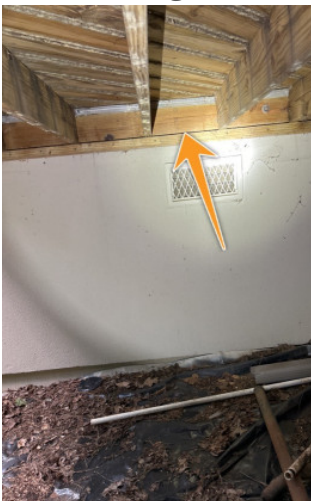
## DEFICIENCY 6.6

#### Bolts At Ledger Band Inadequate

Repair, Safety Issue: The bolts attaching the deck ledger to the structure of the house appear to be inadequate. Consult a deck contractor for further evaluation and installation of properly sized and spaced bolts as needed to prevent the deck from pulling away from the

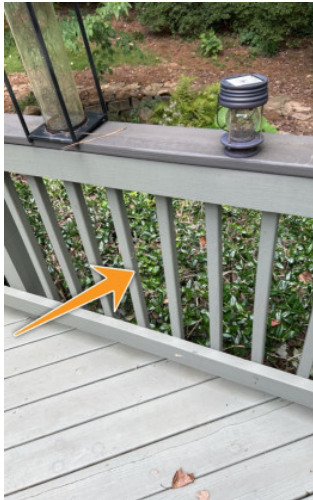
## DEFICIENCY 6.7

#### Deck Railing Picket Spacings

Repair, Safety Issue: The openings between pickets of the deck railing is more than allowed by present day safety standards for child safety (max. 4" spacings recommended). Recommend covering these with mesh or a plastic shield or otherwise, the pickets should be altered as needed.

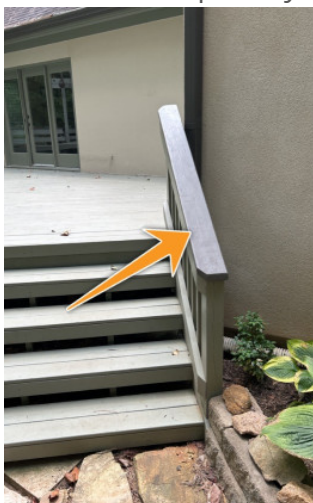
## DEFICIENCY 6.8

#### Handrail Graspability

Repair, Safety Issue: The handrails as noted do not meet current safety standards for proper grasping of the top of the rail. The hand grip portion of the rail should have a minimum width of 1 1/4" and a maximum width of 2 5/8", which should be improved as needed for proper grasping of the rails.

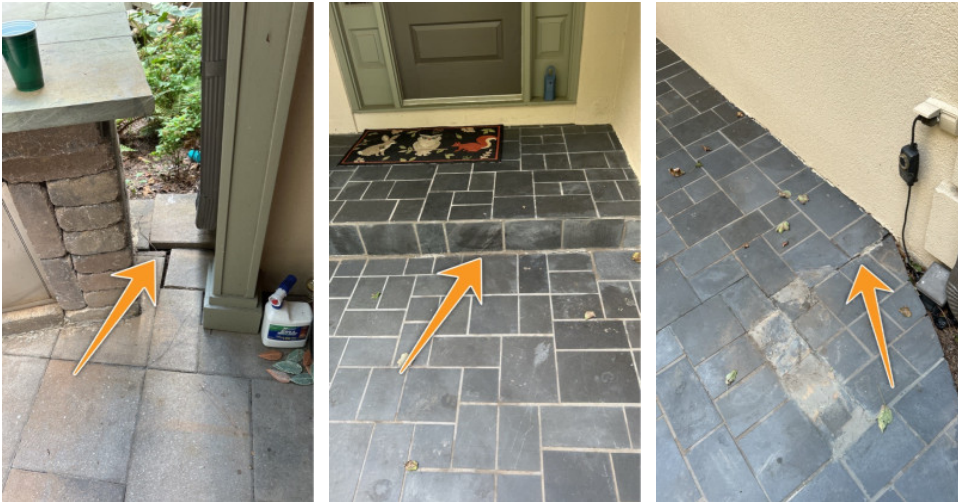
### DEFICIENCY 6.11

Patio Settled / Cracked

Monitor, Possible Repair: The patio has settled and cracked and may need repair or replacement in the future.

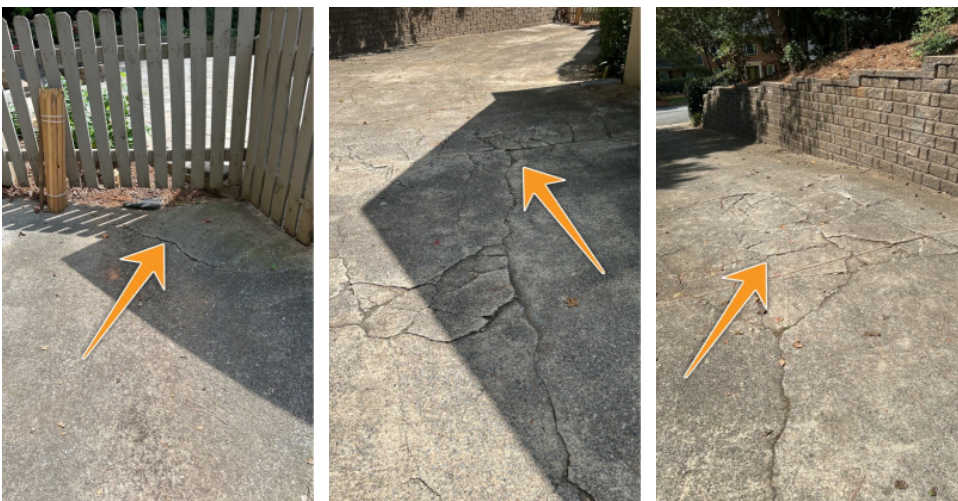
### DEFICIENCY 6.12

Driveway Settlement / Heaving

Monitor, Future Repair: The driveway has heaved and cracked in some areas as noted and will need repair or replacement in the future.

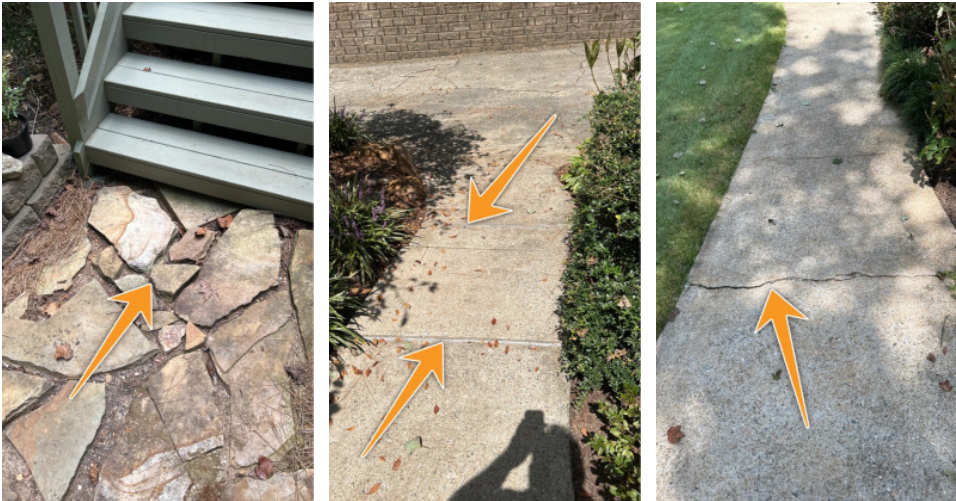
### DEFICIENCY 6.13

Walkway Trip Hazard

Improve, Safety Issue: The walkway as noted presents a trip hazard and should be altered as needed for improved safety.

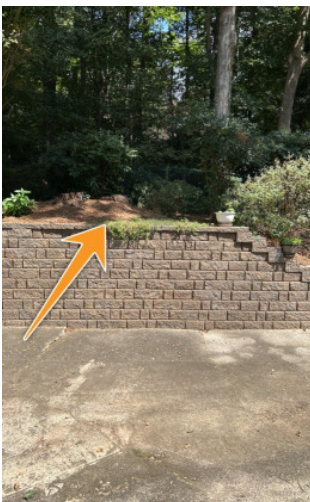
### DEFICIENCY 6.14

Guardrail Needed At Retaining Wall

Repair, Safety Issue: Current safety standards require a guardrail for walking areas that are more than 30" off the ground. This provision also applies to finish grades above retaining

walls that are attached to the structure. There was no guardrail at the retaining wall as noted and should be installed as needed.

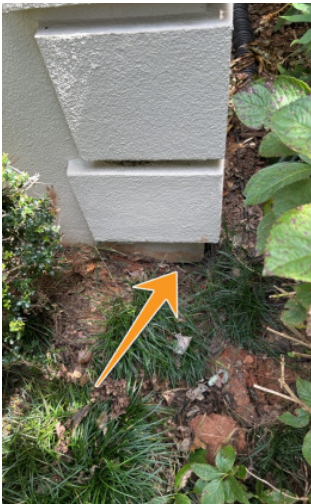
### DEFICIENCY 6.15

Soil Erosion Noted

Monitor, Possible Repair: Signs of soil erosion and wash were noted. If this condition persists, drainage improvements or grade stabilization measures may be necessary to prevent further erosion of the ground.

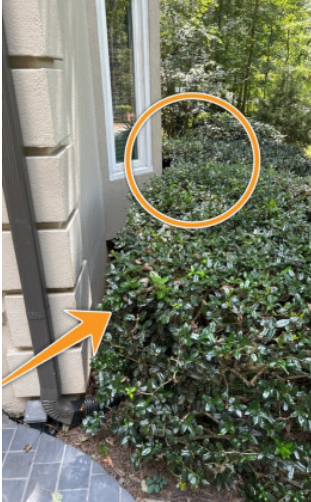
### DEFICIENCY 6.16

Cut Back Shrubbery / Vegetation

Improve: The shrubbery and vegetation growing near exterior walls as noted should be kept trimmed away from siding, window trims, and the eaves to reduce risk of insect and water damage. Overhanging tree branches should be cut back to prevent future damage to the roofing and gutters and to prevent rodent infestations into the attic.

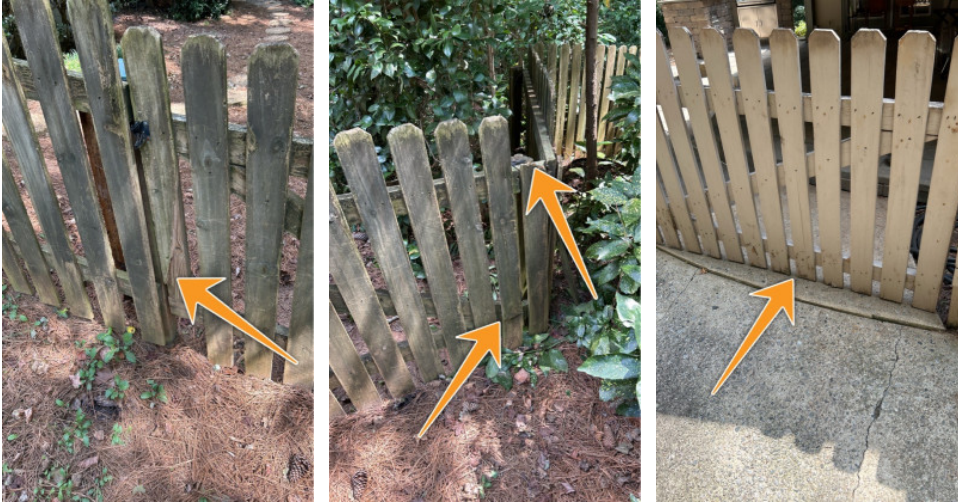
#### DEFICIENCY 6.18

Fence Damaged

Repair: Consult a fence contractor or qualified handy person for repairs.

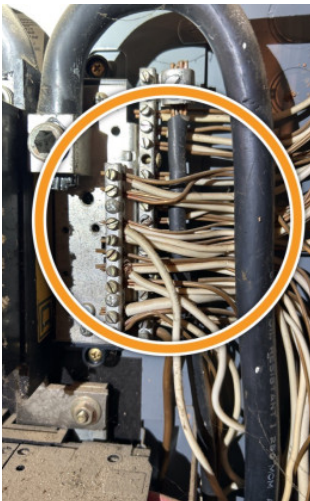
#### Grounds & Neutrals Double Tapped (Improve)

Repair, Improve: Previous safety standards permitted grounds and neutrals to share the

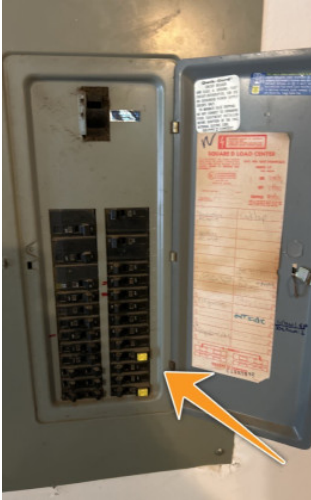
Advanced Age Of Panel

Improve: The electrical panel appears to be an older model that may be reaching the end of its servicable lifespan (approximately 40 years for a typical breaker panel). Consult an electrician for further evaluation and possible replacement.

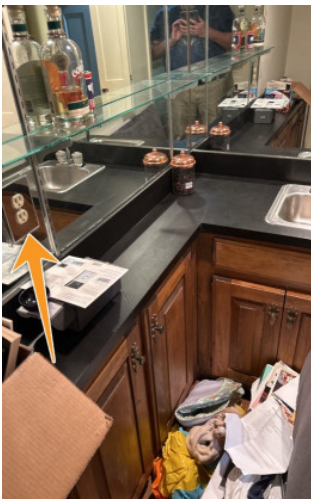
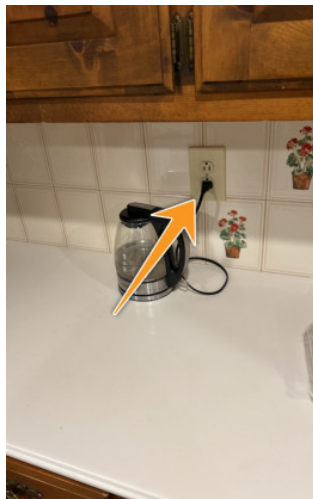
Loose Outlet

Repair: Loose outlet(s) as noted should be tightened to prevent the loosening of the wiring

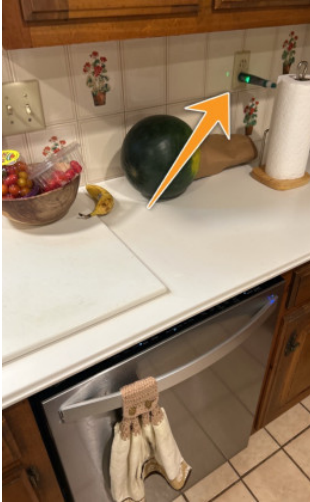
Improve, Safety Issue: The installation of a ground fault circuit interrupter outlet(s) is recommended at the location(s) shown. A ground fault circuit interrupter (GFCI) offers increased protection from shock or electrocution. Up to date weatherproof covers should be installed at all exterior outlets.

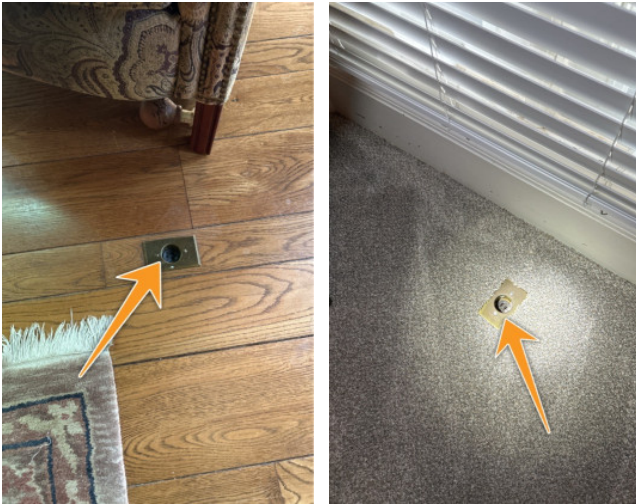
Repair, Safety Issue: Floor outlets are required to be sealed when not in use. Consult a handy person person or electrician for installation of appropriate covers at all floor outlets.

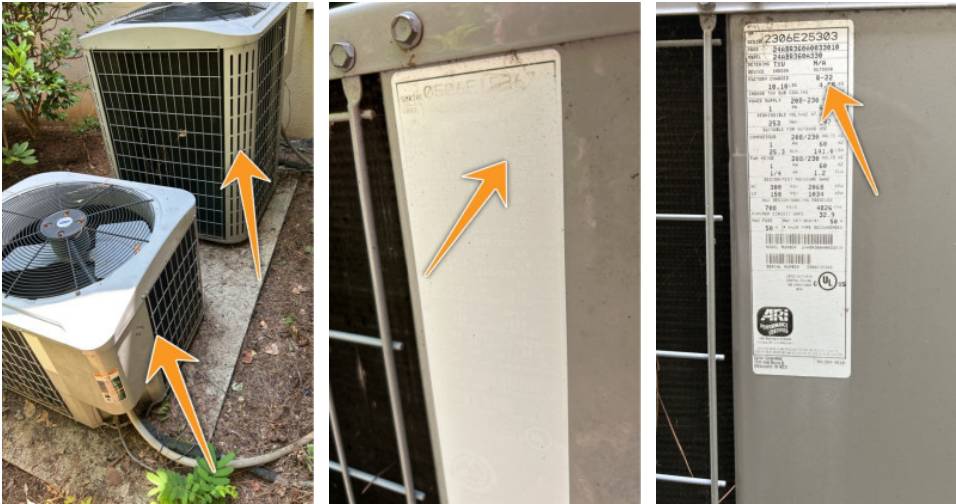
Monitor, Future Repair: The outdoor condensing unit(s) at the location pictured appear to have been manufactured before 2010 and more than likely used an older R-22 refrigerant (typically known as "Freon"). This refrigerant is no longer allowed in equipment manufactured after 2010 due to environmental concerns and was replaced by R-410A refrigerant. While still technically available, Freon is now harder to come by and prohibitively expensive.

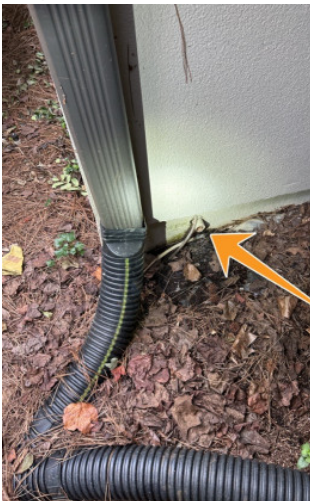
Improve: The discharge location of the condensate line as noted should be improved so that it discharges at least 10 feet from the foundations to prevent unnecessary moisture near the structure.

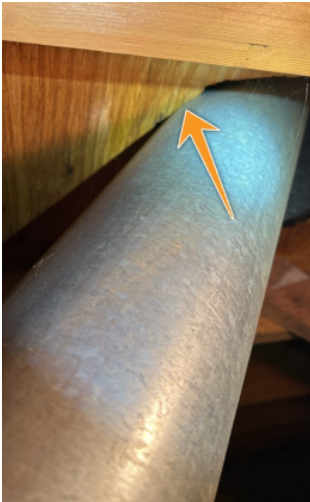
Repair, Safety Issue: There is insufficient clearance between the exhaust flue and combustible materials as noted (a minimum of 1" clearance is typically required). This is a fire hazard and should be corrected immediately by a qualified heating technician. Typically a metal collar is installed on the vent to prevent further movement and contact with adjoining materials.

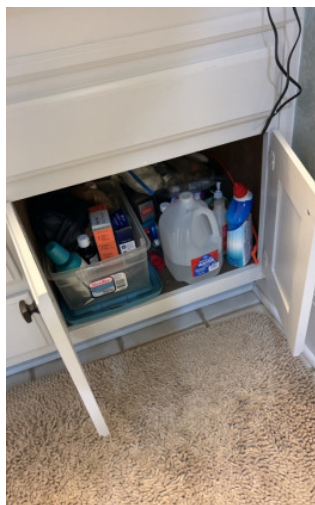
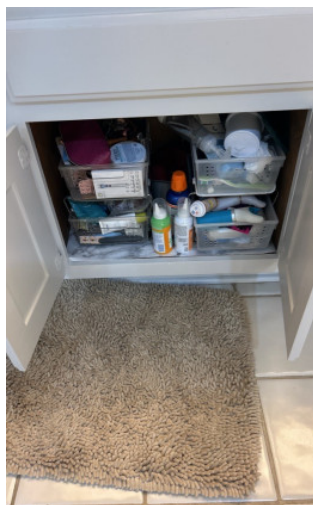
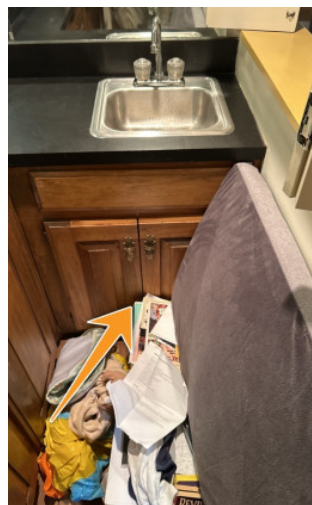
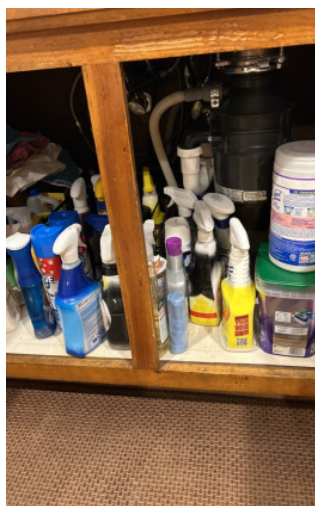
Monitor: Due to storage and/or household items, access was limited or obstructed in the location(s) noted. Inspectors do not touch or move items and your inspector is not able to inspect areas where access is severely limited or obstructed. Remove obstructions and inspect the area(s) noted for signs of leakage.

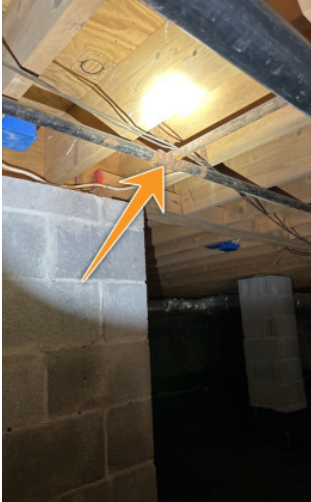
Repair: Rust can lead to deterioration and possibly leakage of the gas piping. Sand and paint with Rustoleum or equivalent for minor rust conditions. Have a plumber replace if more advanced rust piping conditions are evident.

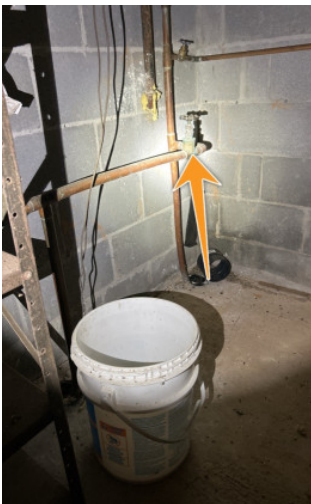
Improve: The main whole house water shutoff valve appears to be at the location pictured (confirm with seller) and should be labeled for proper identification. The shut-offs for the outside hose faucets should also be properly labeled for future access. We recommend shutting off the water when leaving the house for extended periods of time.

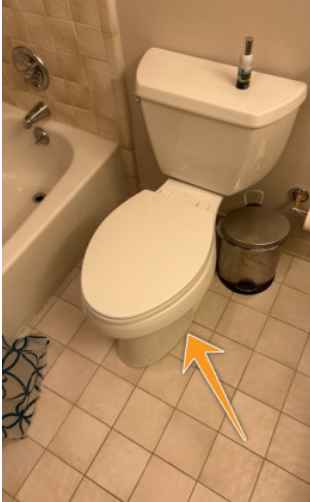
Repair: The toilet at the location noted was loose and needs repair. Have the wax ring checked for leaks and the toilet properly bolted to the floor.

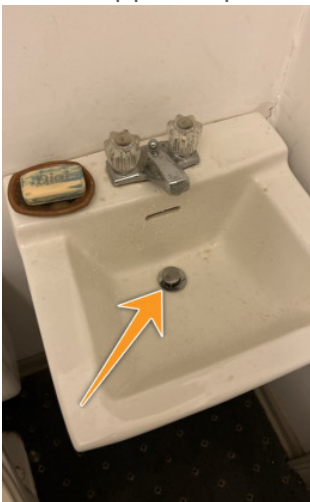
Repair: The sink stopper(s) as noted did not function properly or are missing and need repair or replacement altogether.

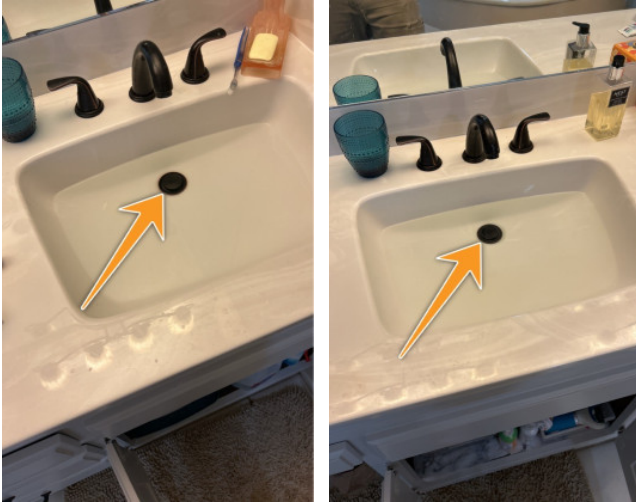
Repair: The sink was draining slowly indicating that an obstruction may exist or the sink stopper needs adjustment. Have the stopper adjusted and then check the P-trap and drain line for blockages and clear as needed.

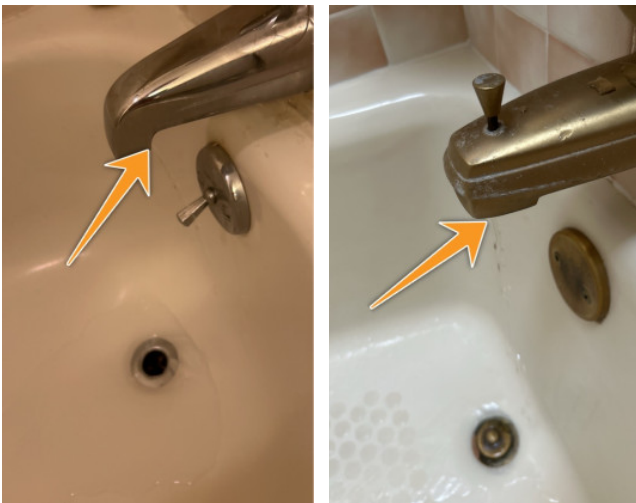
Repair: The shower diverter at the bathtub does not completely divert all of the water to the shower head, which should be improved as needed for proper function.

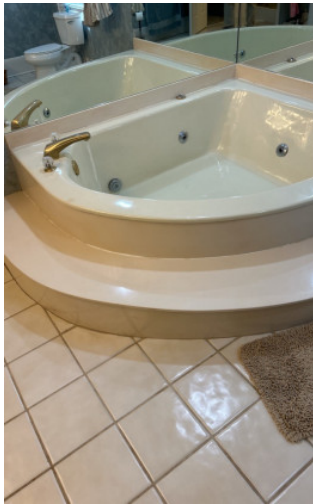
Monitor, Possible Repair: Access to the whirlpool motor should be provided (or its whereabouts should be verified with the current owner).

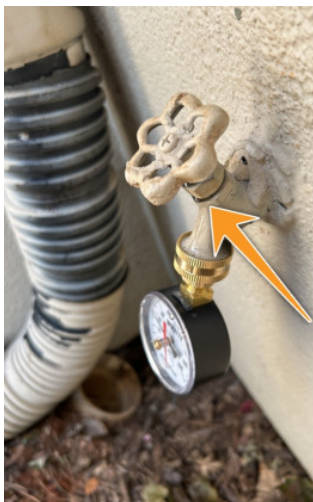
Repair: The exterior hose bibb at the location pictured does not shut off entirely or otherwise leaks at the handle, which places unnecessary moisture next to the foundation. It should be repaired or replaced as needed.

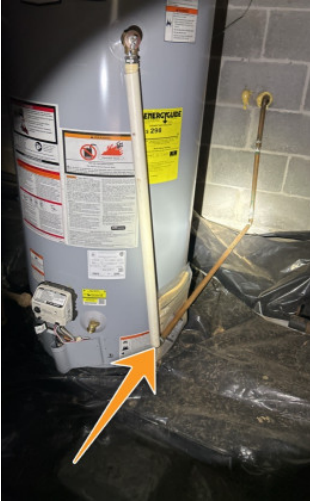
Repair, Safety Issue: Current safety standards in the state of GA allow discharge piping for the TPR (Temperature and Pressure Relief) valve to route upwards, but a drain mechanism or bleeder valve is required at the lowest point of the line before it turns up. This device should be added as needed to drain water build up in the lines, which can cause damage to the TPR valve.

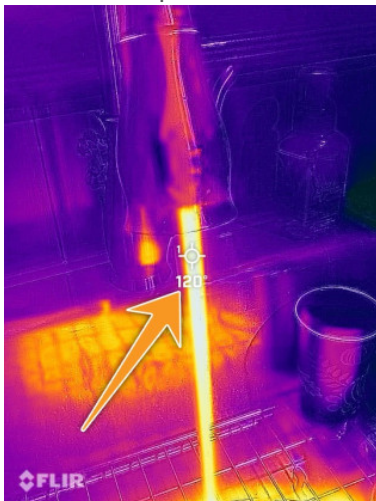
Monitor: Water temperature measured at or below 120 degrees Fahrenheit, the threshold for scald hazards. No action necessary, FYI only.

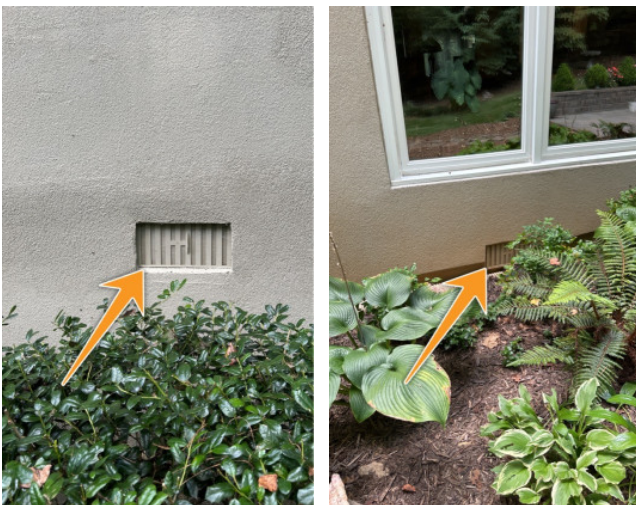
Monitor: Ventilation of the crawl space may be insufficient. A full vapor barrier and dehumidifier were noted, so monitor for excess humidity and moisture in the crawlspace; if necessary, additional ventilation will help control humidity and reduce the potential for rotting of wood components, termite infestations, and toxic mildew growth. Ventilation can

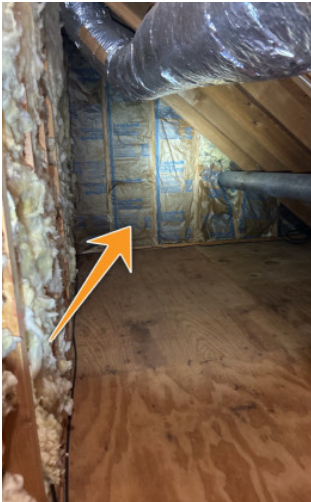
Repair, Safety Issue: The insulation batts are installed with the paper vapor barrier exposed, which presents a fire hazard (see label on facing). The insulation should be either turned around so that the vapor barrier is not exposed or covered with an approved product (e.g., drywall). Otherwise, the insulation should be replaced with a product that does not have a paper backing (known as "unfaced" insulation).

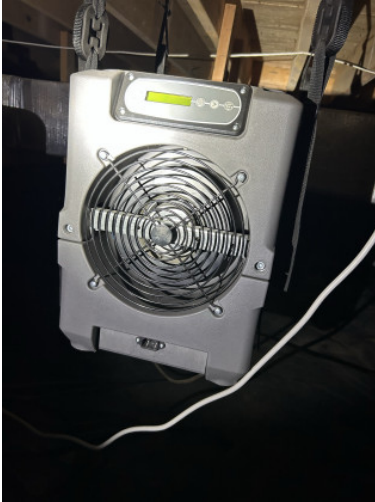
Repair: The permanent dehumidifier installed in the crawlspace was not operative at the time of inspection and had been replaced with a light duty home/office unit. Consult the owner for details, or a waterproofing contractor for further evaluation and repair as necessary.

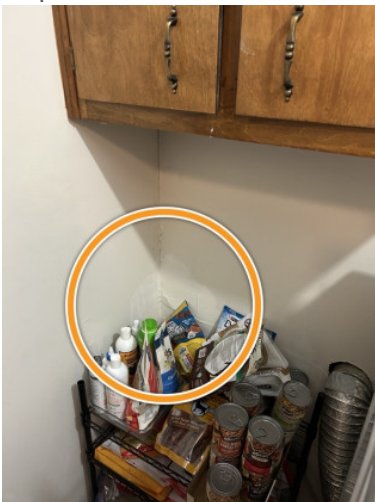
Monitor: Previous repairs were noted. Consult the seller for history of damage and repairs, and monitor for future leakage or damage.

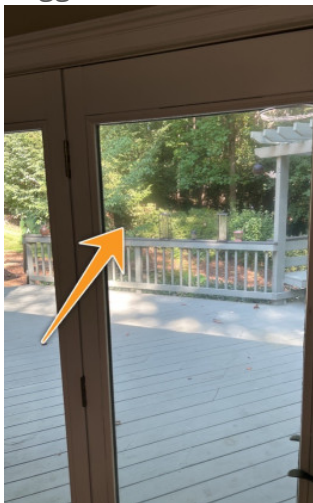
Repair: "Fogged" glass was noted, which should be replaced. This condition is typically caused by damaged seals around the perimeter of the insulated glass, which in turn allows condensation to develop between the panes. All damaged glass panels in this area should be replaced by a qualified glass replacement contractor. The contractor should inspect all other insulated panels in the house for additional condensation that may be occurring in the glass.

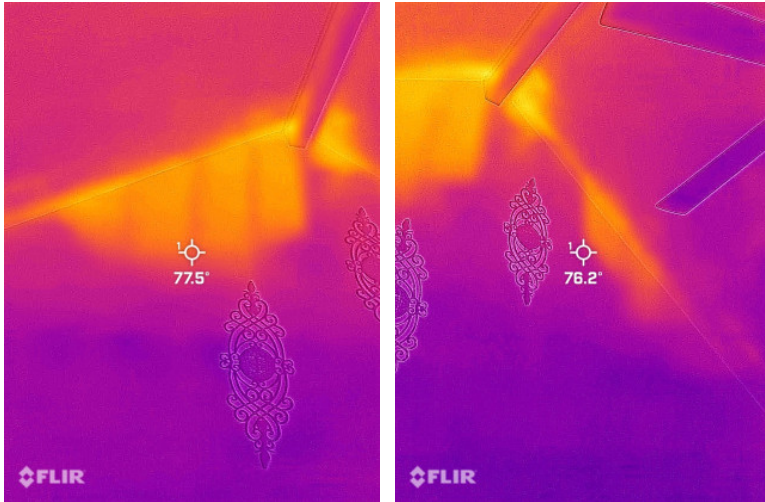
Monitor: Thermal imaging was performed on the walls and ceilings of the living space. No concerns with water intrusion were noted at the time of inspection, but there were some typical, minor, warm spots where insulation may be missing, compressed, or damaged. Monitor for general comfort and consult an insulation contractor for repair if desired.

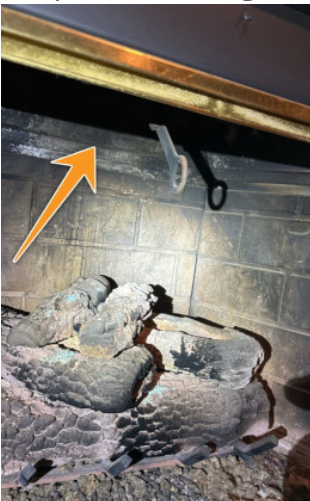
Repair, Safety Issue: The fireplace chimney could use cleaning due to the presence of built-up soot in the chimney from the gas logs. All flues and gas connections should be checked on an annual basis for proper safety.

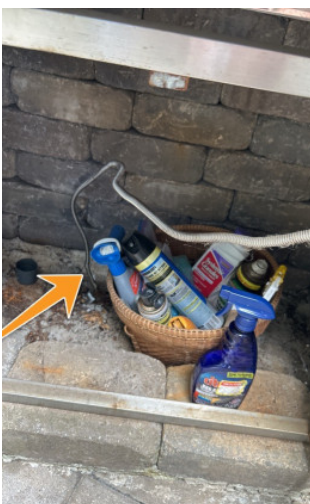
Repair, Safety Issue: There does not appear to be a gas shut-off valve below the cooktop, which should be added as needed for proper control and safety.

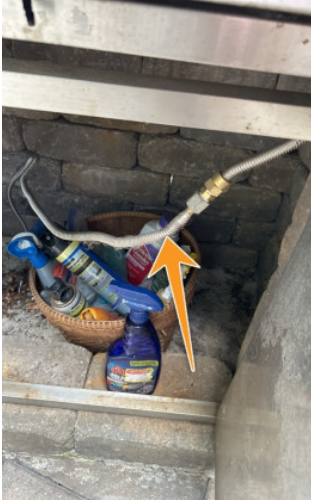
Improve: Flexible gas piping can be prone to mechanical damage and leakage. Use caution when placing items below the cooktop, or make sure shelving is installed to prevent damage to the gas line. Consider having a plumber or appliance contractor add a section of rigid pipe if possible.

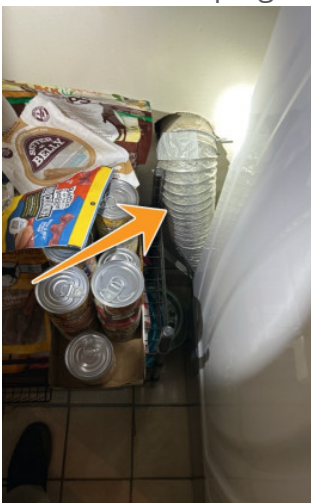
Improve, Safety Issue: The flexible clothes dryer exhaust vent pipe as noted should be replaced semi-rigid, or, ideally, rigid smooth wall piping where possible to prevent lint build-up in the line which can cause damage and possible fires at the dryer element.

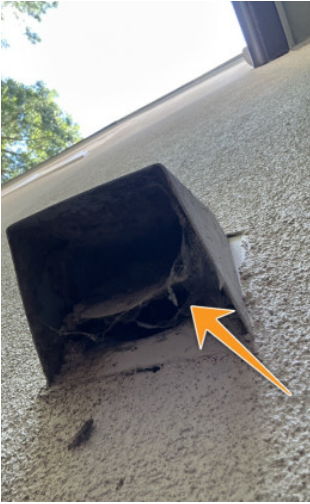
Repair, Safety Issue: The clothes dryer exhaust vent pipe appears clogged with lint and should be cleaned. Blocked piping can cause damage and possible fires at the dryer element.

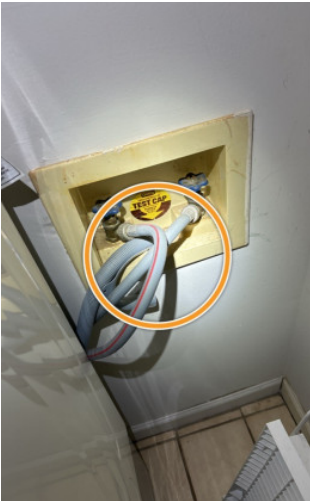
Improve, Monitor: Recommend installing stainless steel braided hoses for the water connections to the washing machine for added protection against damage to interior finishes from possible leaks at these connections.

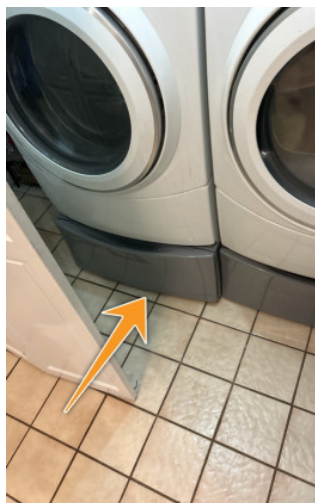
Improve: Recommend installing a metal or more durable composite overflow pan, rather than brittle plastic, that is connected to a drain line under the washing machine (and newer dryers that have water connections for steam functionality) to prevent damage to interior finishes from leaks. A better solution would be to install a tiled floor with a curb and floor drain. Otherwise, a leak detection system should be used. Also recommend installing metal braided hoses for the water connections for added protection.

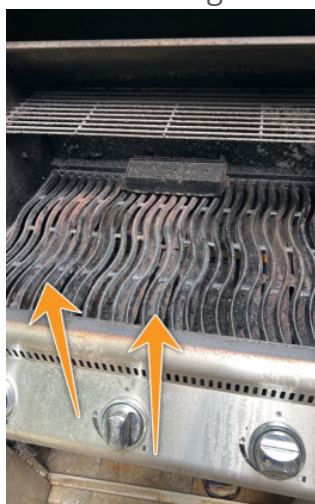
Repair: The electronic igniter for the outdoor grill did not work when tested using normal controls. Consult the seller for details of operation, or consult an appliance repair technician for troubleshooting and repair.
