Top Choice Inspectors

Residential Inspection Report

141 Gamble Lane , Pueblo, Colorado 81001

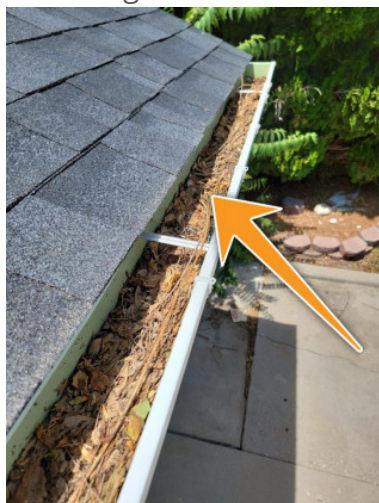
DEFICIENCY 2.1

Debris - gutters

I found debris accumulating in the gutters. I recommend cleaning to facilitate water flow.

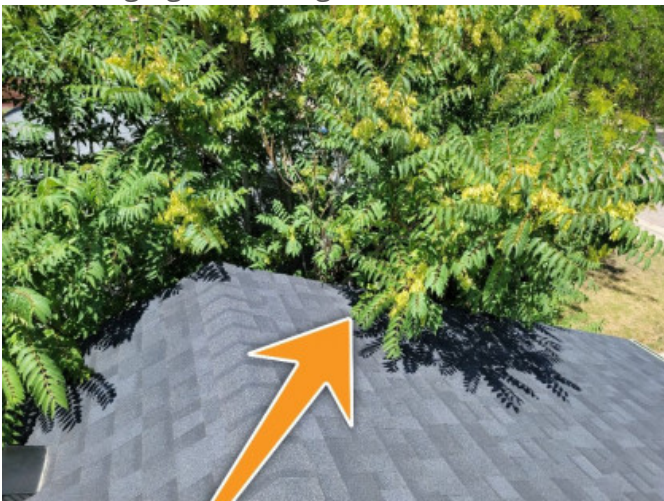
DEFICIENCY 3.4

Overhanging Roof - Vegetation

Trees observed overhanging the roof. This can cause damage to the roof when large limbs fall during high winds or other adverse weather. It can also clog gutters/downspouts if debris is not cleaned out regularly. I recommend trimming trees which overhang roofs.

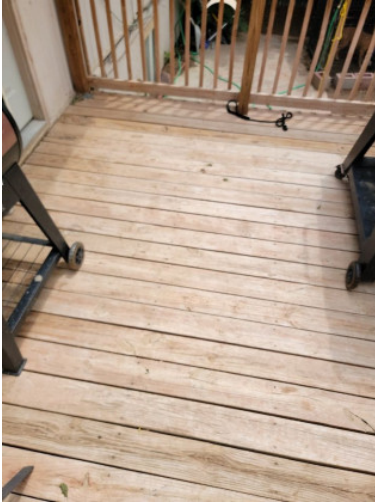
DEFICIENCY 3.8

Water Sealant Recommended - Decks, Balconies, Porches & Steps

The exterior structure is showing signs of weathering and/or water damage. It's important to keep it sealed, not only for visual reasons but also to prevent any water intrusion and rotting. I recommend applying a water sealant to extend life. Here is a helpful article on staining & sealing.

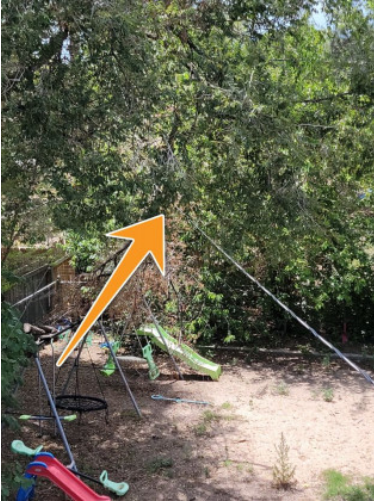
DEFICIENCY 5.1

Contact with Tree(s) -Service Entrance

It is recommended that the tree branches are cut back so they are not in contact with wires. This will help prevent power outages during high wind storms and during the winter months.

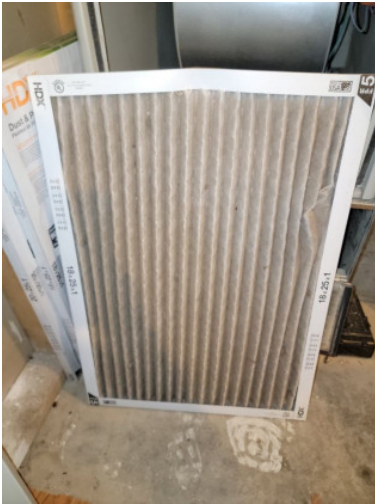
DEFICIENCY 7.1

Dirty Filter - Furnace

The furnace filter is dirty and needs to be replaced every 1 to 3 months.

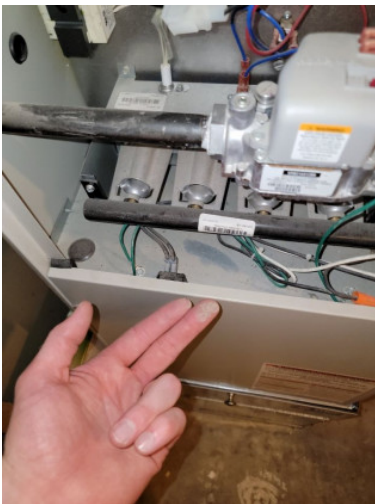
DEFICIENCY 7.2

Clean/Service - Furnace

The furnace is dirty. I recommend servicing by a qualified HVAC technician.

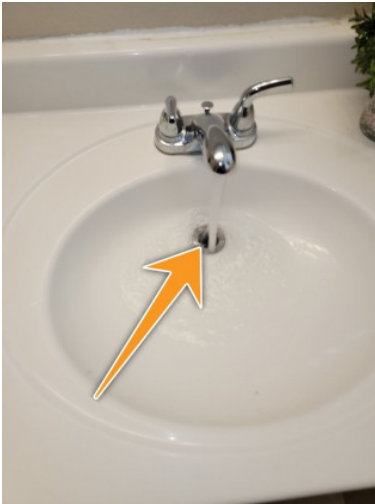
DEFICIENCY 8.4

Not Functioning - Drain Assembly

The drain stopper at the fixture was missing or not functioning. Repair or replace.

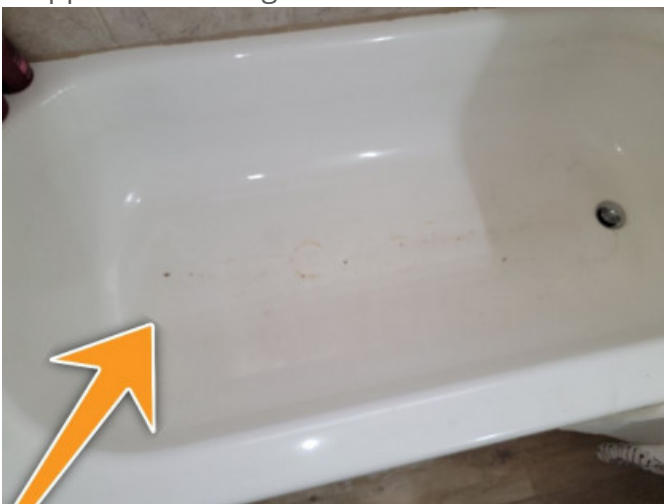
DEFICIENCY 8.6

Chipped - Plumbing Fixture

There appears to be a chip in the fixture. I recommend using a sealant before it chips further.

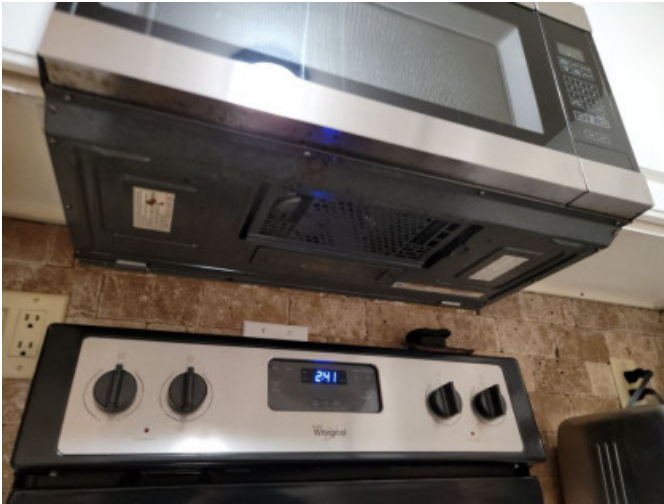
DEFICIENCY 10.4

Light Burnt Out - Built-in Microwave

Replace Bulb.
