Residential Inspection Report

5240 Prairie Grass Lane , Colorado Springs, Colorado 80922

November 03, 2022 09:30 am

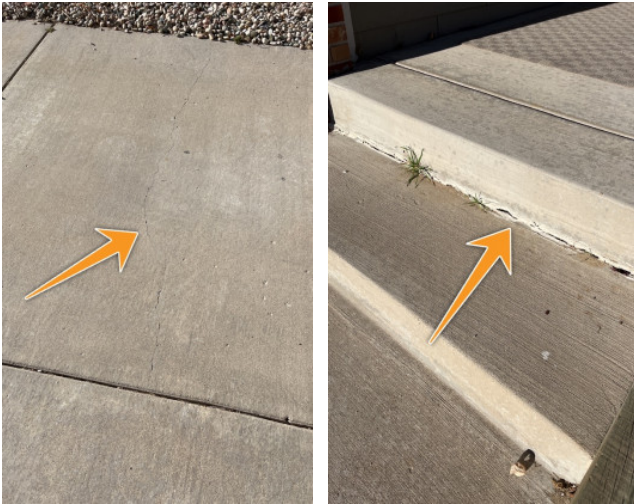
DEFICIENCY 3.1

Cracking/Settling - Minor - Walkways Patios Driveways

I observed some minor cracks in the cement. This is very typical due to soil movement. I would consider these cracks cosmetic, but I do recommend using a sealant to prevent water intrusion. Monitor and maintain as necessary.

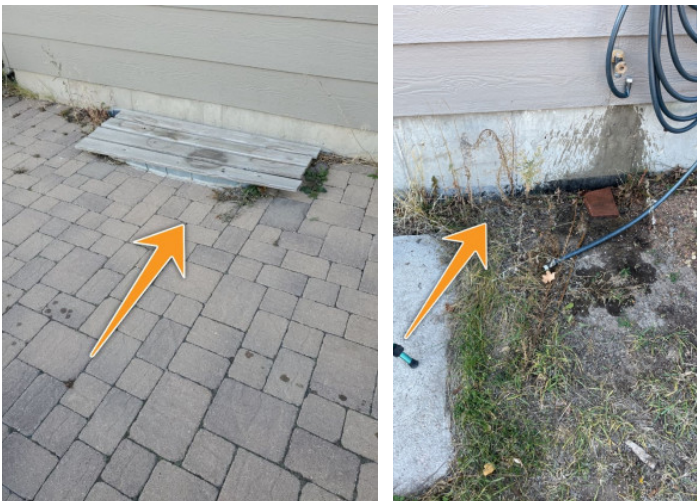
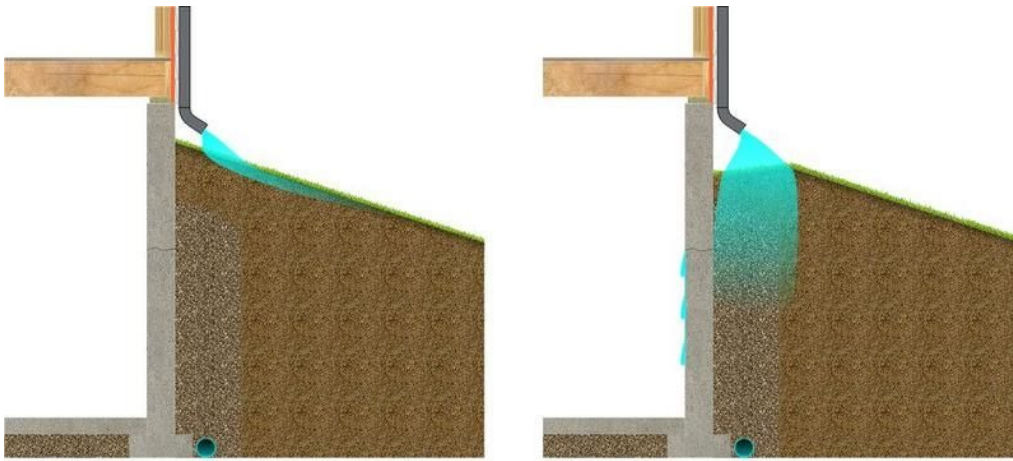
DEFICIENCY 3.2

Negative Grading - Landscaping

POSITIVE DRAINAGE

NEGATIVE DRAINAGE

Grading is sloping toward the home in one or more areas. This could lead to water intrusion and foundation issues. I recommend qualified landscaper or foundation contractor re-grade so water flows away from home.

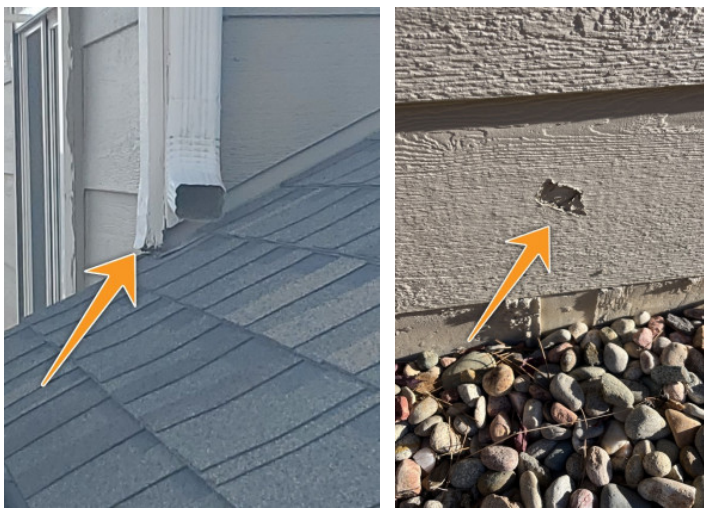
DEFICIENCY 3.6

Damaged - Siding/Trim

There appears to be one or more areas of damaged siding. Recommend replacement or repair of siding.

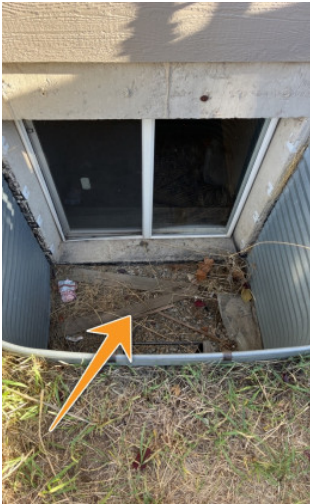
DEFICIENCY 3.7

Debris - Window Wells

Debris has accumulated in the window wells. I recommend removal before mold, flooding, deterioration or other issues occur.

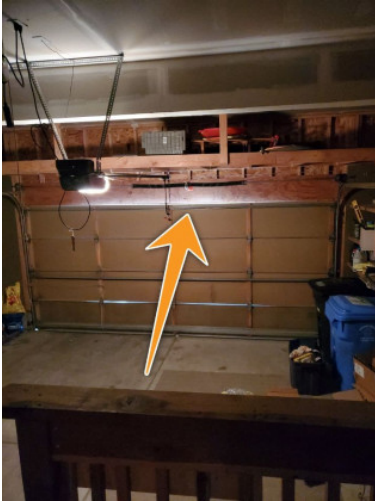
DEFICIENCY 4.1

Weatherstripping Damaged/missing - Garage Door

I recommend repair or replace.

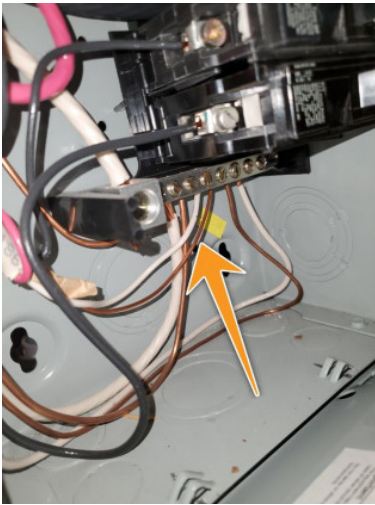
DEFICIENCY 5.1

Improperly Wired Sub Panel

The sub panel does not appear to be wired properly on the neutral buss bar recomend repair.

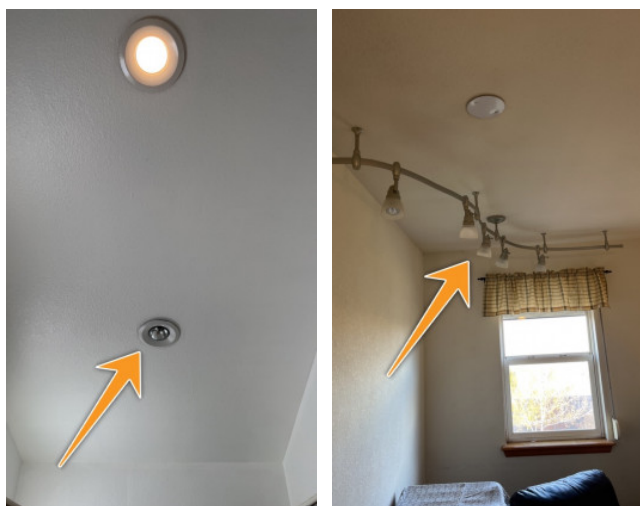
DEFICIENCY 5.5

Inoperable - Light Fixture

Light was not operating during the inspection. It could be just a simple light bulb that is burnt

out, but I recommend communicating with the seller to determine if the light does actually function.

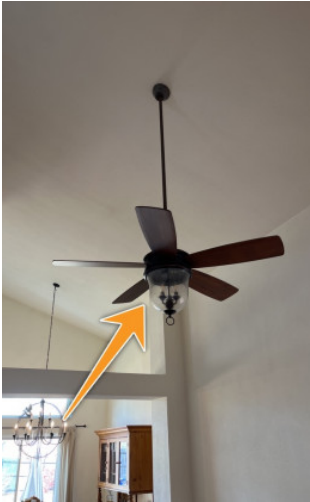
DEFICIENCY 5.6

Inoperable - Ceiling Fan

There is a ceiling fan that was inoperable at time of inspection recommend repair.

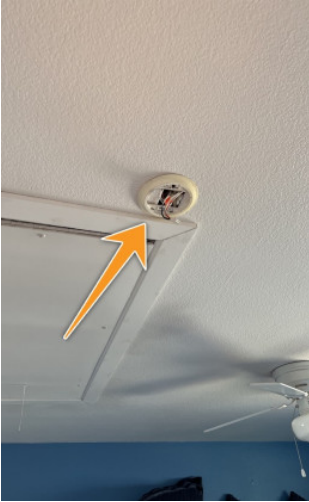
DEFICIENCY 5.8

Missing - Smoke Detectors

Smoke detectors were missing at the time of inspection. I recommend installation.

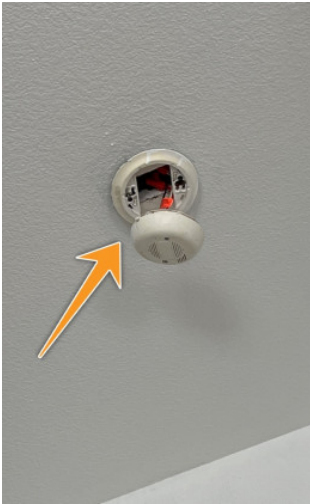
DEFICIENCY 5.10

Hanging - Smoke Detector

One or more smoke detectors were hanging from the power wires at the time of the inspection. Recommend ensuring they work and properly installing them.

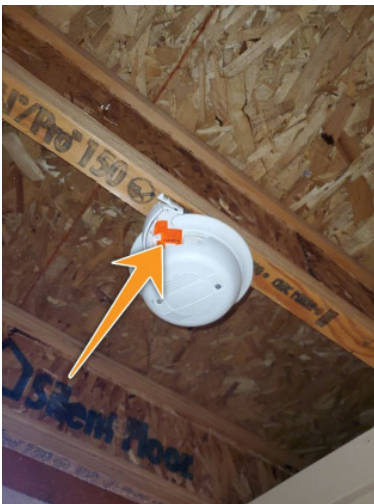
DEFICIENCY 5.11

Battery Missing - Smoke Detector

One or more smoke detectors had the battery missing at the time of the inspection. Recommend replacement.

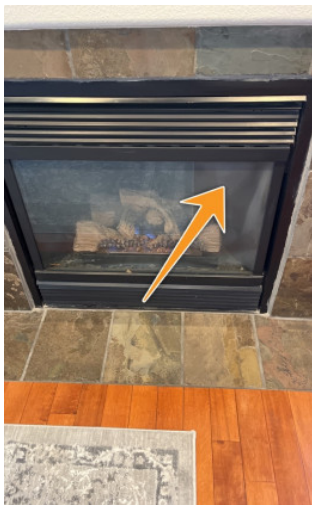
DEFICIENCY 7.2

Foggy glass - Fireplace

The glass on the gas fireplace was foggy at the time of the inspection. Recommend cleaning of glass.

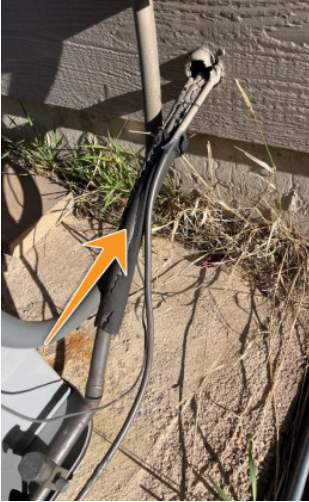
DEFICIENCY 8.5

Missing/Damaged - Insulation for A/C

Missing or damaged insulation on refrigerant line can cause energy loss and condensation. I recommend having condensate lines insulated to improve unit efficiency.

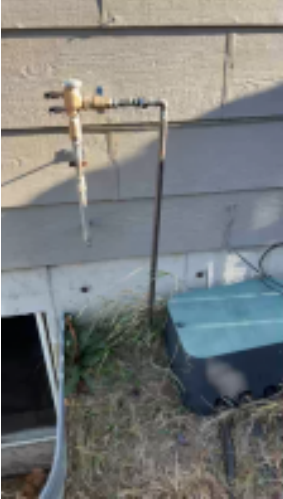
Not tested - Sprinkler System

Irrigation system not tested

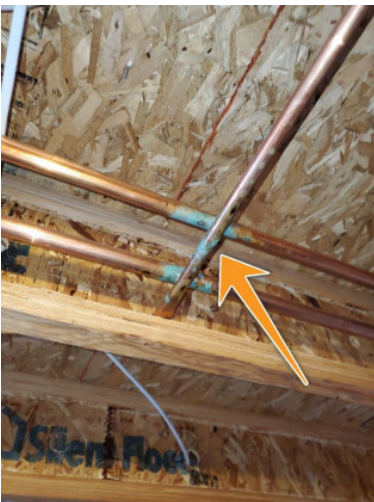
DEFICIENCY 9.2

Corrosion - Supply Pipes

Pipe and/or fittings were observed to have corrosion. This can lead to a shortened lifespan.

Recommend a qualified plumber repair.

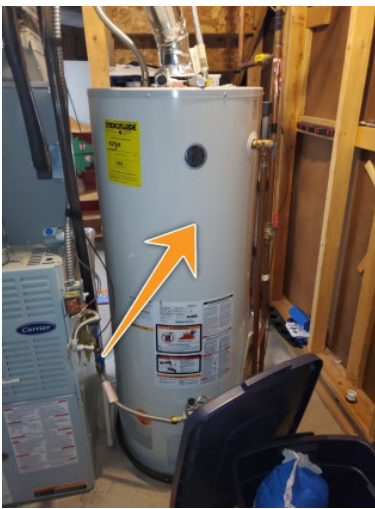
DEFICIENCY 9.3

Dated Water Heater

The expected lifespan of a water heater is 8 to 12 years. One or more of the water heaters in the home fell within that range or past.

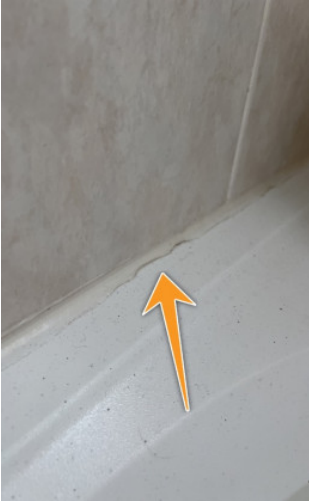
DEFICIENCY 9.5

Maintain Caulking - Plumbing fixture

The caulking around the fixture was in need of repair and/or maintenance. Water intrusion can become a costly repair. I recommend sealing with a flexible caulk or silicone and then annual maintenance.

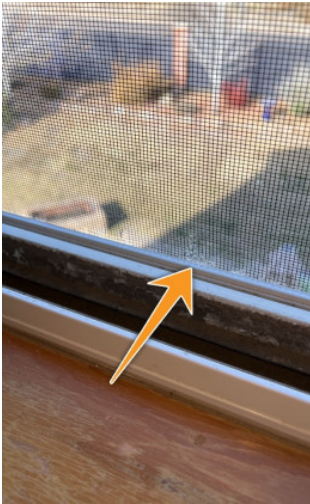
DEFICIENCY 10.3

Damaged Screen - Window

I recommend repair or replacement of the screen.

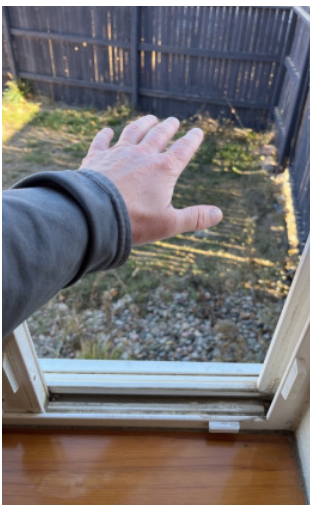
DEFICIENCY 10.4

Missing Screen - Window

When inspecting the windows, I did find that one or more of them did not have screens. I recommend replacing the missing screens.

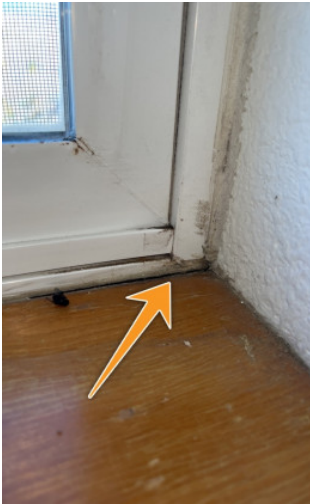
DEFICIENCY 10.5

Caulk Maintenance - Window

I did find one or more windows in the home that need to be caulked on the interior side. Caulking on the interior side is not only for cosmetic reasons, but also to weatherize the window. I recommend using a flexible and paintable caulking, and maintain over the years.
