## Cingo Residential Home Inspection

123 Any St, Atlanta, GA 30120

March 30, 2023 02:00 pm

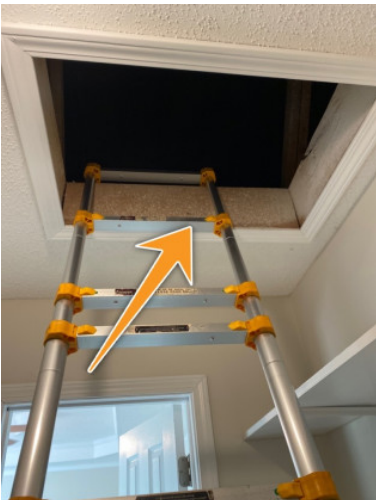
#### DEFICIENCY 2.2

Attic Hatch Needs Cover

Repair: The attic access cover is missing and should be installed to limit flow of air from the attic into the living areas. The cover should be insulated with foam board and weather-stripped to limit unconditioned air infiltration into finished areas. Otherwise an insulated

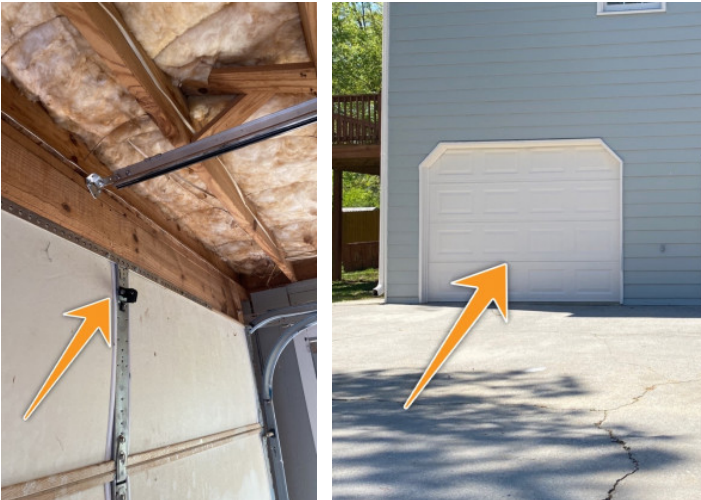
#### DEFICIENCY 3.1

Opener Inoperative

Repair: The garage door opener appears to be inoperative. It should be repaired as necessary by a qualified garage door company. The reversing mechanism should be checked for proper operation.

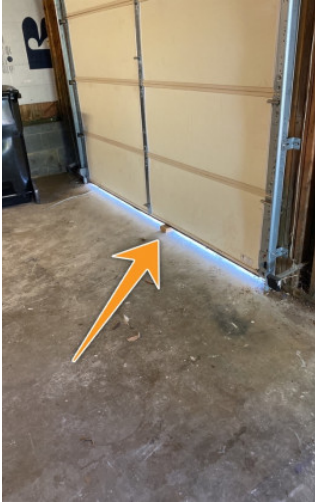
#### DEFICIENCY 3.2

Impact Reverse Adjustment Needed

Repair, Safety Issue: The garage door opener did not automatically reverse using standard testing procedures as required by the National Safety Council (door must reverse upon hitting a 2x4 block of wood laid flat on the floor below the door). There is a risk of injury, particularly to children, and damage to vehicles under this condition. The opener and door should be serviced and adjusted as needed by a qualified garage door service company.

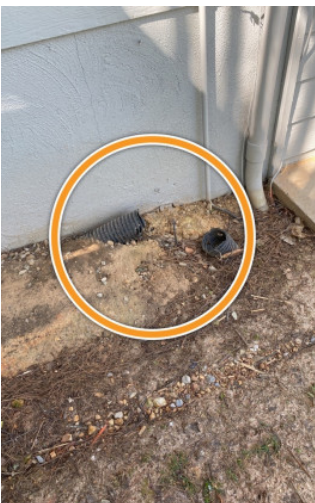
### DEFICIENCY 4.1

French Drains - Monitor

Monitor: The ends of the french drains which should surround the perimeter footings (appear to be at the location pictured). Monitoring these are important for insuring that the

system is draining properly. Make sure they are not tied to an underground piping system for the downspouts. This condition could allow water to become trapped next to the foundation should the piping become clogged with debris.

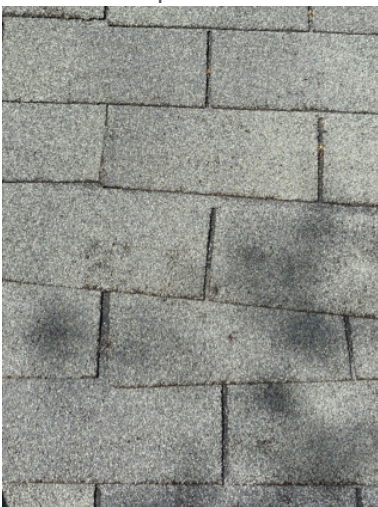
### DEFICIENCY 5.1

General Repairs Needed

Repair: General repairs to the roofing are needed, which should be performed by a qualified roofing contractor. Damaged or missing roofing shingles as noted should be replaced. All "eyebrows" (shingles that are lifted up by protruding nail heads) as noted should be repaired by lifting the shingles and re-driving the nails in the decking. All holes and exposed nail heads

should be caulked and sealed. All roof penetrations should also be examined and sealed as necessary, especially as noted.

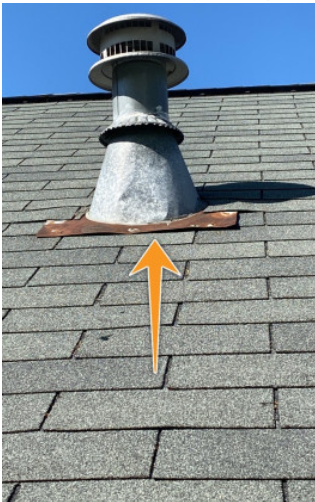
### DEFICIENCY 5.2

Older Flashing - Replace

Repair: The flashing components as noted is older material and should be replaced altogether to avoid leaks.

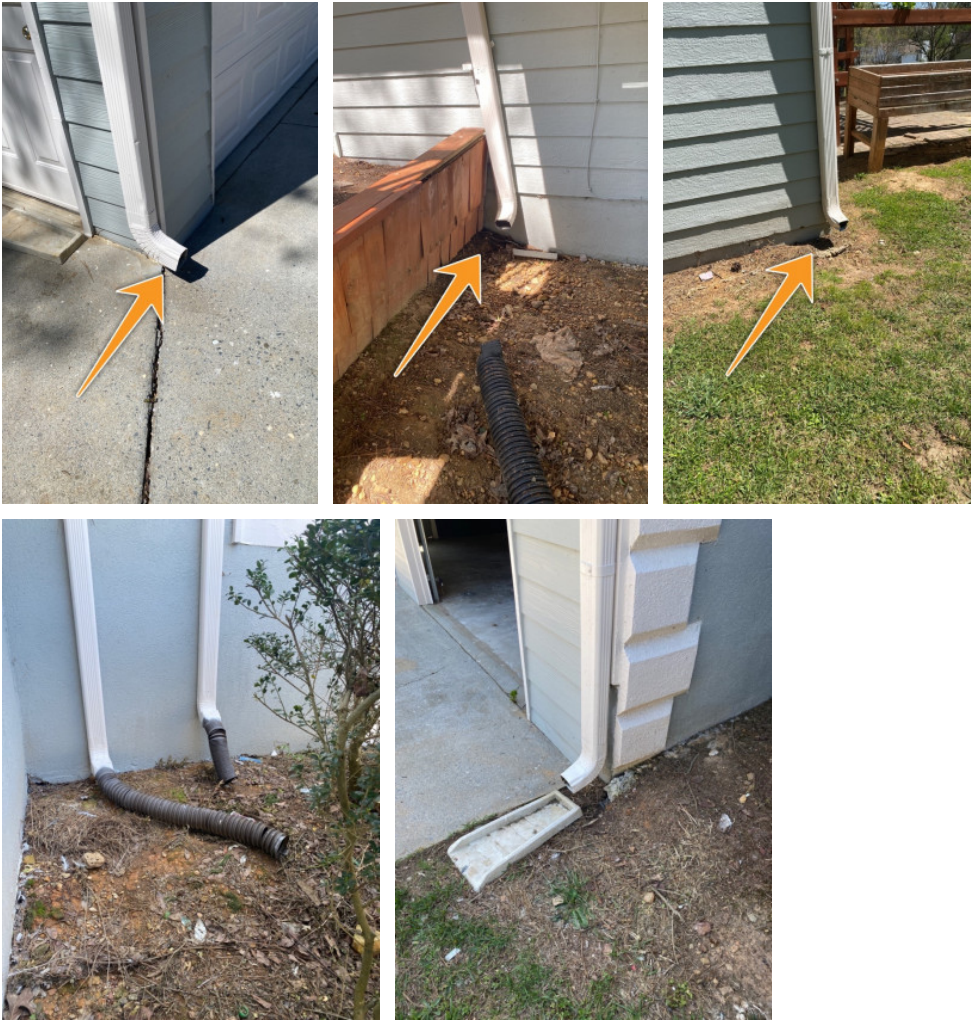
### DEFICIENCY 5.4

Downspouts Discharge Near House

Repair: All of the downspouts should be piped away from the foundation so that they discharge water at least ten (10) feet from the house or into an underground drainage system to prevent moisture infiltration into the basement and settlement of the foundation. The drainage at the left front side appears to be contributing to the damage to the driveway. Recommend using smooth wall piping as opposed to the black ribbed piping, which is more prone to blockages. Storm water should be encouraged to flow away from the building at the point of discharge.

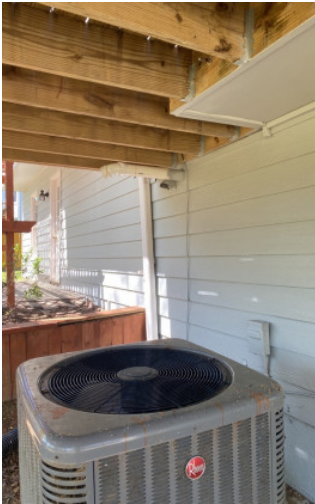
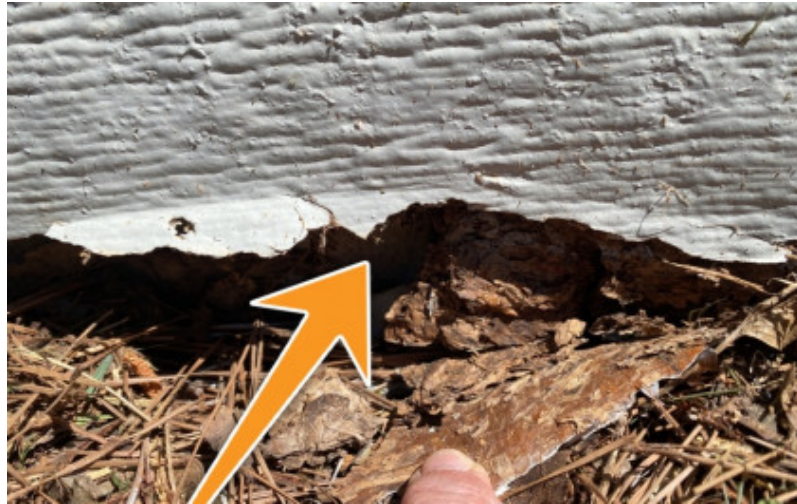
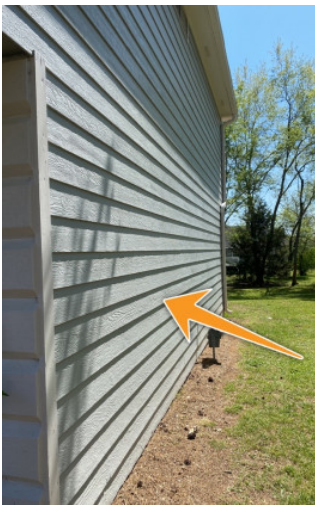
### DEFICIENCY 6.1

Hardboard Siding (Monitor)

Monitor: Hardboard siding such as this has a limited life and is susceptible to weather damage. While it may be possible to prolong the life of this material, substantial re-siding may ultimately be necessary. In the meantime, the siding should be kept well caulked and painted to prevent moisture intrusion and damage.

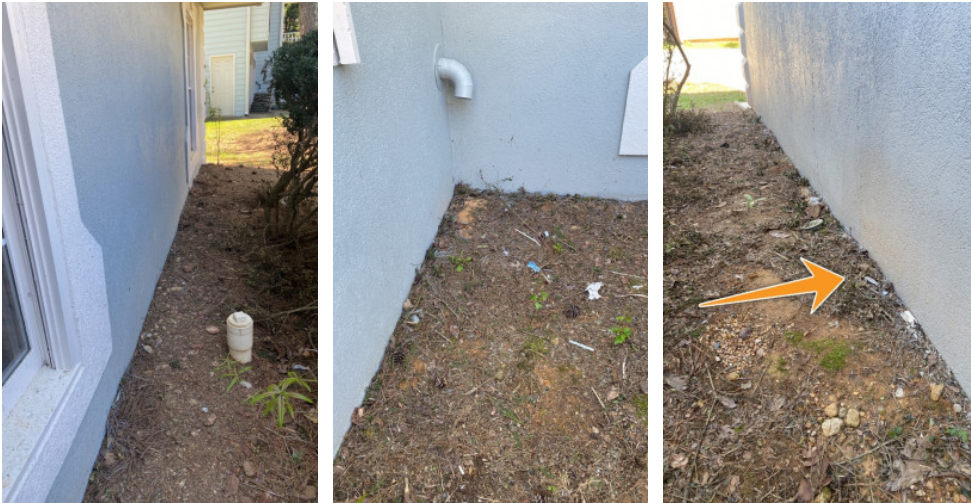
## DEFICIENCY 6.3

Eifs Grade Contact

Repair: Synthetic stucco as noted is a weather sensitive material that should be kept well protected and sealed at all times. The bottom edge of this veneer appears to be in contact with the soil, which can be a source of moisture and insect infiltration. All foam board should be cut back to provide at least 6" clearance with the soil and the exposed edges properly sealed. All joints with woodwork should be properly caulked. All windows, doors, chimneys and intersecting roofs should be properly flashed. Consult with a professional stucco contractor adept in repairing these systems.

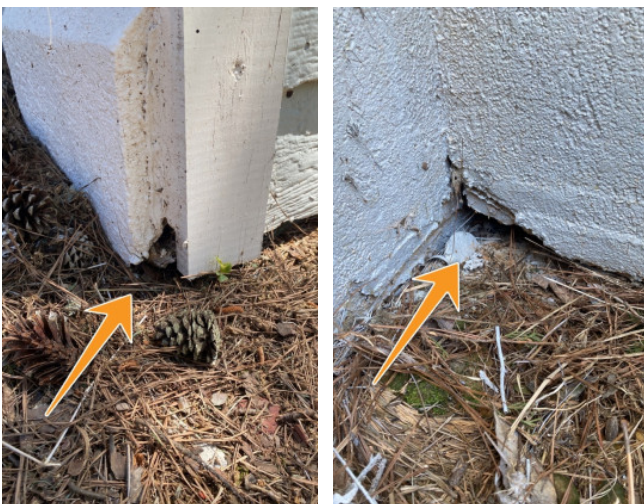
## DEFICIENCY 6.4

Eifs Exposed Foam At Grade

Repair: Synthetic stucco as noted is a weather sensitive material that should be kept well protected and sealed at all times. The bottom edge of this veneer appears to have been cut

back from the grade but the edge of the foam backing is exposed which can be a source of moisture and insect infiltration. All exposed edges of the foam should be properly sealed and all joints with woodwork properly caulked. Consult with a professional stucco contractor adept in repairing these systems.

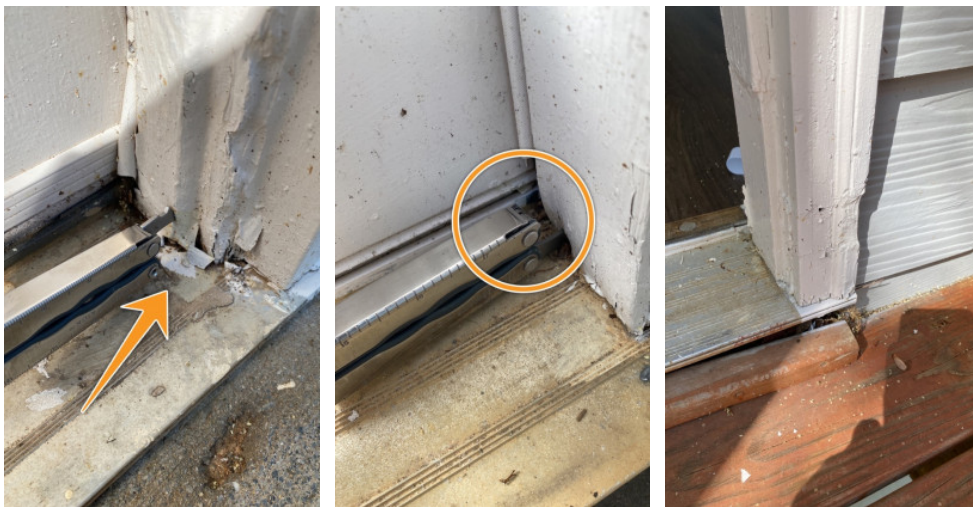
### DEFICIENCY 6.5

Door Rot Noted

Repair: The door frames show various degrees of rot/damage and needs repairs. Following repair of the damaged areas (which should be combined with exterior painting) proper maintenance of the windows and doors and control of water from roof or surface runoff can avoid further damage.

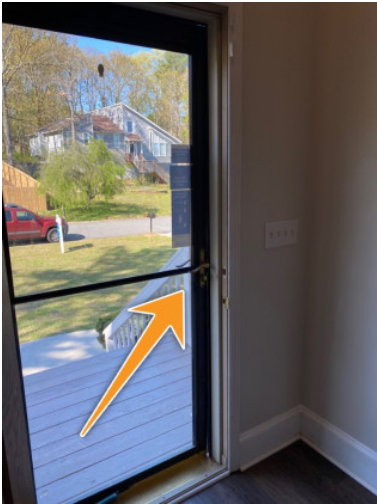
### DEFICIENCY 6.6

Adjust Exterior Door

Improve: Exterior doors should be adjusted to close and fit properly as noted for ease of operation and to limit outside air and moisture infiltration.

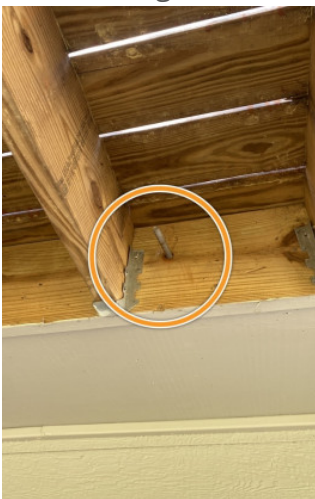
### DEFICIENCY 6.8

Bolt Missing Washer and Nut

Repair: One of the bolts attaching the deck ledger to the structure of the house was missing

its washer and nut. Repair and check all bolts.

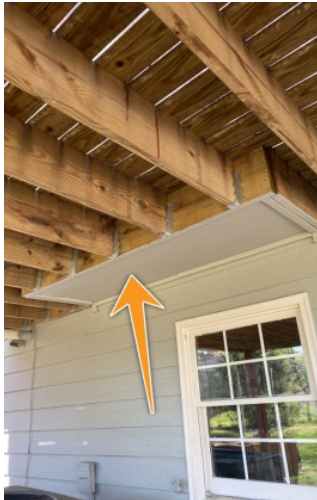
### DEFICIENCY 6.9

Deck Supported By Bay Or Overhang

Repair, Safety Issue: Decks should not be supported by bays or overhangs and in such cases, should be self supported with columns. The area of the deck at the location pictured is attached to and appears to be supported by the overhang and should instead be supported by separate columns installed on proper footings under the floor system.

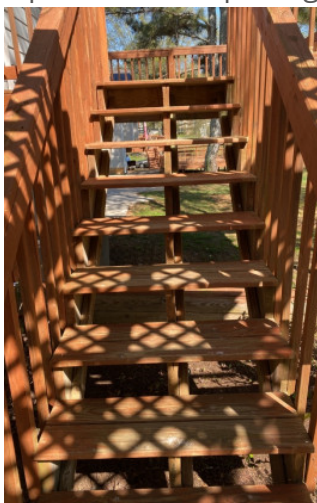
Open Risers / Openings Between Treads >4"

Repair, Safety Issue: Openings between stairs treads are not allowed to be greater than 4" as recommended for child safety.

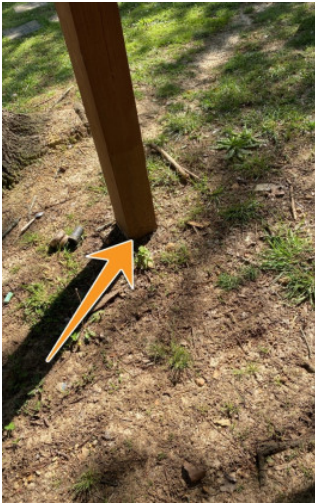
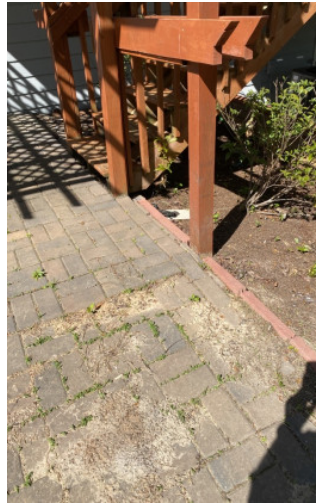
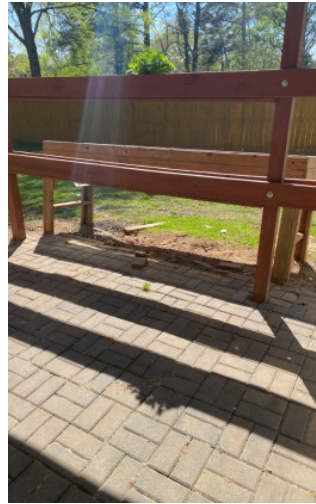
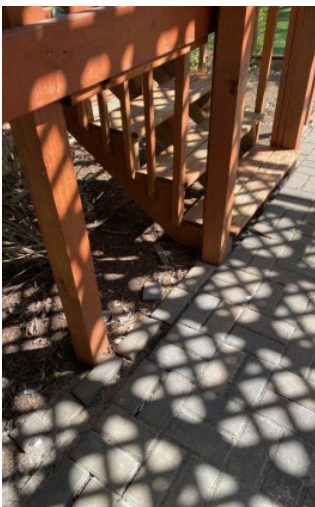
### Grade Contact With Wood Columns

Repair: The grade is in contact with the base of the support wood posts for the deck, which can cause moisture and termite damage in the future. Recent studies have shown that even pressure treated wood can rot over time due to constant contact with the soil. Make sure the footings for the posts are in place and extend at least 2" above the ground to keep the bottoms of the posts dry and free from soil contact.

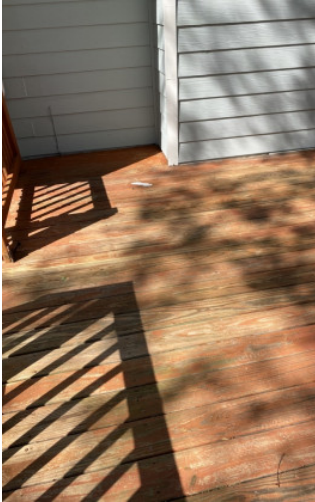
### Deck Paint / Stain Needed

Improve: The wood deck should be power-washed and then painted or stained to improve durability and protection against further weather damage.

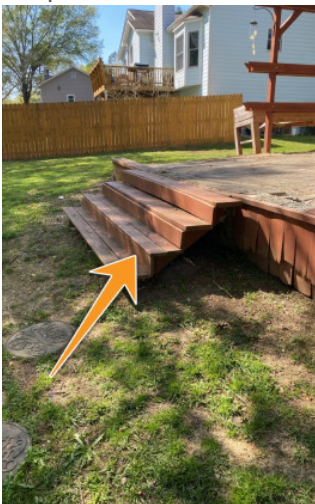
Steps Settled

Possible Repair, Safety Issue: The steps at the rear have settled. Repairs or rebuilding altogether should be considered for improved safety. A landing is needed.

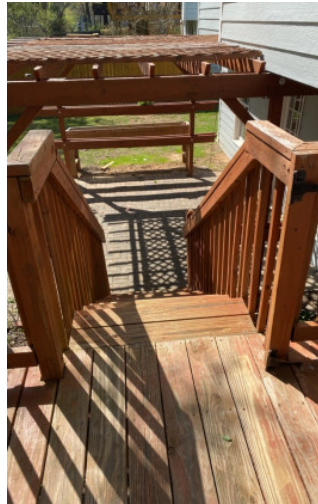
Handrail Needed (Improve)

Improve, Safety Issue: Recommend installing a handrail at the exterior steps at the location pictured for improved safety. Current safety standards recommend a handrail for steps of four (4) or more risers.

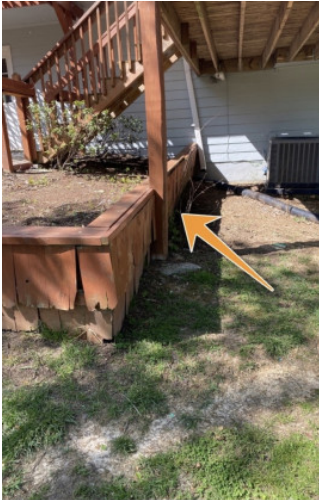
Guardrail Recommended At Retaining Wall

Improve, Safety Issue: Current safety standards require a guardrail for walking areas that are more than 30" off the ground. This provision also applies to finish grades above retaining walls that are attached to the structure. There was no guardrail at the retaining wall as noted and should be installed as needed.

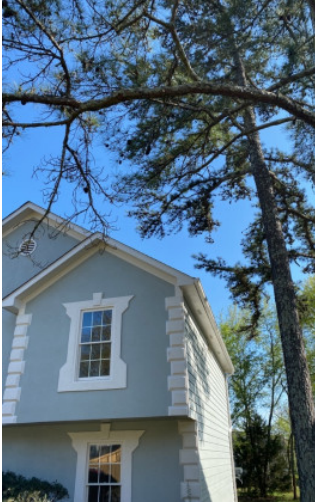
Cut Back Overhanging Limbs

Improve: All overhanging limbs as noted should be cut back to prevent further damage to the roofing shingles and gutters and to prevent rodent infestations into the attic.

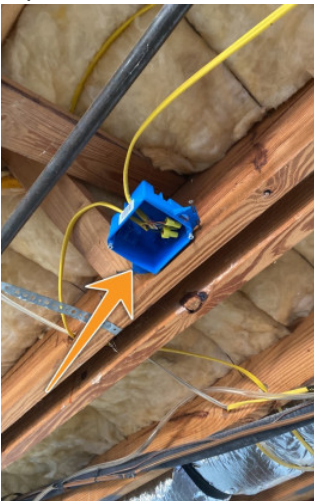
##### Open Junction Boxes

Repair: All open junction boxes as noted should be fitted with cover plates, in order to protect the wiring and to reduce the risks of potential fires that may be caused by poor connections.

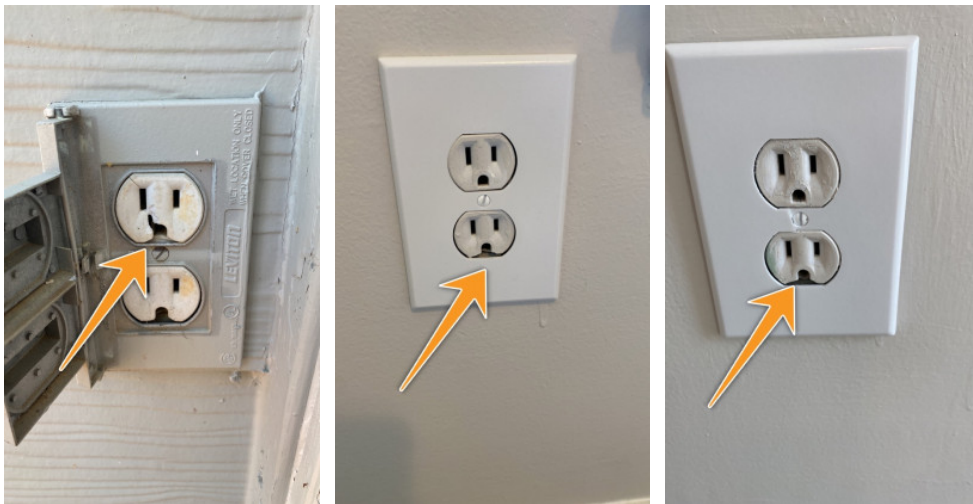
Damaged Outlet

Repair, Safety Issue: Damaged outlets as noted should be replaced to prevent shocking hazards. The electrician should check all interior and exterior for damage and replace as needed. OBJ

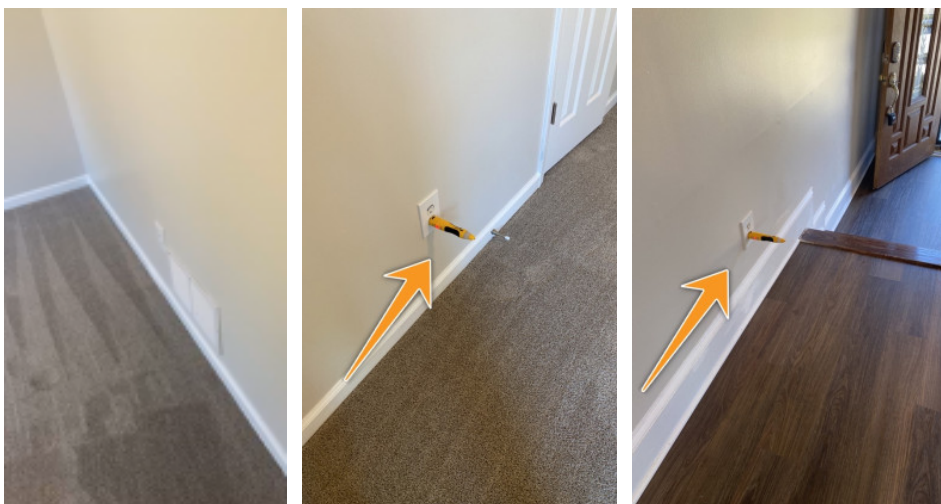
Reversed Polarity Outlet

Repair, Safety Issue: Outlets having reversed polarity (hot and neutral wires reversed) as noted (s) should be investigated and repaired as necessary. Wiring at the outlet or in the panel may need reconfiguration. The electrician should check all outlets and switches for proper wiring.

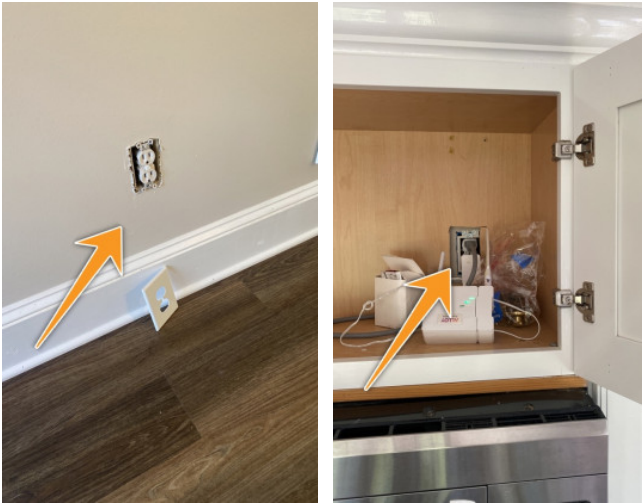
Missing Cover Plates

Repair, Safety Issue: Missing outlet and damaged cover plates as noted should be replaced as needed to avoid a shock hazard.

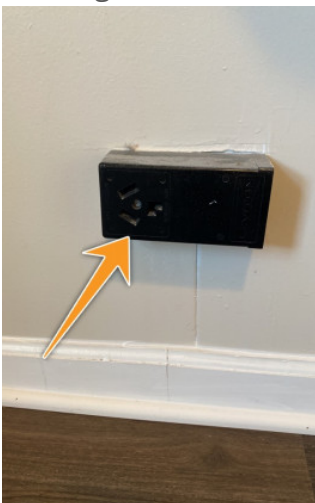
4 Prong Outlet Needed At Dryer Improve

Improve: The dryer outlet does not meet current standards for grounding requirements (4-pronged outlets now required). Recommend having an electrician change this outlet to the newer 4-pronged outlet if a newer model dryer is used.

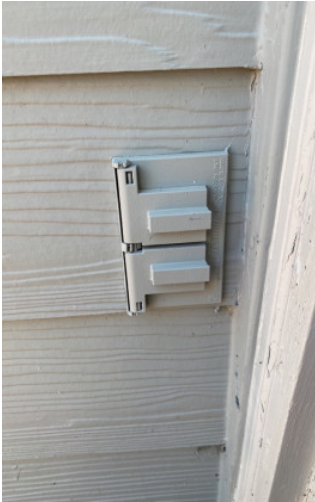
Exterior Outlets Need Weatherproof Covers

Improve: Up to date and tighter weatherproof covers should be installed on the exterior outlets as noted to prevent moisture intrusion and damage to the wiring.

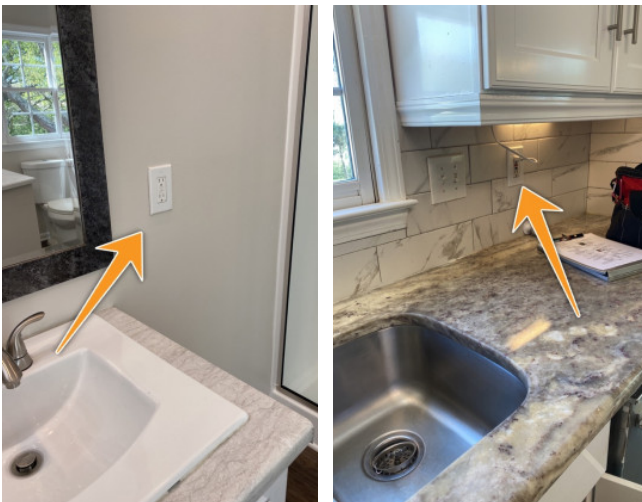
GFCI Outlet Did Not Trip Properly

Repair, Safety Issue: A ground fault circuit interrupter (GFCI) outlet as noted did not respond correctly to testing with an outlet tester. The receptacle(s) and circuit(s) should be investigated and repaired by a licensed electrician as needed for proper protection. The electrician should check all GFCI outlets for proper operation and locations and make repairs as needed.

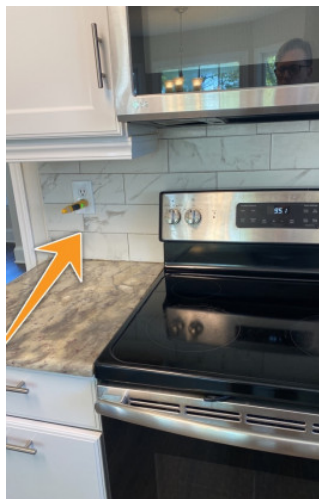
GFCI Recommended All Locations

Improve, Safety Issue: The installation of ground fault circuit interrupter (GFCI) outlets is recommended in the kitchen, baths, and at all exterior locations. A ground fault circuit interrupter (GFCI) offers increased protection from shock or electrocution. Up to date weatherproof covers should be installed at all exterior outlets.

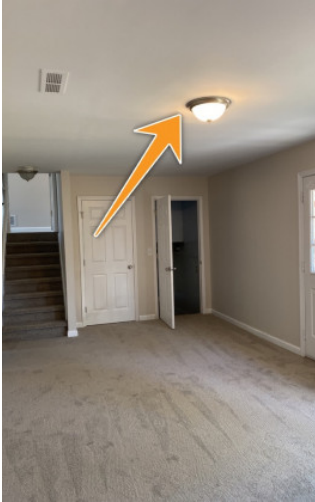
Switch Needed for Light in the Bonus Room

Repair: A light switch for the bonus room could not be found at the time of the inspection. Have the electrician install a switch to control the light or identify where the switch is located.

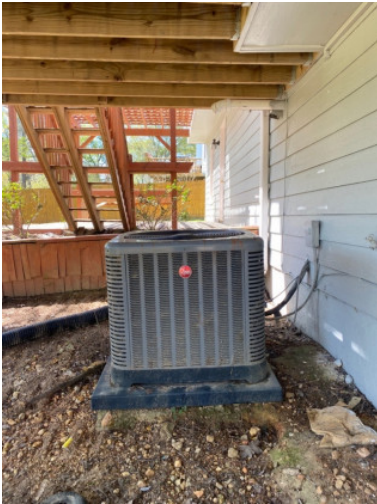
Repair: The outdoor unit of the air conditioning system is out of level. This condition should be corrected to allow for proper operation of the fan motor and compressor.

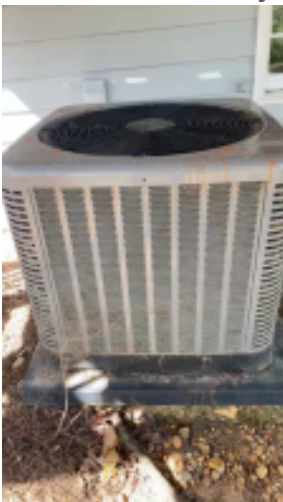
Outdoor Unit Noisy

Monitor, Possible Repair: The outdoor unit of the air conditioning system is excessively noisy, which could indicate bad bearings in the compressor or fan motor. This condition should be further investigated during servicing and repaired as needed.

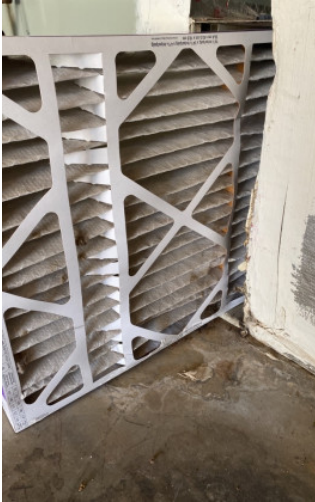
Repair, Safety Issue: The dirty air filter(s) as noted should be replaced. Dirty filters indicate the systems may have not been serviced recently. The furnace(s) should be serviced and cleaned by a qualified HVAC service company before closing if this has not been done within the last six months according to manufacturers' recommendations. The heat exchangers should be checked for cracks, which can allow carbon monoxide poisoning to infiltrate the supply air. The gas venting system should be checked for proper drafting and safety. Check with the seller concerning all previous service records.

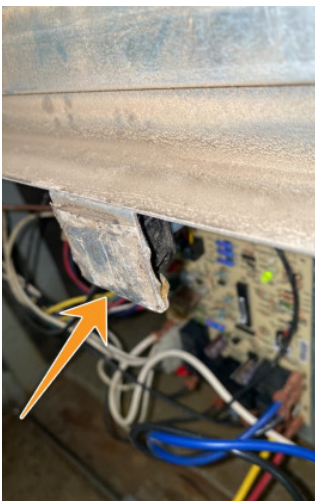
Repair, Safety Issue: The automatic shut-off switch for the blower fan at the furnace did not shut the system off as is necessary to prevent combustion air from contaminating the air supply for the system. Proper operation of this safety device should be checked for all furnaces and repaired as needed by the HVAC technician.

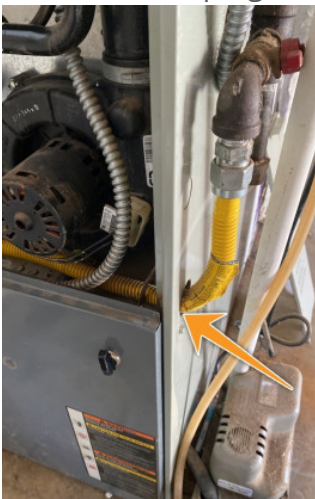
Flexible Gas Piping

Repair, Safety Issue: The gas supply line serving the furnace is flexible piping which passes through the outer case of the furnace without protection. This piping runs the risk of being damaged by the edge of the casing and should be replaced with rigid pipe or otherwise protected to prevent future leaks. A drip leg would also be required here.

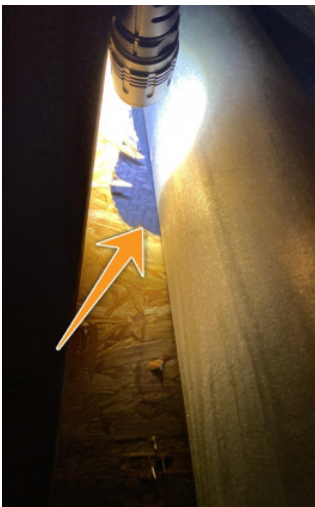
Repair, Safety Issue: There is insufficient clearance between the exhaust flue and combustible materials as noted (a minimum of 1" clearance is typically required). This is a fire hazard and should be corrected immediately by a qualified heating technician. Typically a metal collar is installed on the vent to prevent further movement and contact with adjoining materials.

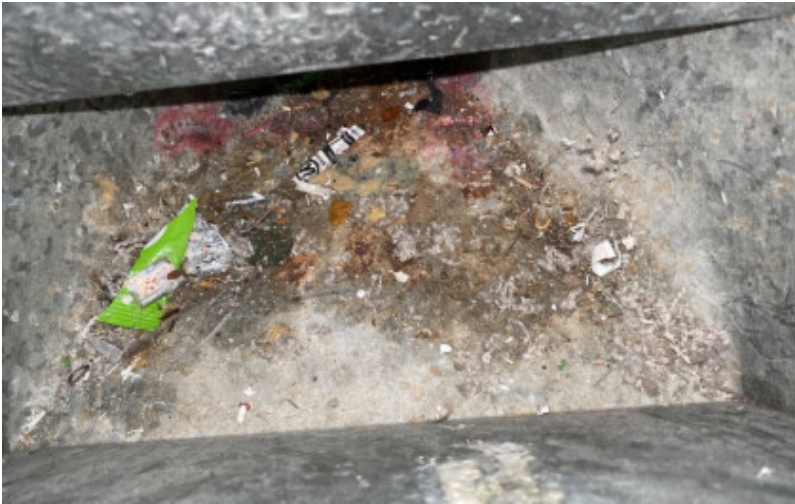
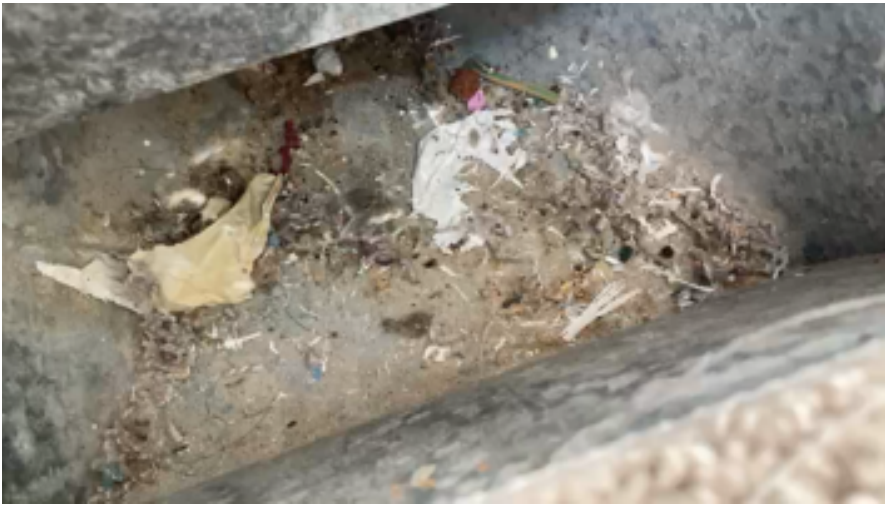
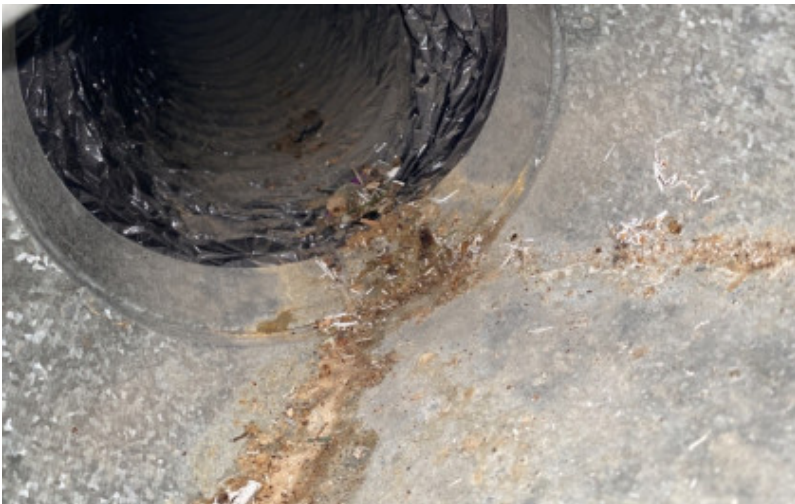
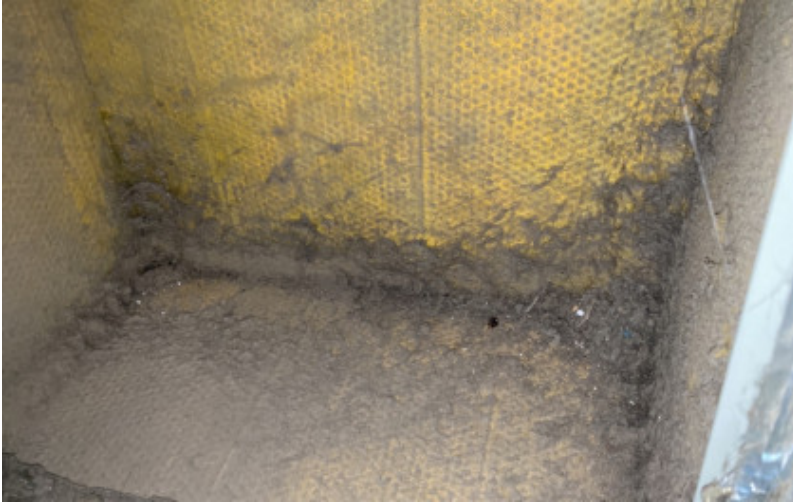
Improve, Safety Issue: Due to the age of the ductwork and dust noted in the system, recommend having all supply and return lines vacuumed and cleaned to reduce dust and mold build-up in the systems, which can produce unhealthy air.

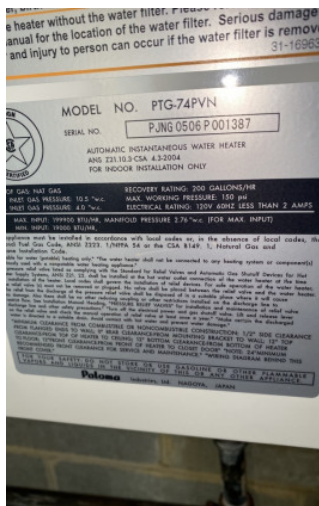
Monitor, Future Repair: The water heater is an older unit that has lasted beyond its typical life span. It would be wise to replace this unit in the near future. One cannot predict with certainty when replacement will become necessary.

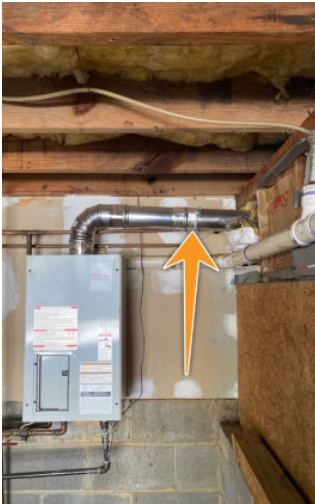
Repair, Safety Issue: The slope on the water heater vent pipe does not appear to be sufficient for proper venting of the exhaust gases. This should be checked and repaired as necessary.

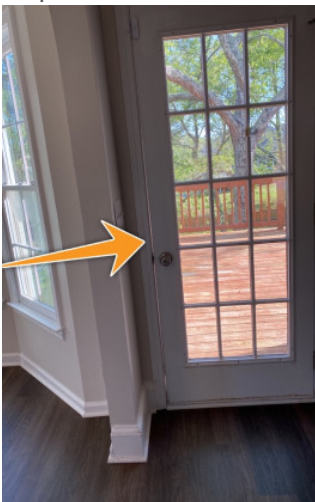
Repair: The weatherstripping is damaged and should be repaired or replaced as needed to limit outside air infiltration into conditioned areas.

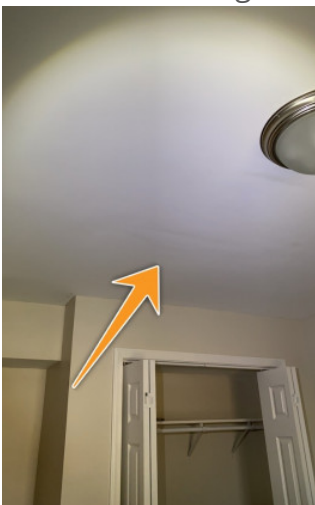
Monitor: Previous damage was noted in the walls/ceilings, which has been repaired. Consult with seller concerning history of past leaks or settlement here.

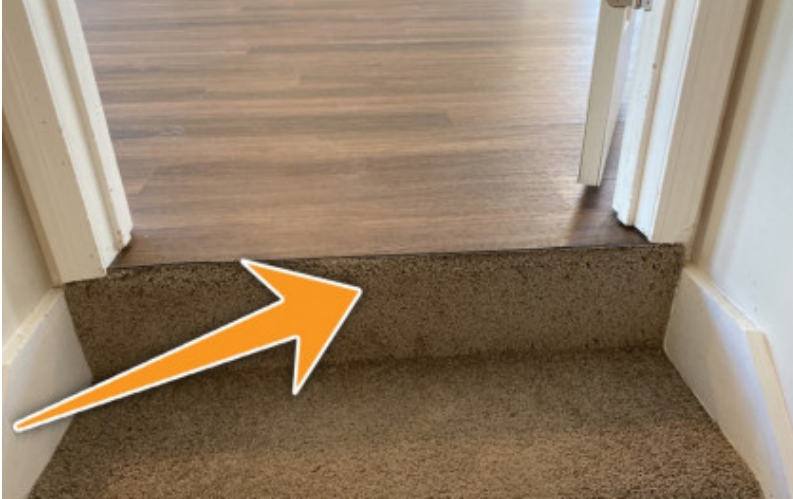
Repair, Safety Issue: The transition at the top of the steps at the carpet and [OBJ] flooring as noted poses a tripping hazard and should be altered for proper safety.

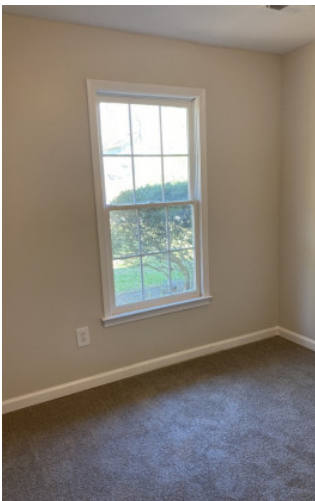
Repair, Safety Issue: A majority of the windows are painted or otherwise stuck shut. Present day safety standards require at least one operable window per bedroom for emergency egress and ventilation.

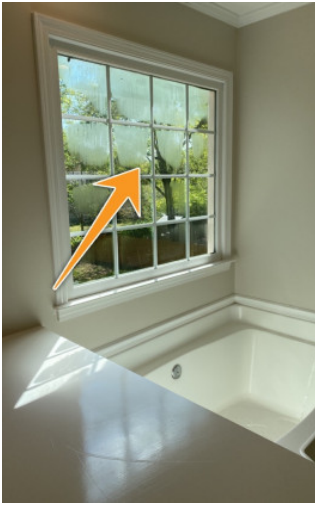
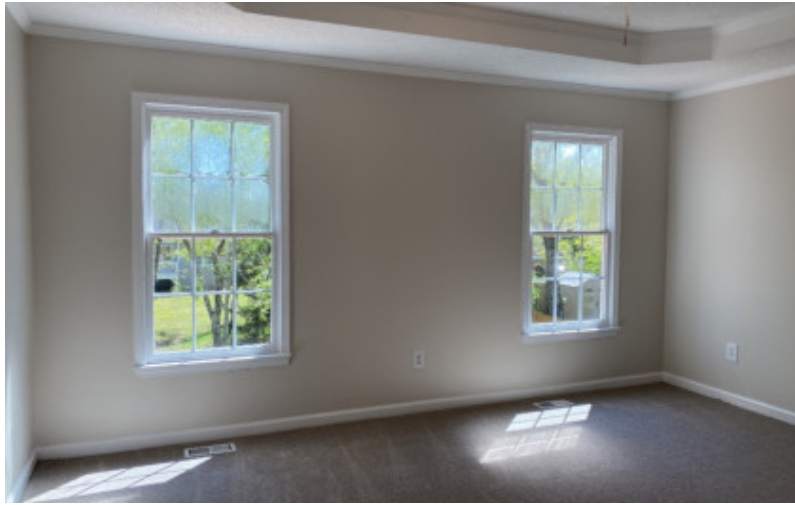
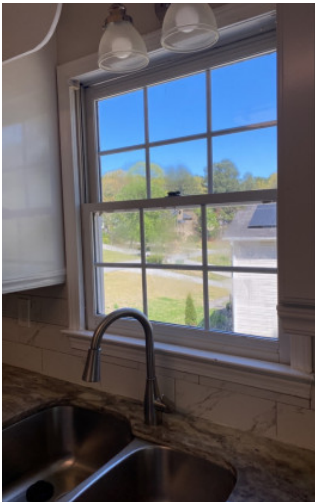
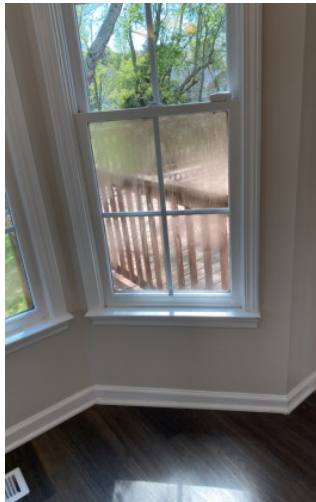
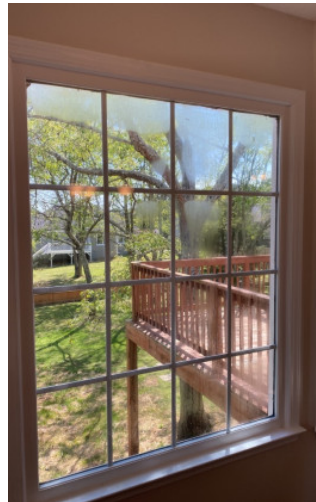
Repair: "Fogged" glass was noted, which should be replaced. This condition is typically caused by damaged seals around the perimeter of the insulated glass, which in turn allows condensation to develop between the panes. All damaged glass panels in this area should be replaced by a qualified glass replacement contractor to prevent further moisture damage to wood components and for proper visibility through the glass. The contractor should inspect all other insulated panels in the house for additional condensation that may be occurring in the glass. Other windows may be fogged but cannot be positively determined until the glass is cleaned.

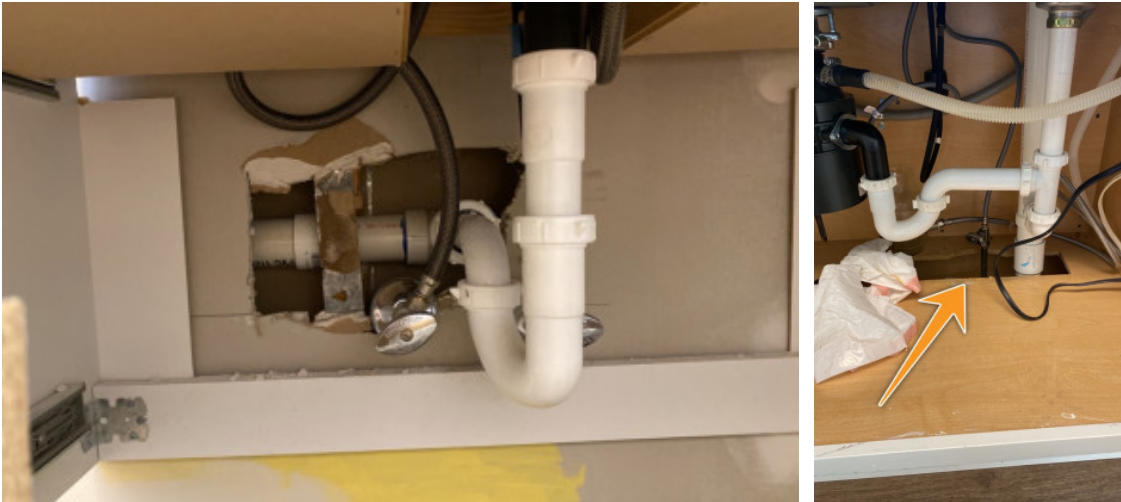
Repair: The inside panels of the cabinets as noted should be repaired and sealed to prevent the infiltration of outside air and insects.

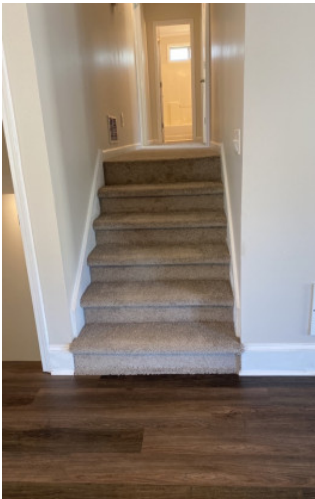
Handrail Missing

Repair, Safety Issue: Handrails are required when there are four or more steps. Add handrail for proper safety.

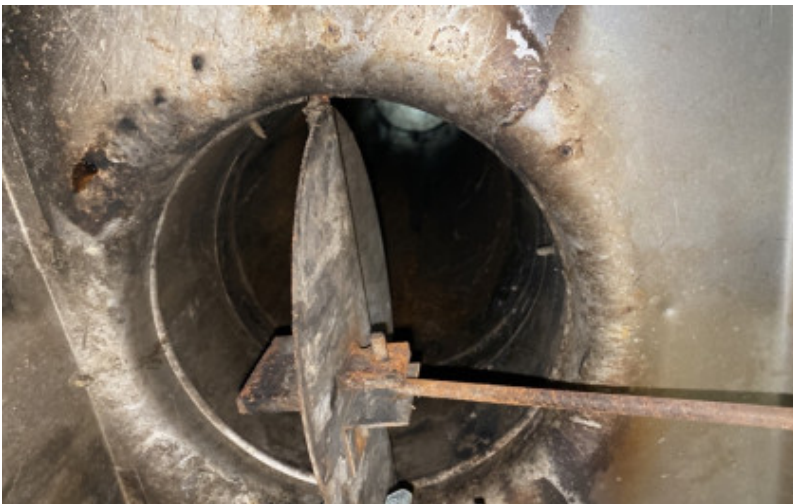
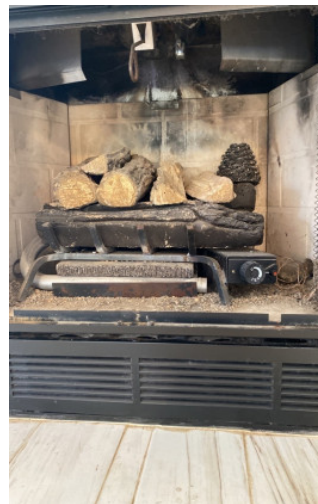
Fireplace Servicing Needed?

Possible Repair, Safety Issue: Since the chimney flue(s) are not entirely visible, we recommend that you consult with the seller concerning recent inspections and cleaning performed on the fireplace components and have this performed before closing as needed. Fireplaces and chimneys should be inspected and cleaned once a year under normal usage.

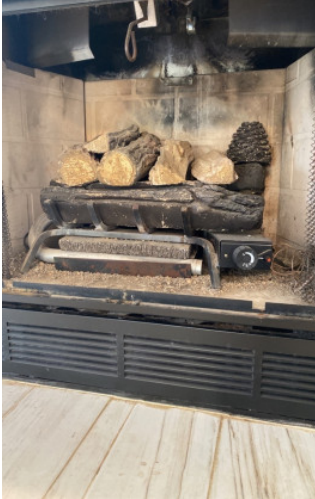
Gas Logs Turned Off

Monitor: Check with the seller concerning the proper operation of the gas logs as the pilot was not lit at the time of the inspection, which prevented the testing of this appliance.

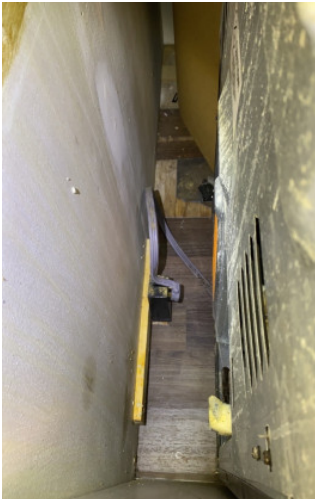
Anti-Tip Device Needed

Repair, Safety Issue: There was no apparent anti-tip device installed for the oven/range unit, which should be added as needed to prevent the range from tipping when the doors are open.

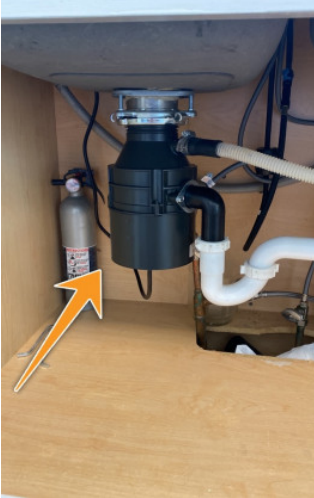
Disposal Inoperative?

Monitor, Possible Repair: The waste disposal did not turn on with the switch nearby and is either inoperative or not connected. Check with the seller concerning another switch location and it's proper operation and have repaired if needed.

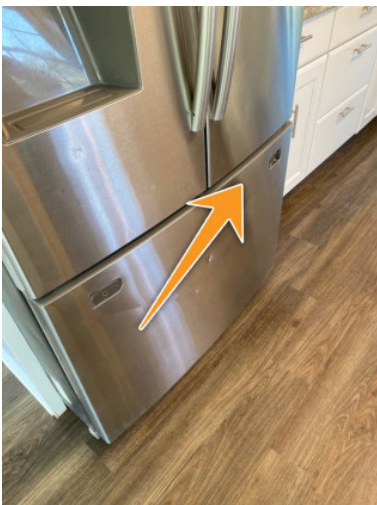
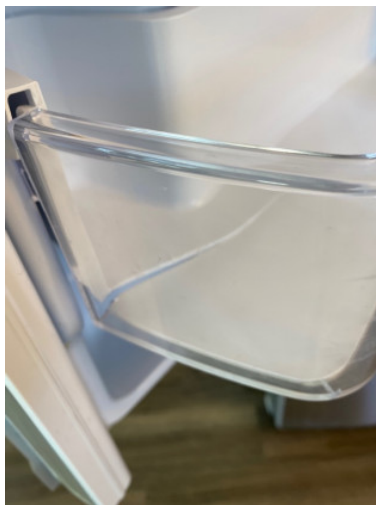
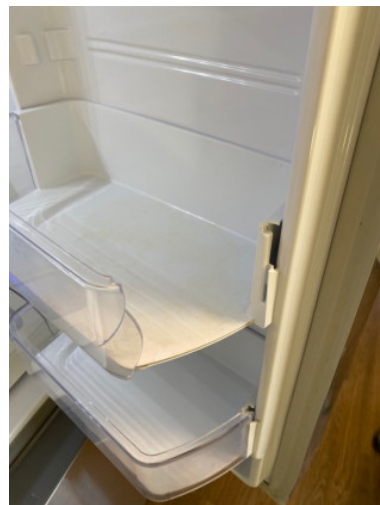
Damage Noted

Repair: Several items were noted as damaged on the refrigerator: freezer exterior handle, interior door shelves, ice maker.

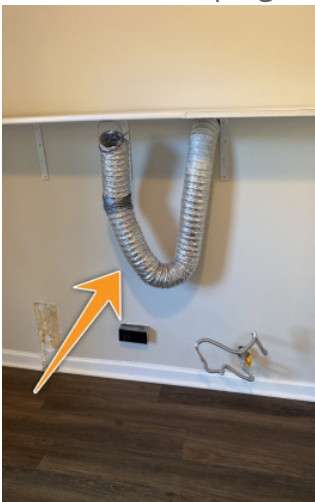
Improve, Safety Issue: The flexible clothes dryer exhaust vent pipe as noted should be replaced with rigid smooth wall piping where possible to prevent lint build-up in the line which can cause damage and possible fires at the dryer element.

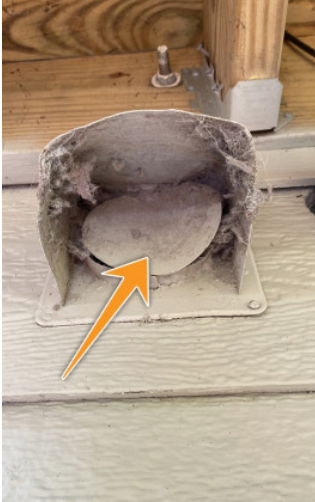
Repair, Safety Issue: The clothes dryer exhaust vent pipe appears clogged with lint and should be cleaned. Blocked piping can cause damage and possible fires at the dryer element.

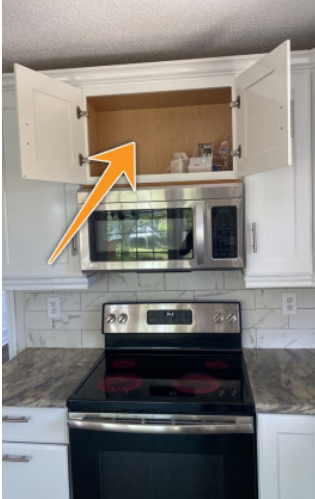
Exhaust Fan Vents Into Kitchen

Improve: The cooktop hood fan currently vents into the kitchen should ideally be improved to exhaust to the building exterior.

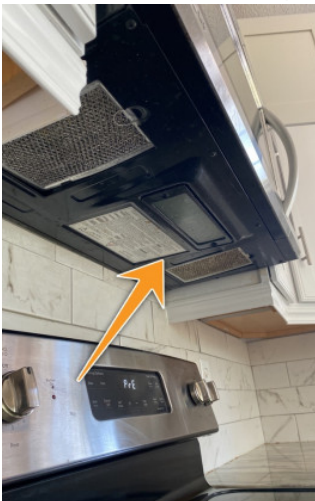
Repair: The light did not operate when tested using standard controls. Replace bulb and test; consult an appliance repair technician for more involved repairs.
