Residential Inspection Report

17860 White Marble Drive , Monument, Colorado 80132

May 01, 2023 09:00 am

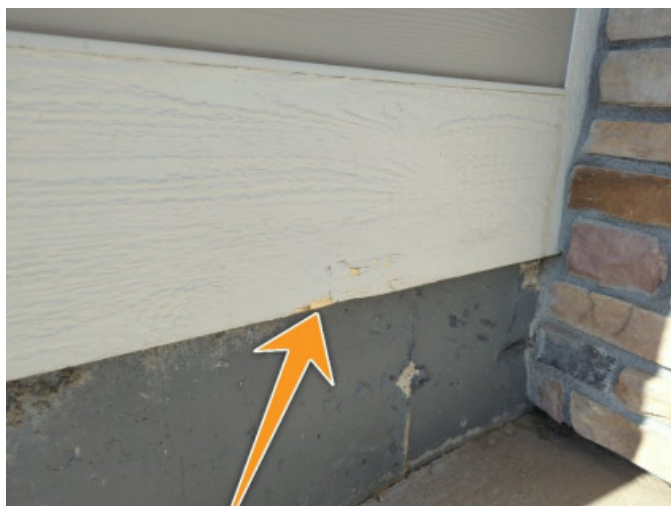
DEFICIENCY 3.3

Paint/caulk maintenance

Estimated Severity : ■ □□ Repair

At the time of inspection there were areas of the home that were in need of paint touch up and/or caulk maintenance to help seal the exterior siding and trim. Recommend performing exterior maintenance as needed to maintain the life of the siding.

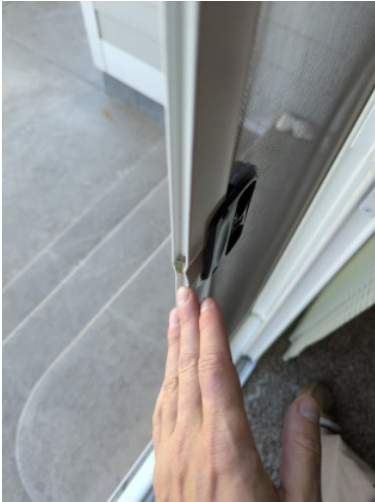
DEFICIENCY 3.4

Screen Damage - Exterior Doors

Estimated Severity : ■ Minor/Maintenance

The sliding glass door screen appears to be damaged. Recommend repair or replacement.

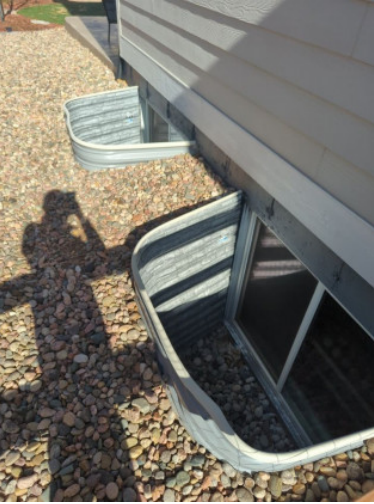
DEFICIENCY 3.5

Missing Window Well Covers

Estimated Severity : ■ Repair

The basement window wells are missing there covering

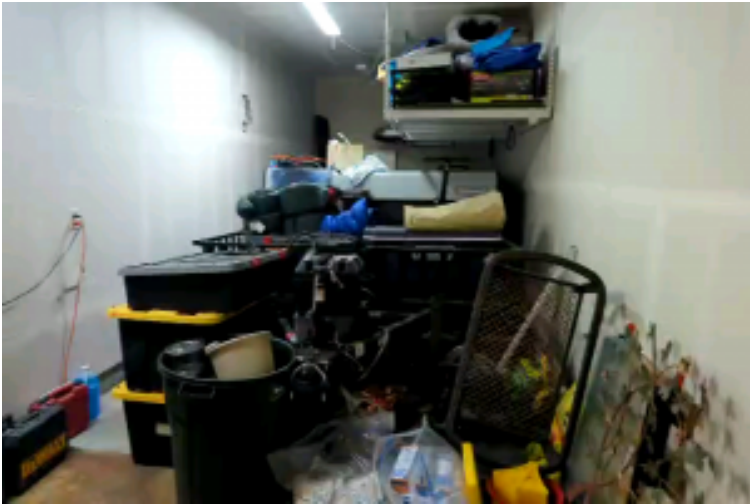
LIMITATION 4.1

Occupied / Furnished Disclaimer

Due to the home being furnished at the time of inspection, not all floor surfaces, wall surfaces, countertop surfaces, or electrical receptacles could be inspected or tested.

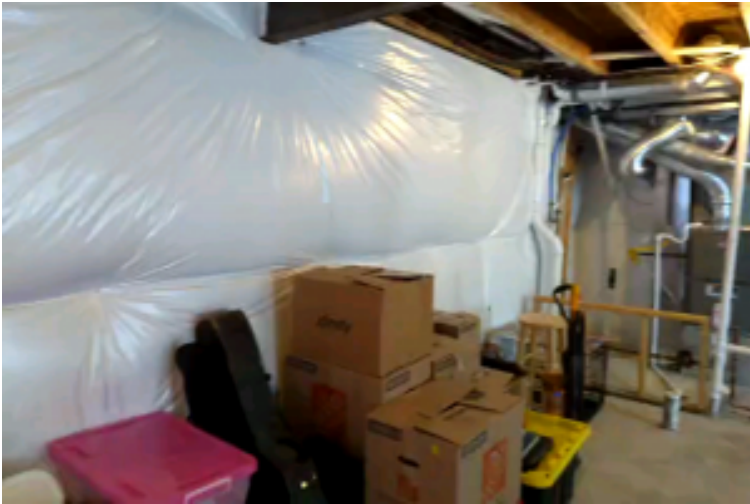
LIMITATION 6.1

Insulated / Finished Walls Disclaimer

Foundation basement or crawlspace walls were finished and/or insulated at the time of inspection. Only walls which were fully exposed could be thoroughly inspected for structural deficiencies.

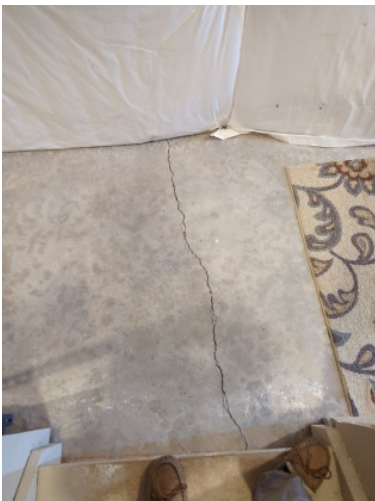
DEFICIENCY 6.2

Typical cracks - Slab

Estimated Severity : Repair

There is evidence of typical cracking in the basement concrete slab. Recommend sealing the cracks and monitoring for further movement.

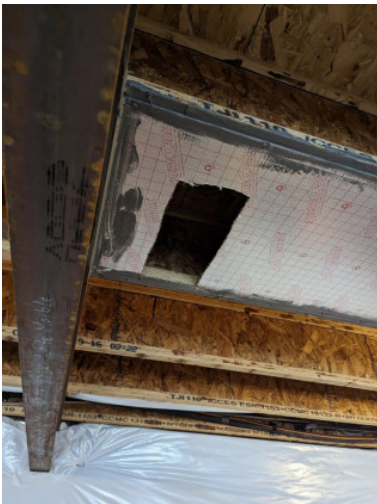
DEFICIENCY 7.3

Missing register cover

Estimated Severity : ■ Minor/Maintenance

Recommend replacement

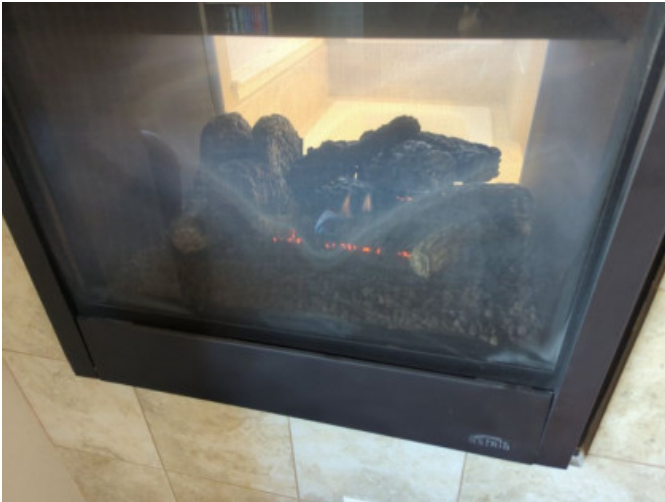
DEFICIENCY 7.4

Foggy glass - Fireplace

Estimated Severity : ■ Minor/Maintenance

The glass on the gas fireplace was foggy at the time of the inspection. Recommend cleaning of glass.

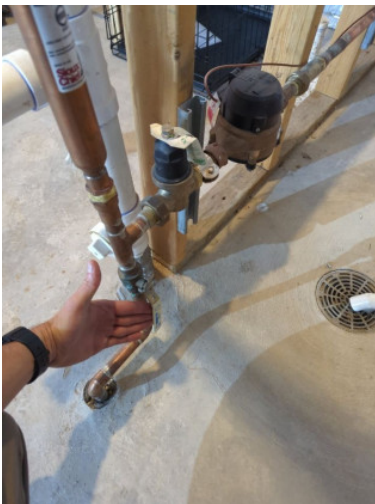
CUSTOM 9.5

Main Water Shutoff

Location of the main water shut off

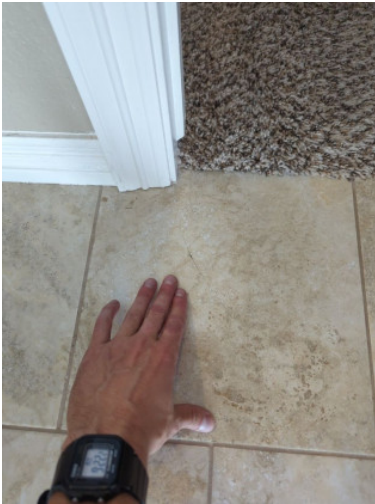
DEFICIENCY 10.1

Damaged - Tile

Estimated Severity : ■ Minor/Maintenance

When inspecting the home's flooring, I found that one or more tiles in the home were damaged. I recommend having the damaged tiles replaced.

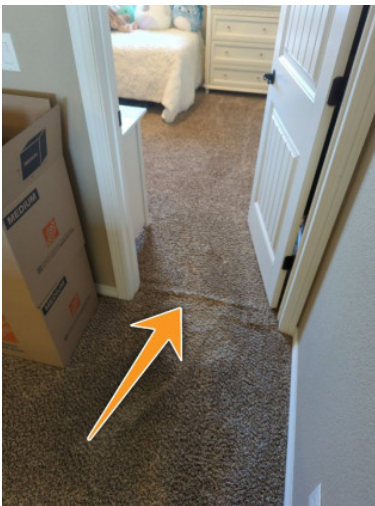
DEFICIENCY 10.2

Re-stretch Carpet

Estimated Severity : ■ Repair

The carpet may need to be re stretched recommend repair as needed.

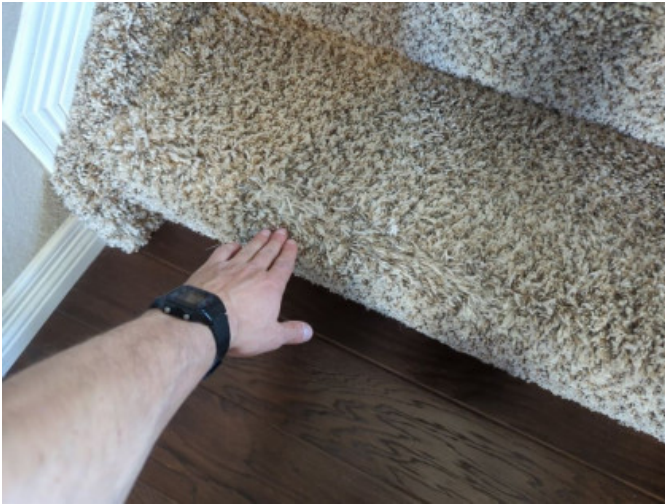
DEFICIENCY 10.3

Carpet - Typical Wear

Estimated Severity : ■ Repair

The carpet show signs of typical wear in the common areas and high traffic areas of the home.

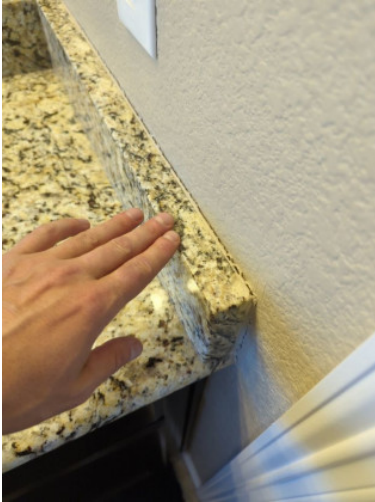
DEFICIENCY 10.5

Maintain Caulking - Countertop

Estimated Severity : ■ Minor/Maintenance

The countertop was missing sufficient caulk/sealant at the wall or sink. This can lead to water damage. I recommend adding sealant at sides and corners where counters touch walls and sinks. Here is a helpful DIY video on caulking gaps.

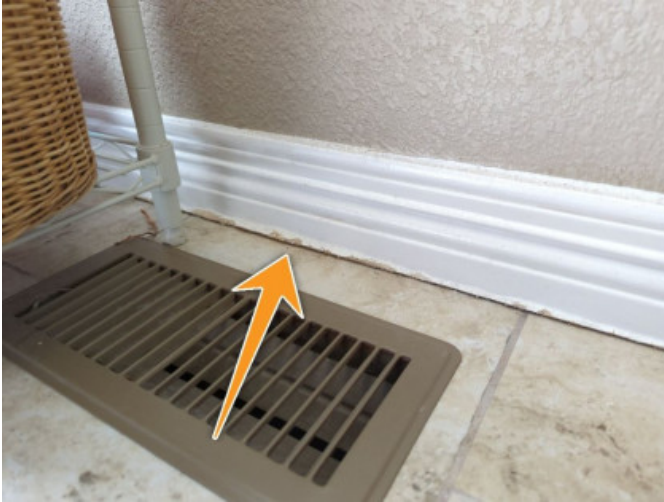
DEFICIENCY 10.7

Minor damage - Interior Trim

Estimated Severity : ■ Minor/Maintenance

There was minor damage to one or more pieces of trim at the time of the inspection. Recommend repair or replacement.
