Residential Inspection Report

17860 White Marble Drive , Monument, Colorado 80132

May 01, 2023 09:00 am

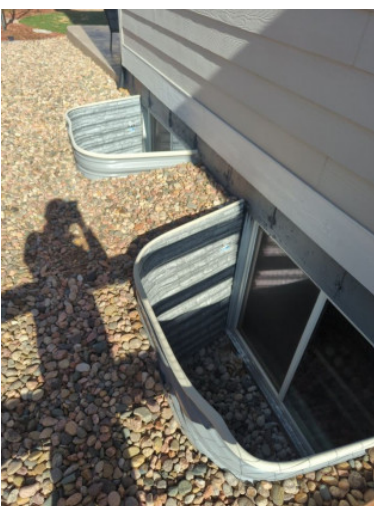
DEFICIENCY 3.3

Missing Window Well Covers

The basement window wells are missing there covering

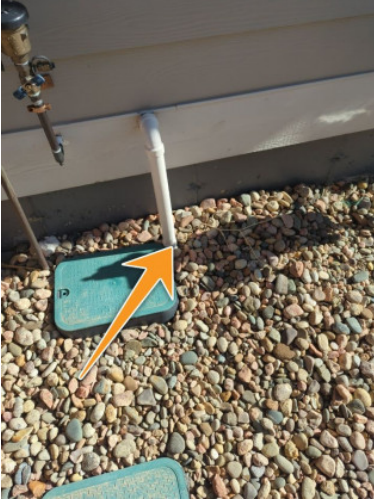
LIMITATION 9.1

Unable To Observe Sump Pump Discharge

I was unable to view where the sump pump discharge terminated. It is buried beneath the front porch and I was unable to find where it ends. Recommend asking seller pertinent information regarding sump pump discharge.

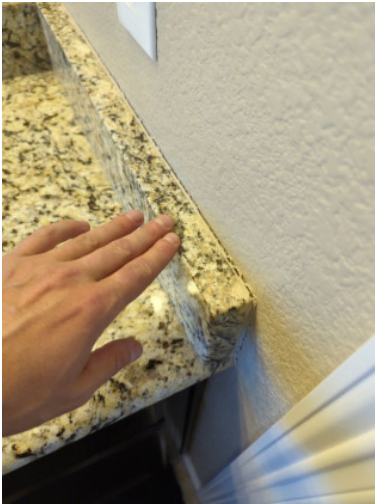
DEFICIENCY 10.5

Maintain Caulking - Countertop

The countertop was missing sufficient caulk/sealant at the wall or sink. This can lead to water damage. I recommend adding sealant at sides and corners where counters touch walls and sinks. Here is a helpful DIY video on caulking gaps.
