Top Choice Inspectors

Residential Inspection Report

123 Sample Drive, Anytown, USA 54321

April 15, 2024 10:30 am

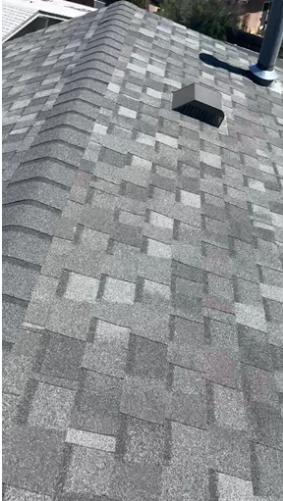
DEFICIENCY 2.1

Damaged (General) - Coverings

The roof coverings showed signs of damage, and wear. I recommend a qualified roofing professional to evaluate and repair.

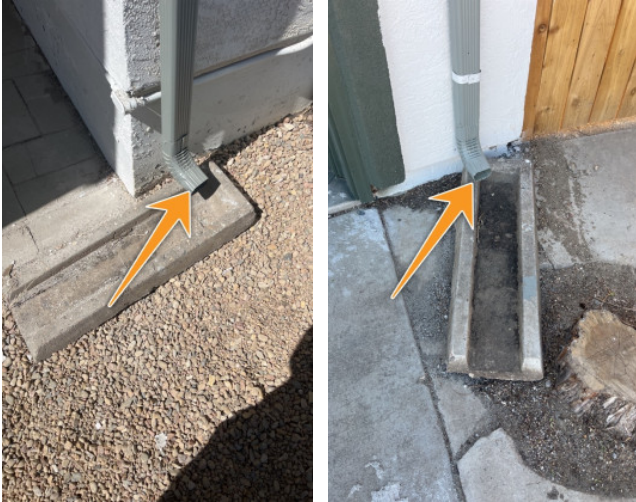
DEFICIENCY 2.2

Downspouts Draining Near Foundation - Gutters

One or more downspouts drain too close to the home's foundation, or are damaged resulting in run-off spillage. This can result in excessive moisture in the soil at the foundation, which can lead to foundation/structural movement. I recommend adjusting the downspout extensions to drain at least 6 feet from the foundation.

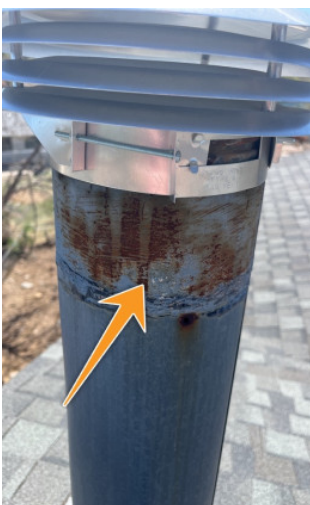
DEFICIENCY 2.3

Rusting Flue - Minor

The metal flue shows signs of rust

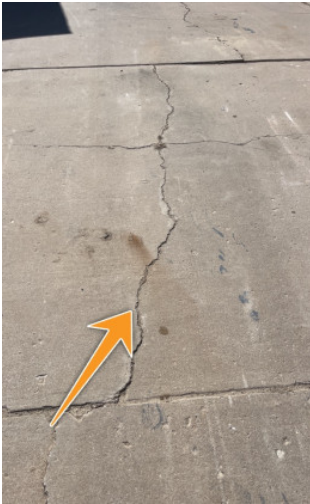
DEFICIENCY 3.1

Cracking/Settling - Minor - Walkways Patios Driveways

I observed some minor cracks in the cement. This is very typical due to soil movement. I would consider these cracks cosmetic, but I do recommend using a sealant to prevent water intrusion. Monitor and maintain as necessary.

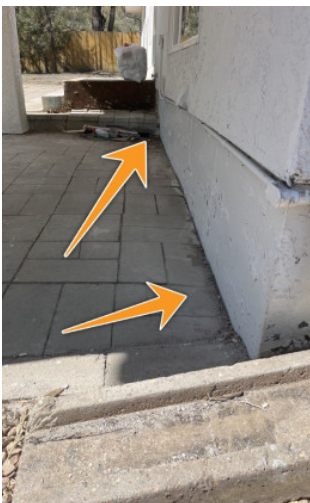
DEFICIENCY 3.2

Negative Grading - Walkways Patios Driveways

It appeared that the concrete showed negative slope and drains towards the structure. Run-off leading to the home can have negative effects on foundation structural integrity over time. I recommend a concrete contractor evaluate and repair.

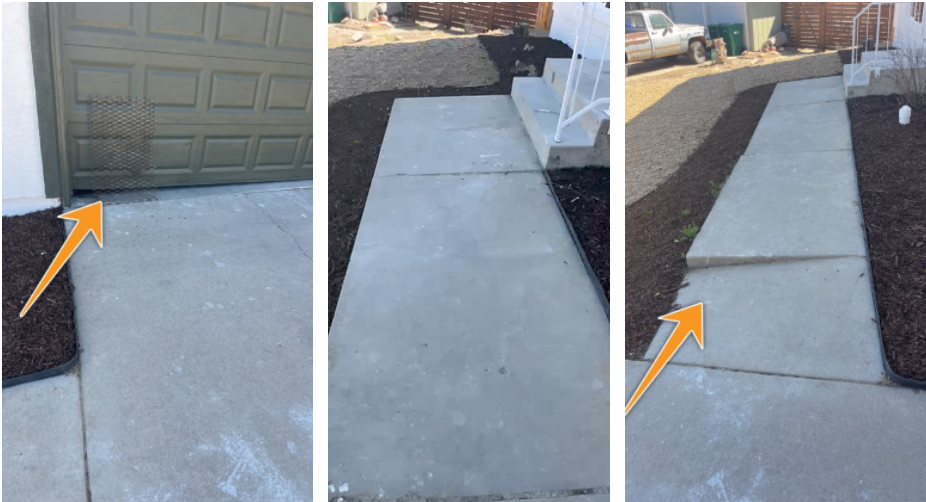
DEFICIENCY 3.3

Settling - Walkways Patios Driveways

While inspecting the home, concrete appeared to be settling and separating from other sections of the foundation. This is often due to poor compaction of soil before concrete pouring or erosion. I recommend sealing joints if minor to prevent moisture intrusion and further settling and separation. If major settling has occurred, I recommend concrete contractor evaluate for repair or replacement.

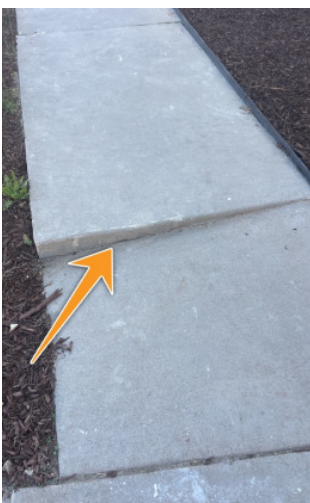
DEFICIENCY 3.4

Trip Hazard - Walkways Patios Driveways

While inspecting the home, I found that one or more areas had a trip hazard. If driveways, sidewalks, patios, etc. have a height difference of more than about 3/4 of an inch, I recommend having the trip hazard repaired.

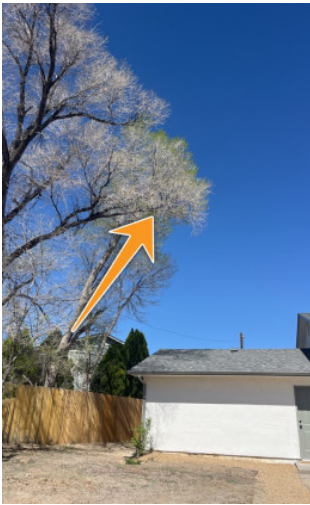
DEFICIENCY 3.5

Overhanging Roof - Vegetation

Trees observed overhanging the roof. This can cause damage to the roof when large limbs fall during high winds or other adverse weather. It can also clog gutters/downspouts if debris is not cleaned out regularly. I recommend trimming trees which overhang roofs.

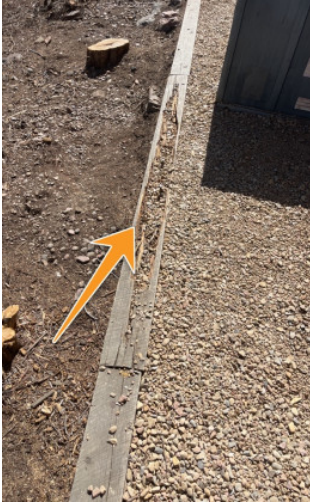
DEFICIENCY 3.6

Rotten Timbers - Retaining Wall

Rotten timbers were observed at the time of the inspection. Recommend evaluation and repair as necessary.

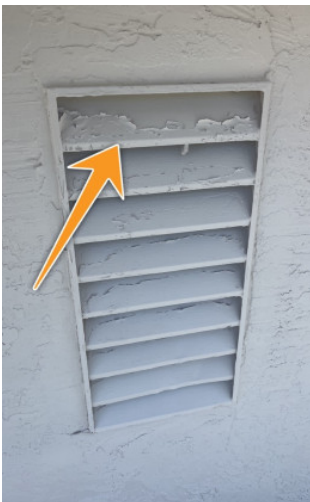
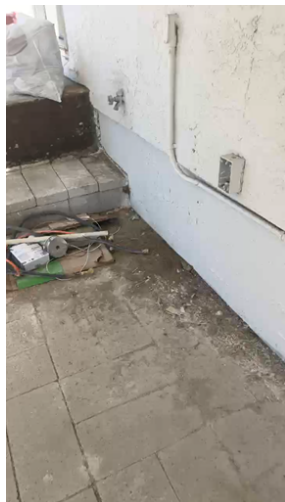
DEFICIENCY 3.7

Damaged Paint - Siding/Trim

The exterior of the home (all sides) are in need of repainting recommend evaluation and repair prior to closing.

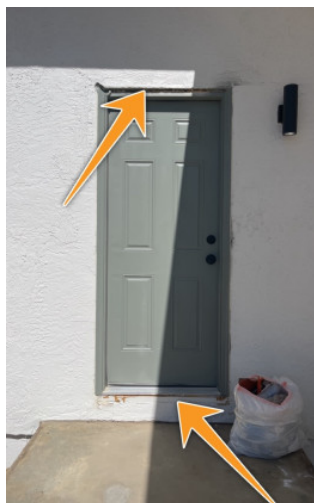
DEFICIENCY 3.8

Missing Trim

One or more locations were observed where trim was missing on the siding. Recommend installation to properly seal the exterior.

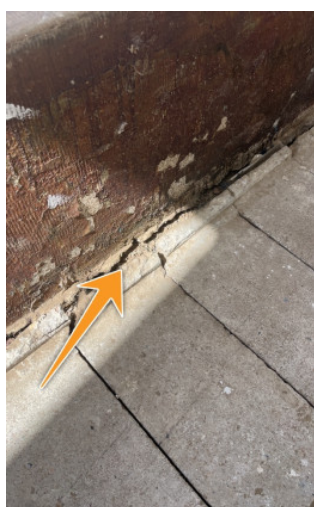
DEFICIENCY 3.9

Undermining - Decks, Balconies, Porches & Steps

There appears to be undermining of the soil underneath the cement pad. I recommend monitoring or replacing soil if needed.

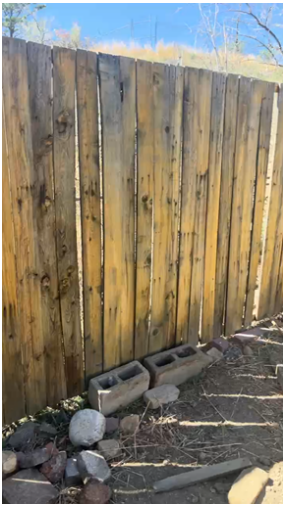
DEFICIENCY 3.10

Damaged Fence

Areas of the fence were damaged at time of inspection. Recommend further evaluation and repair as needed

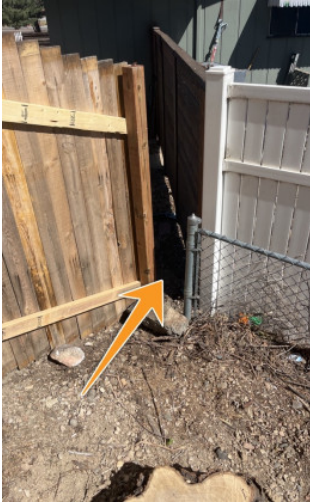
DEFICIENCY 3.11

Gap In Fence

Recommend repair as needed.

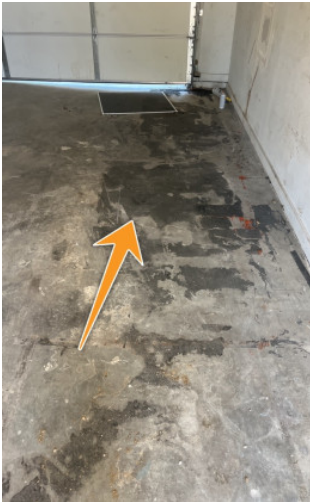
DEFICIENCY 4.1

Staining - Garage Floor

Garage floor shows visible staining from oil/grease. I recommend scrubbing with a degreaser or cleaning solution. Here is a DIY resource to help.

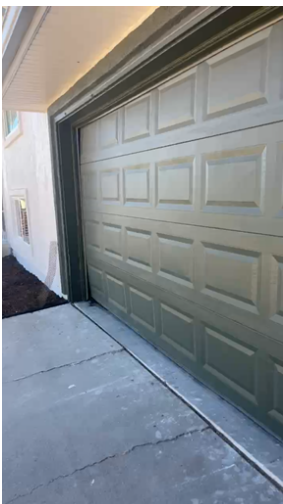
DEFICIENCY 4.2

Damage - Garage Door

The garage door has slight damage which was not causing any problems with the opening of the door at the time of inspection.

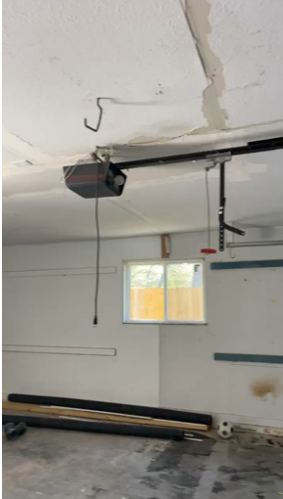
DEFICIENCY 4.3

One or more garage doors was inoperable at the time of the inspection. Recommend repair by qualified garage door contractor.

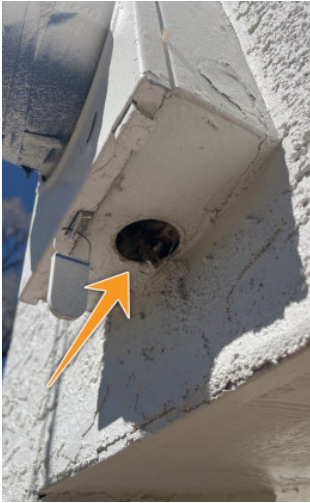
DEFICIENCY 5.1

Knockouts Missing - Service Entrance

"Knockouts" are missing on the service entrance. This poses a safety hazard and it is recommended that the opening caused by the missing knockout(s) be properly sealed by a licensed electrician.

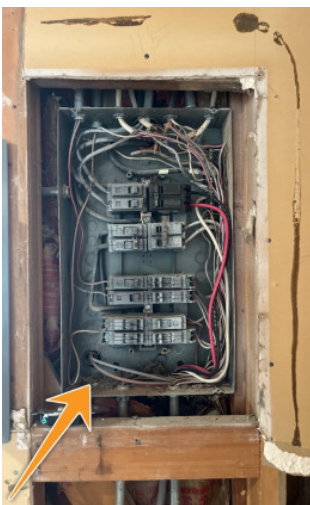
DEFICIENCY 5.2

Missing Cover - Main Panel

At the time of inspection there was no front cover for the electrical panel. This typically has all the labels for the panel as well as the legend listing what breakers are acceptable to be installed per manufacturer standards. Recommend a qualified electrician evaluate and properly cover and label panel.

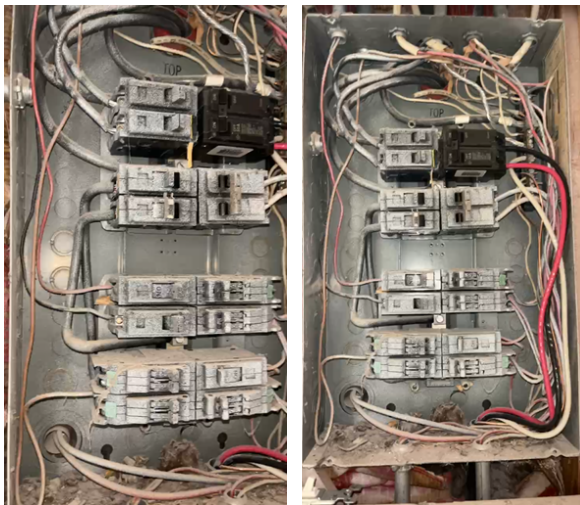
DEFICIENCY 5.3

Breaker tripping with sparks when light switch is turned on in the entryway.

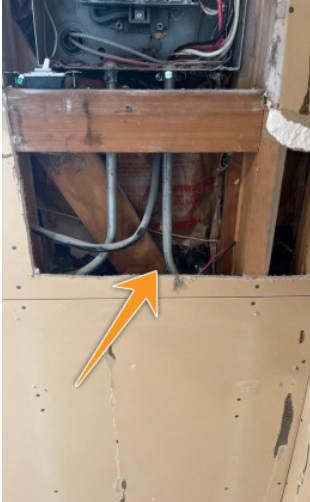
DEFICIENCY 5.4

Loose and/or Exposed Wiring

There is unsafe and exposed wiring visible and present during the home inspection. I recommend a licensed electrician repair and secure properly.

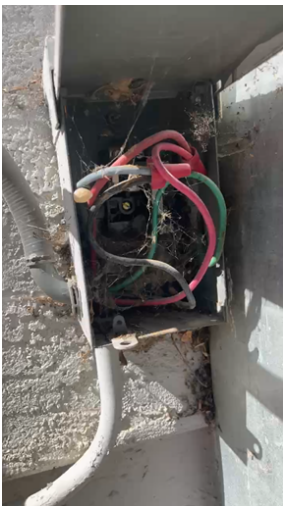
DEFICIENCY 5.5

It appears that electrical work was done by someone unfamiliar with proper building practices. Recommend evaluation and repair by a licensed electrician.

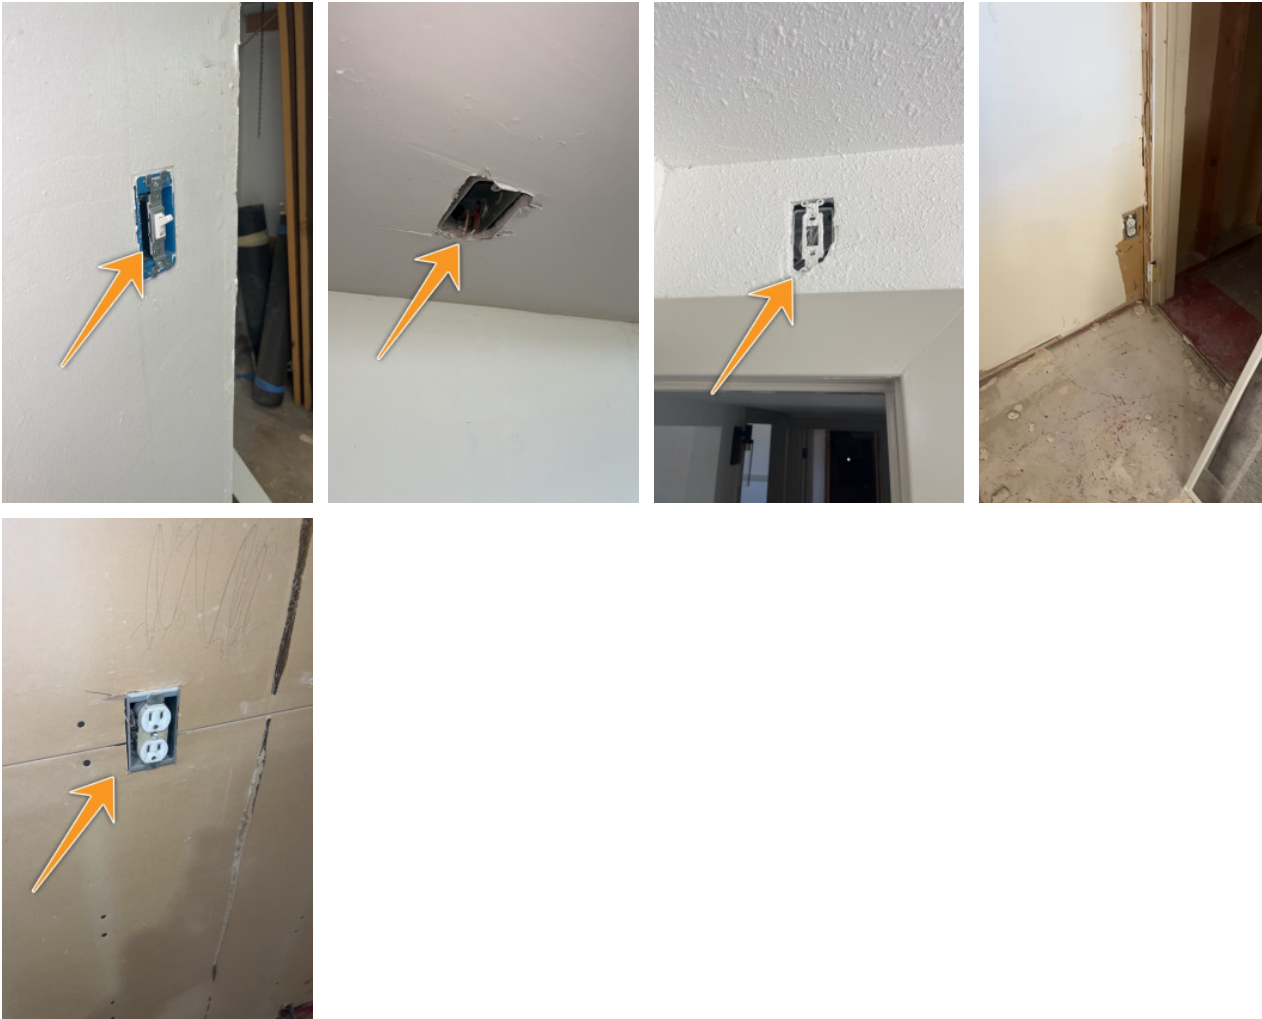
DEFICIENCY 5.6

Missing - Cover Plates

One or more light switches/receptacles are missing a cover plate. This causes short and shock risk. I recommend installation of plates.

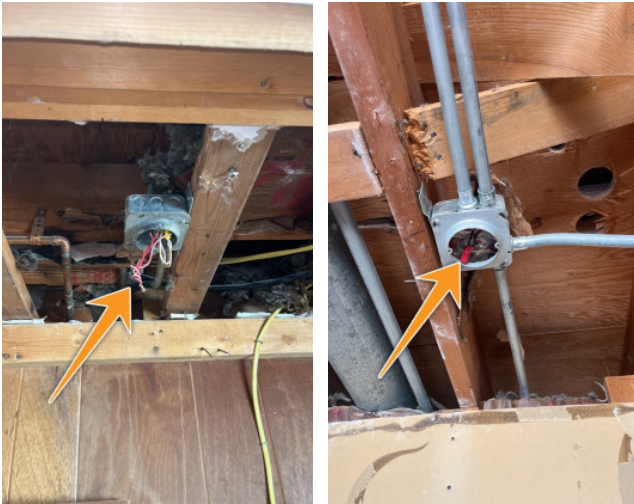
DEFICIENCY 5.7

Missing - Light Fixture

There appears to be a missing light fixture with exposed wiring recommend repair or replacement of light fixture.

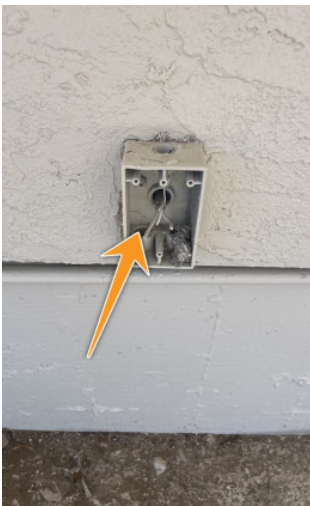
DEFICIENCY 5.8

Missing - Junction Box Cover

Recommend repair

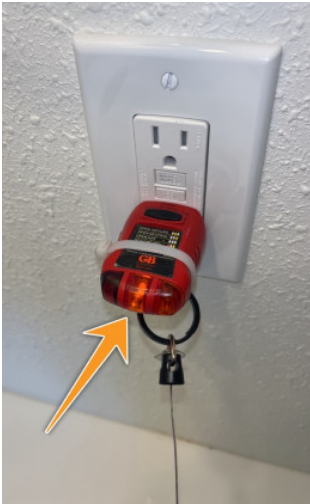
DEFICIENCY 5.9

One or more receptacles have and open ground at the time of inspection. I recommend a qualified electrician evaluate the receptacles and make any repairs necessary.

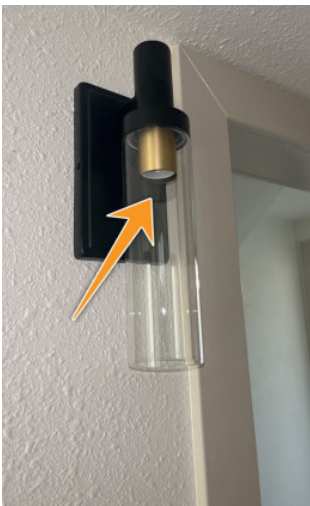
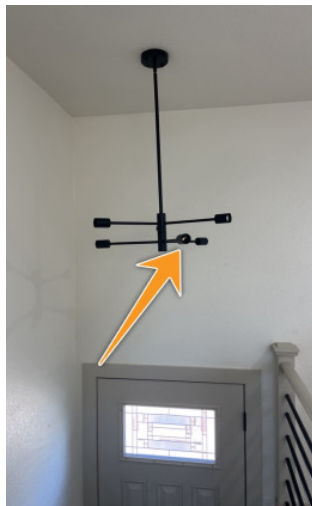
DEFICIENCY 5.10

Missing Bulbs - Light Fixture

Recommend installing bulbs.

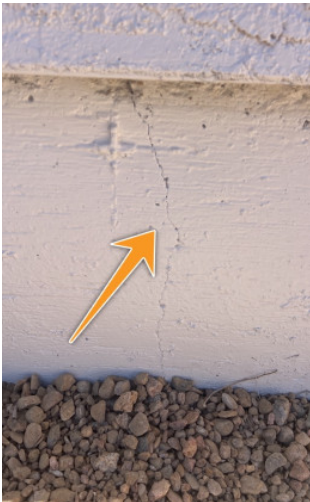
DEFICIENCY 6.2

Cracks - Minor - Foundation

Minor cracking was noted at the foundation. This is common as concrete ages and shrinkage surface cracks are normal. I recommend sealing then monitoring for more serious shifting/displacement. Here is an informational article on foundation cracks. If you are concerned with the structural integrity of the home, I recommend consulting a structural engineer.

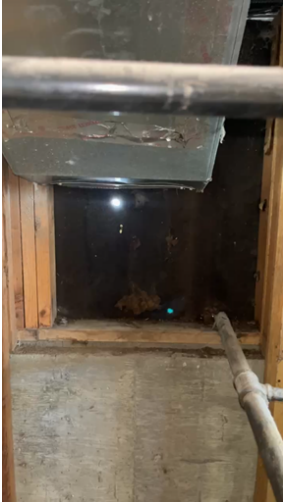
DEFICIENCY 6.3

At the time of inspection there was daylight visible in one or more areas of the mechanical room Recommend evaluation and repair.

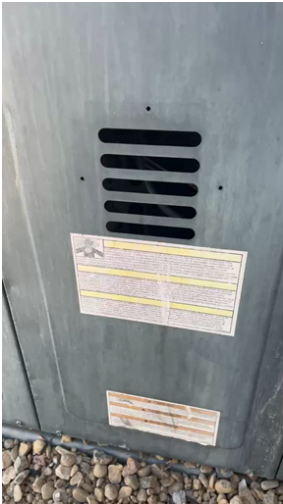
DEFICIENCY 7.1

Moisture Staining/Corrosion - Furnace

There was moisture staining/corrosion present inside and/or outside the furnace cabinet at the time of the inspection. Recommend further evaluation by a qualified HVAC professional

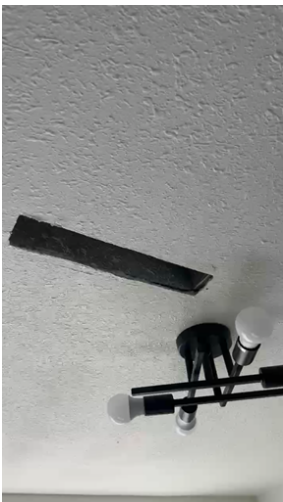
DEFICIENCY 7.2

Missing register cover

Recommend replacement

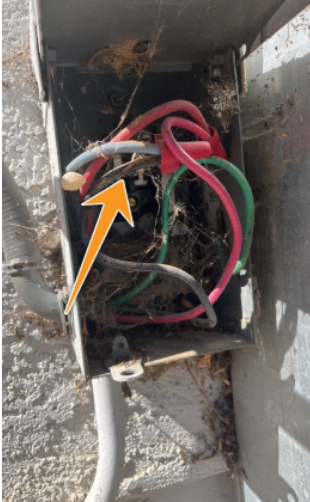
DEFICIENCY 8.1

Missing/Damaged - Emergency Shut Off

Cooling system shut off is missing oritdamaged. Recommend professional electrician service.

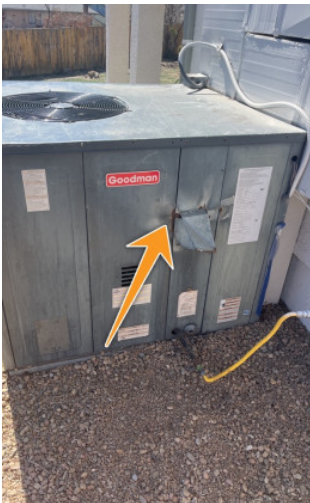
DEFICIENCY 8.2

Corrosion - Exterior Condenser

There are signs of exterior wear and rust on the unit recommend an evaluation and repair if needed.

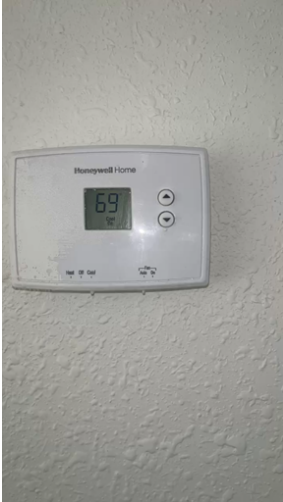
DEFICIENCY 8.3

At the time of inspection the air conditioner failed to turn on. I recommend having a qualified hvac contractor evaluate and make any repairs necessary.

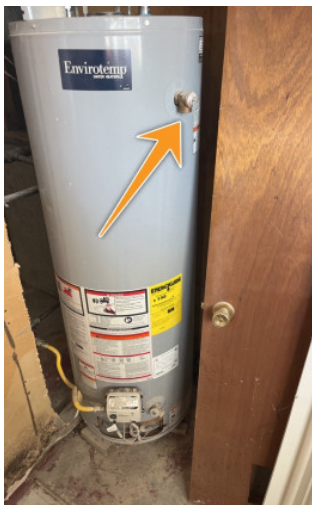
DEFICIENCY 9.1

Missing TPR Valve Extension - Water Heater

Recommend installation of a TPR valve extensions so it terminates 6 inches from the floor.

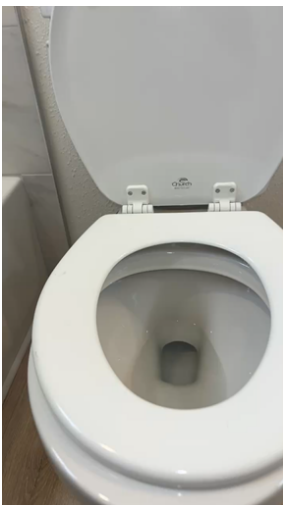
DEFICIENCY 9.3

Damaged Toilet Seat

Recommend repair or replacing on toilet seat.

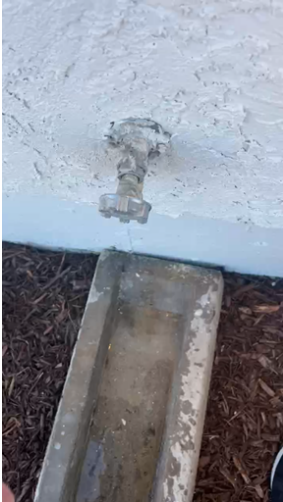
DEFICIENCY 9.4

The hose spigot handle was loose. recommend securing. The spigot was functional.

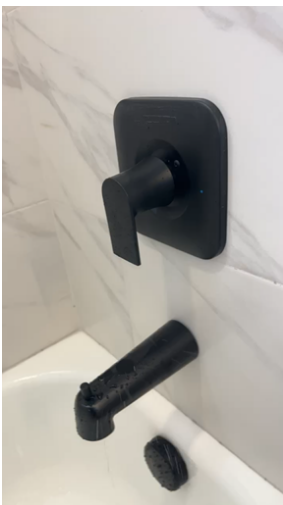
DEFICIENCY 9.5

Loose Handle - Plumbing Fixture

Recommend repair

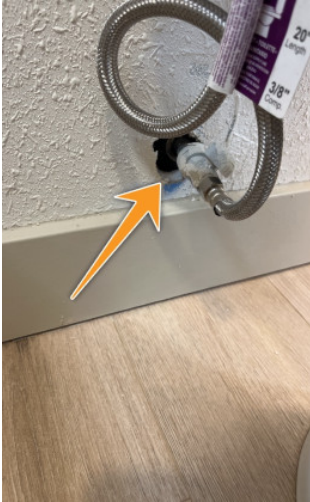
DEFICIENCY 9.6

Missing Collar-Toilet

At the time of inspection, the collar was missing that covers up the hole in the wall from the supply line going to the toilet. Recommend installation.

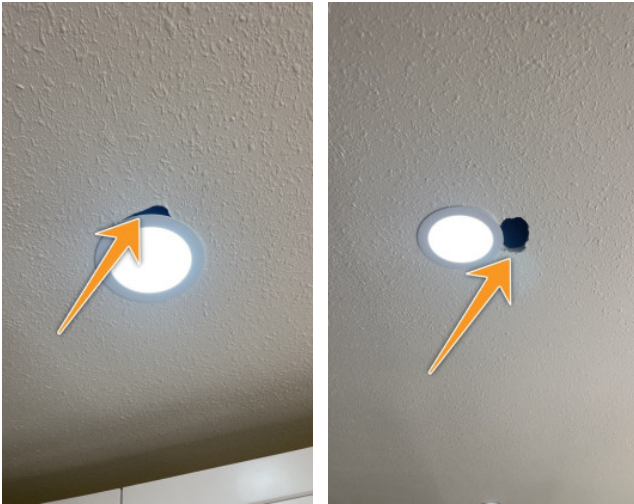
DEFICIENCY 10.1

Damage drywall

minor drywall damage was present at time of inspection

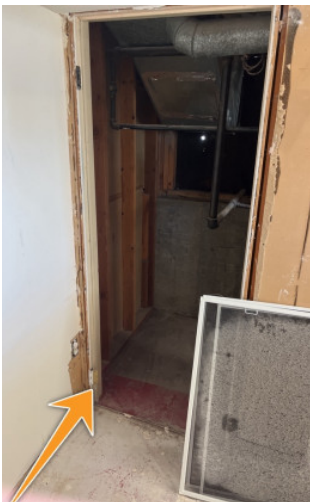
DEFICIENCY 10.2

Missing - Interior Door

One or more of the interior doors in the home was missing at the time of the inspection. I recommend replacing the missing door.

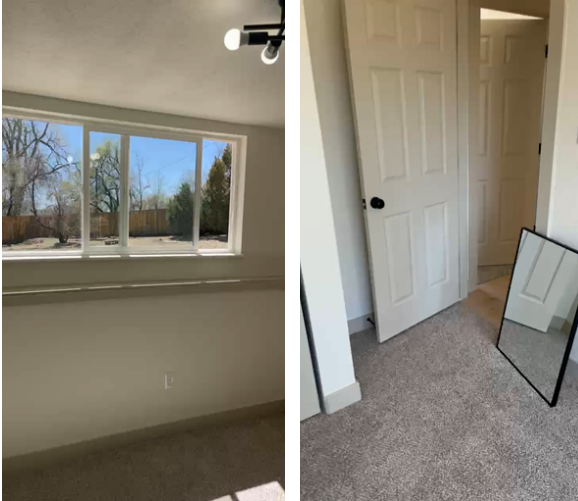
DEFICIENCY 10.3

Missing Screen - Window

When inspecting the windows, I did find that one or more of them did not have screens. I recommend replacing the missing screens.

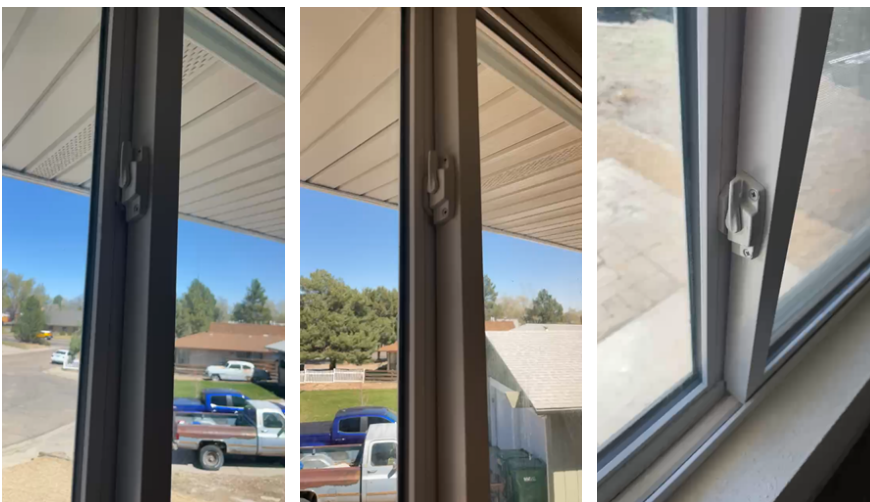
DEFICIENCY 10.4

One or more windows in the home or unable to lock or latch properly. Recommend evaluation and repair by a window professional.

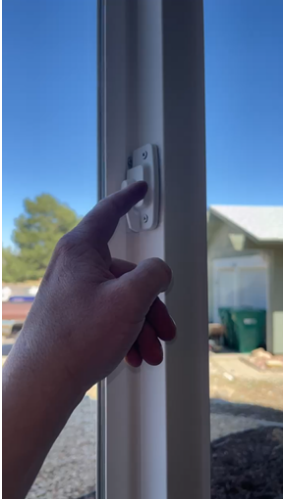
DEFICIENCY 10.5

Hardware Loose - Window

Loose window hardware was observed at the time of the inspection. Recommend evaluation and repair as necessary.

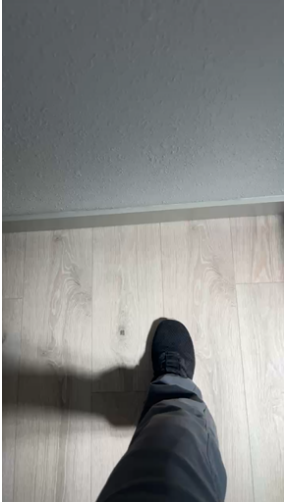
DEFICIENCY 10.6

The floor moved and squeaked at the time of the inspection. Recommend evaluation and repair.

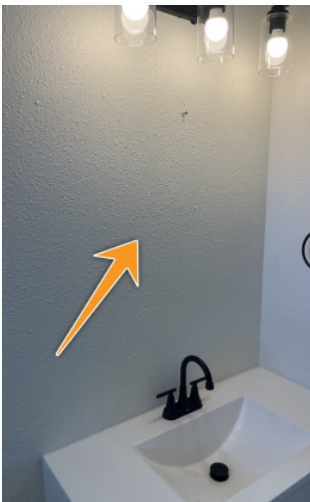
DEFICIENCY 10.7

Missing Mirror - Bathroom

Recommend installation.

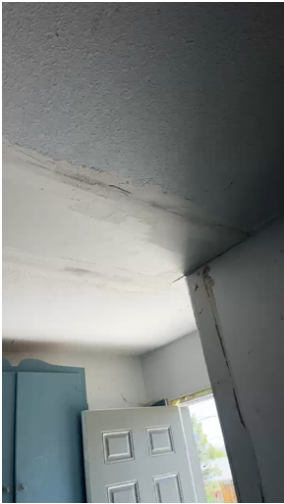
DEFICIENCY 10.8

Damaged Drywall Texture - Walls/Ceiling

One or more locations on the walls and ceiling had damaged texture on the drywall. Recommend touching up as needed.

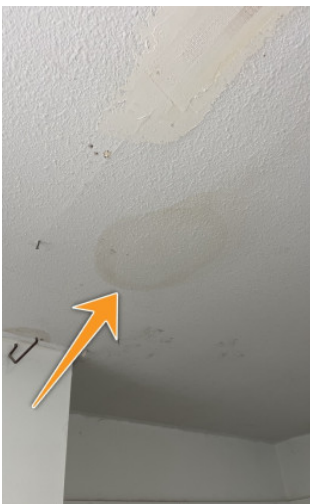
DEFICIENCY 10.9

Water Stain - Tested Dry - Interior

While inspecting the interior of the home, I noticed one or more water stains. I recommend monitoring the area for the moisture to return.

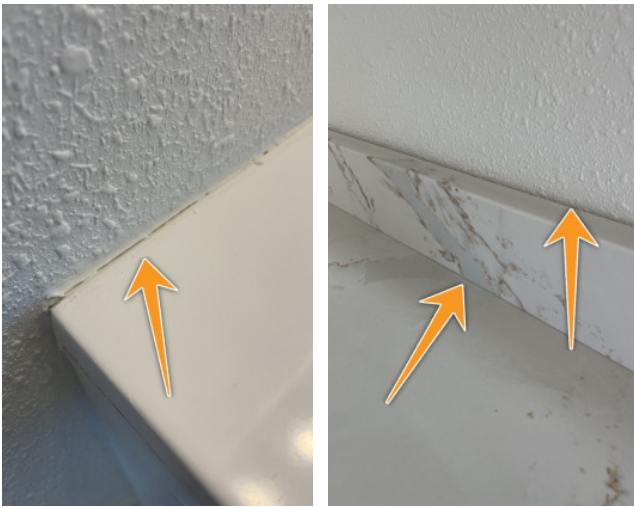
DEFICIENCY 10.10

The countertop was missing sufficient caulk/sealant at the wall or sink. This can lead to water damage. I recommend adding sealant at sides and corners where counters touch walls and sinks. Here is a helpful DIY video on caulking gaps.

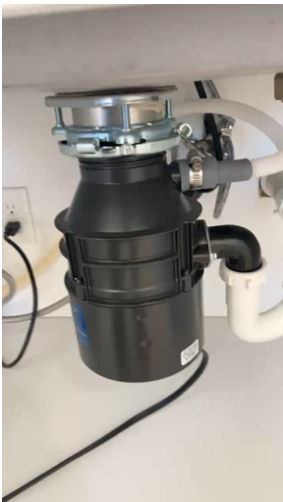
DEFICIENCY 11.1

Solid debris was in garbage disposal. Recommend removal for operation.

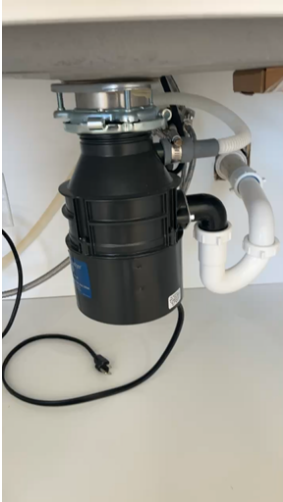
DEFICIENCY 11.2

Missing On/Off Switch

The garbage disposal was missing. It's on/off switch at the time of inspection. I recommend installing for easy operation.

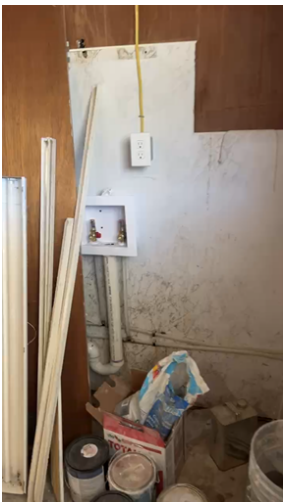
DEFICIENCY 11.3

The flex pipe material was not installed at the time of inspection. Recommend installing to properly vent dryer to exterior.

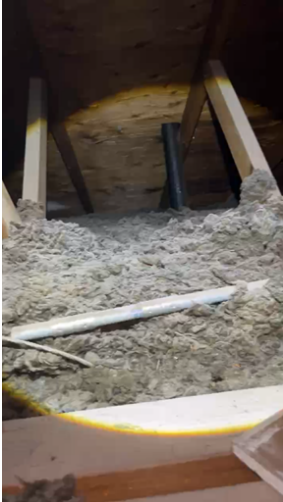
DEFICIENCY 12.1

Insulation depth was inadequate. I recommend a qualified attic insulation contractor install additional insulation. Adding insulation in your attic is one of the easiest and most cost effective ways to increase your home's energy efficiency and reduce your utility bills.
