Top Choice Inspectors

Residential Inspection Report

123 Sample Drive, Anytown, USA 54321

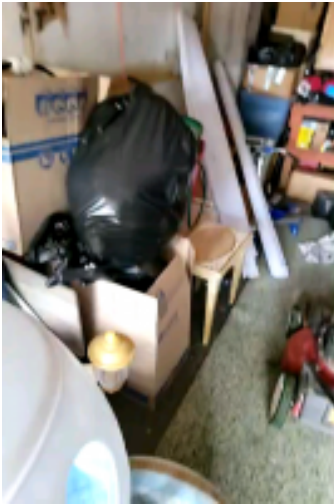
Occupied / Furnished Disclaimer

Due to the home being furnished at the time of inspection, not all floor surfaces, wall surfaces, countertop surfaces, or electrical receptacles could be inspected or tested.

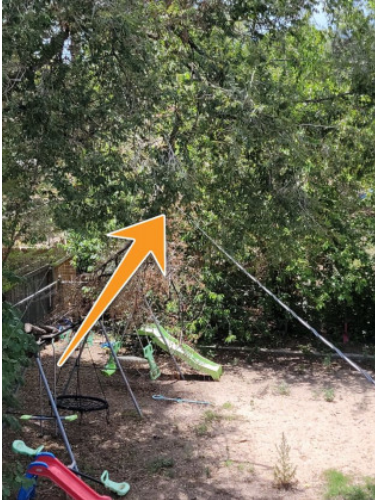
DEFICIENCY 5.1

Contact with Tree(s) -Service Entrance

It is recommended that the tree branches are cut back so they are not in contact with wires. This will help prevent power outages during high wind storms and during the winter months.

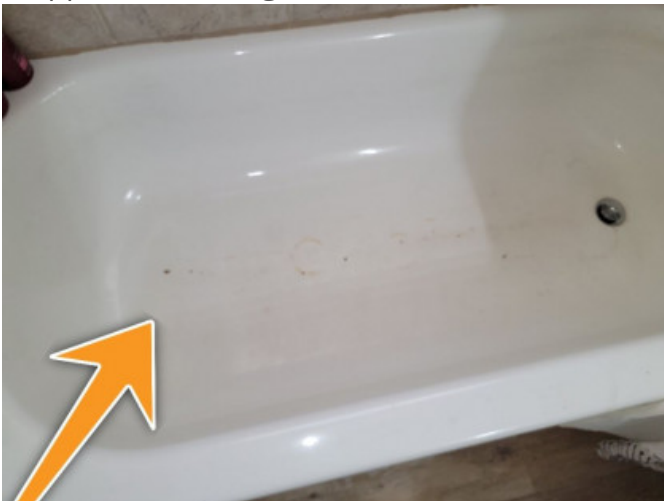
DEFICIENCY 8.6

Chipped - Plumbing Fixture

There appears to be a chip in the fixture. I recommend using a sealant before it chips further.

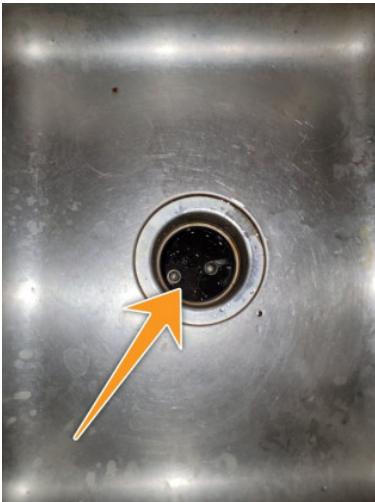
DEFICIENCY 10.5

Missing Rubber Boot - Garbadge Disposal

The garbage disposal was missing the rubber boot. This helps control noise as well as debris coming out during operation.

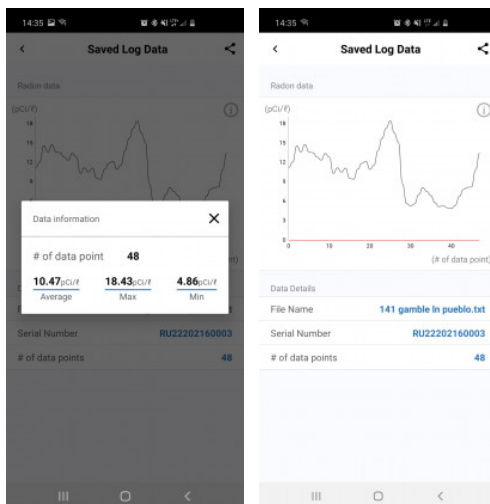
DEFICIENCY 13.1

High Levels - Radon

Average radon levels of 10.47 pCi/L exceeded the 4 pCi/L EPA threshold. I recommend a longer test, up to 90 days, or installation of a mitigation system in the home.
