# Top Choice Inspectors

## Residential Inspection Report

123 Sample Drive, Anytown, USA 54321

November 03, 2022 09:30 am

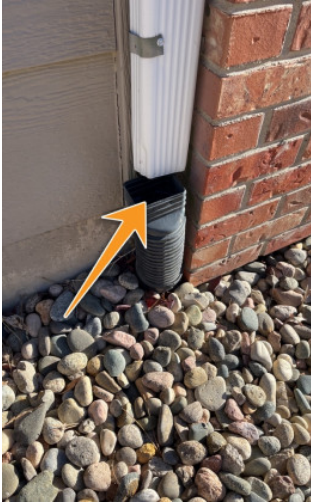
## DEFICIENCY 2.1

Detached Downspout - Gutters

One or more downspouts around the property were detached at the time of the inspection. Recommend repair or replacement.

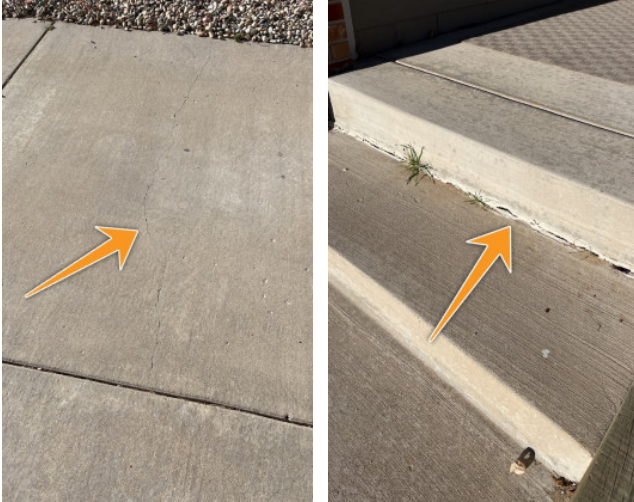
**DEFICIENCY 3.1****Walkways Patios Driveways**

Cracking/Settling - Minor - Walkways Patios Driveways

I observed some minor cracks in the cement. This is very typical due to soil movement. I would consider these cracks cosmetic, but I do recommend using a sealant to prevent water intrusion. Monitor and maintain as necessary.

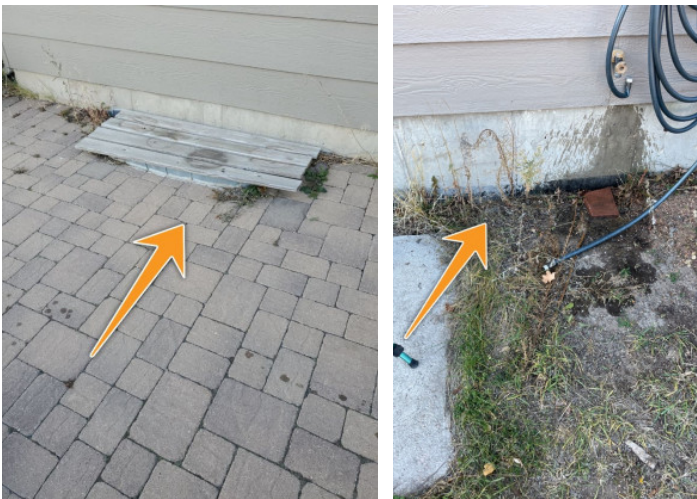
### DEFICIENCY 3.2

Negative Grading - Landscaping

Grading is sloping toward the home in one or more areas. This could lead to water intrusion and foundation issues. I recommend qualified landscaper or foundation contractor re-grade so water flows away from home.

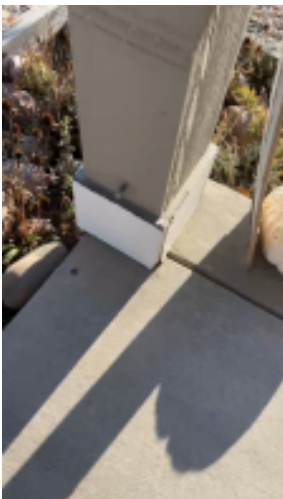
### DEFICIENCY 3.3

Water Intrusion and Dry Rot - Siding/Trim

Siding showed signs of water intrusion. This could lead to further siding deterioration. Recommend a qualified siding contractor evaluate and repair.

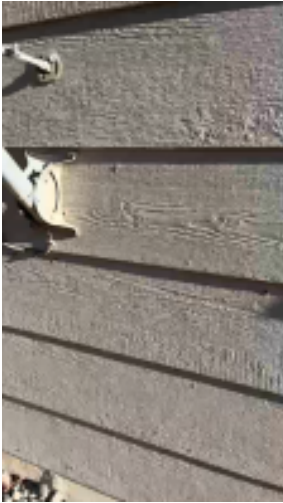
### DEFICIENCY 3.4

Seal Maintenance - Siding/Trim

Caulking is failing at seams where siding meets trim, transitions, or is penetrated. I recommend monitoring and replacing caulk when needed.

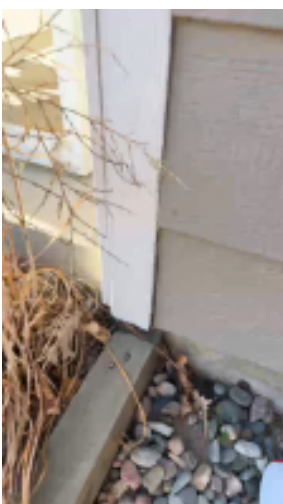
### DEFICIENCY 3.5

Typical Wear For The Age - Siding/Trim

The siding and trim had minor signs of wear, peeling paint and maintenance needed typical for the age of the home. Recommend monitoring and performing all maintenance as needed.

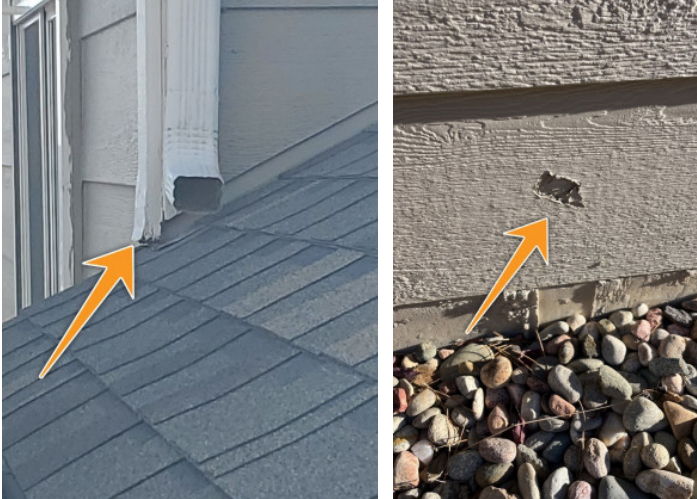
## DEFICIENCY 3.6

Damaged - Siding/Trim

There appears to be one or more areas of damaged siding. Recommend replacement or repair of siding.

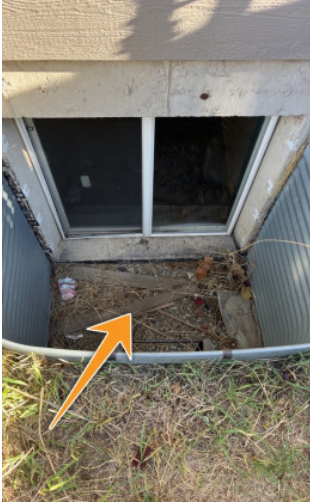
## DEFICIENCY 3.7

Debris - Window Wells

Debris has accumulated in the window wells. I recommend removal before mold, flooding, deterioration or other issues occur.

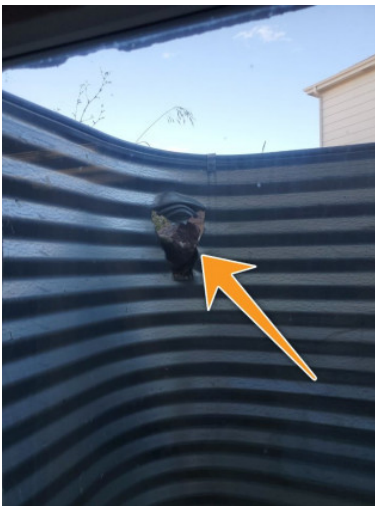
### DEFICIENCY 3.8

Damaged/Failure - Window Well

Window wells show signs of failure. Recommend having evaluated by landscaper / gardener for repair or replacement.

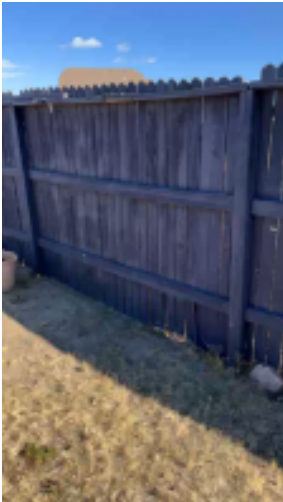
### DEFICIENCY 3.9

## Typical Wear For The Age - Fence

The fence showed signs of typical wear, splitting, sagging and aging. I recommend repair as needed.

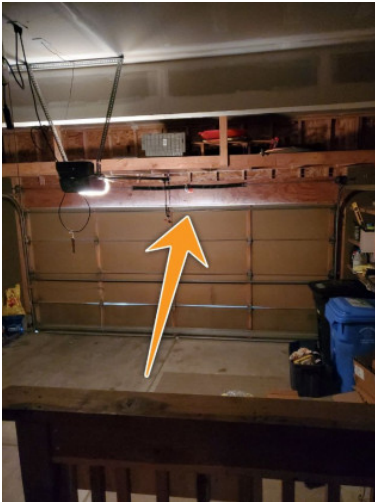
#### DEFICIENCY 4.1

Weatherstripping Damaged/missing - Garage Door

I recommend repair or replace.

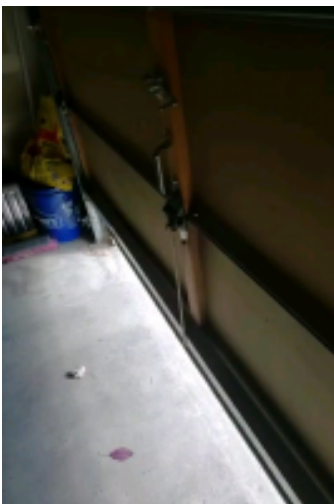
### DEFICIENCY 4.2

Reduce Resistance Setting - Garage Door Opener

The garage door opener's safety settings was not functioning properly during the inspection. When the opener is bringing the door down and upward pressure is applied, the door should go back up. I recommend having the resistance settings adjusted to ensure proper safety. This can usually be accomplished by consulting the user manual for the opener equipment. It is usually a very simple adjustment.

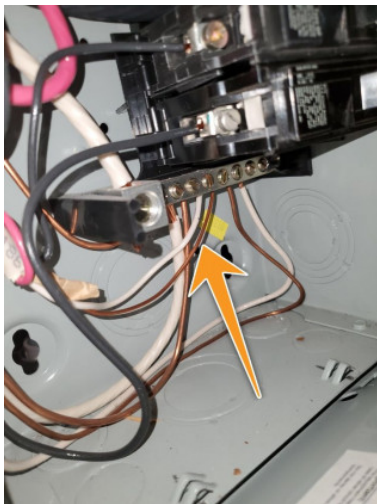
### DEFICIENCY 5.1

Improperly Wired Sub Panel

The sub panel does not appear to be wired properly on the neutral buss bar recomend repair.

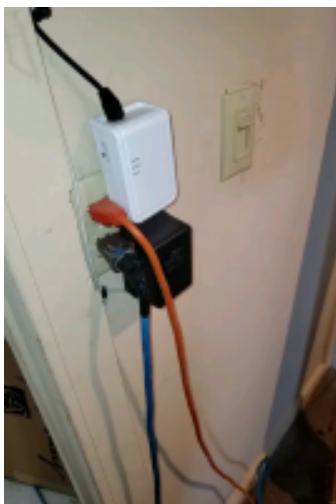
### DEFICIENCY 5.2

Loose and/or Exposed Wiring

There is unsafe and exposed wiring visible and present during the home inspection. I

recommend a licensed electrician repair and secure properly.

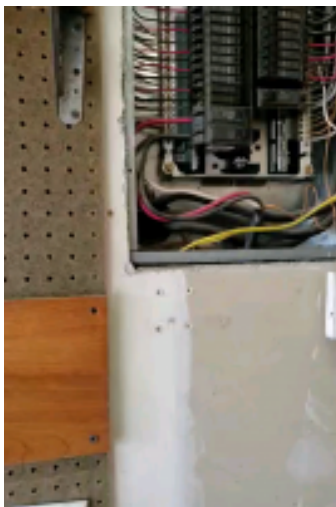
### DEFICIENCY 5.3

GFCI Protection Not Installed

There are receptacles in the home that aren't protected by GFCI when they should be. Receptacles near water sources, in garages, and outside need to be GFCI in order to prevent accidental shocks. I recommend having an electrician evaluate the home's receptacles in order to ensure safety. Here is a link to read about how GFCI receptacles keep you safe.

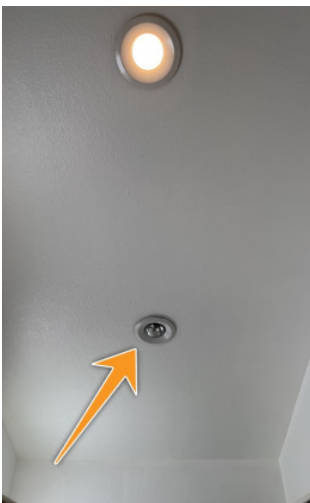
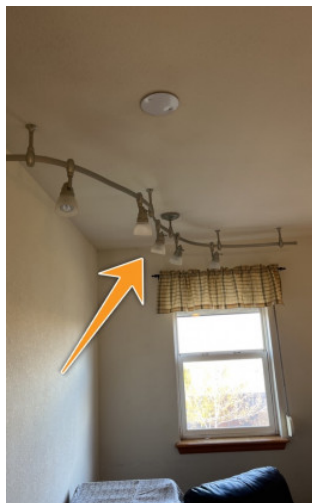
## DEFICIENCY 5.5

Inoperable - Light Fixture

Light was not operating during the inspection. It could be just a simple light bulb that is burnt out, but I recommend communicating with the seller to determine if the light does actually function.

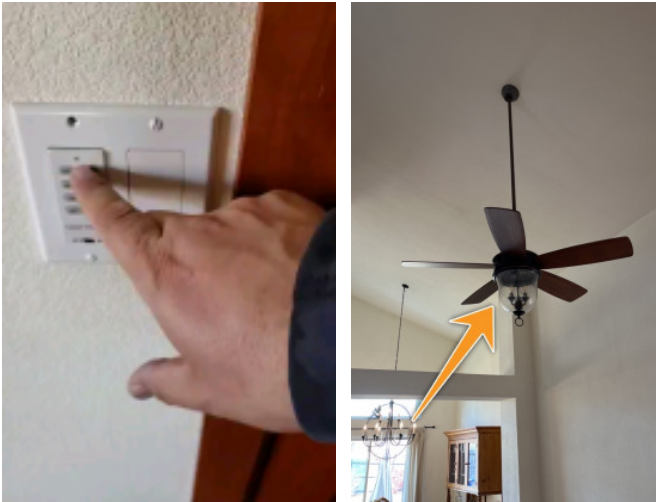
## DEFICIENCY 5.6

Inoperable - Ceiling Fan

There is a ceiling fan that was inoperable at time of inspection recommend repair.

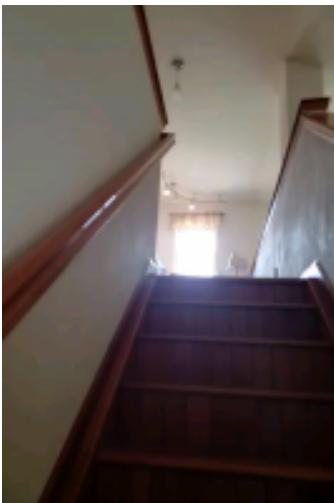
## DEFICIENCY 5.7

Improperly Wired 3 Way - Switch

A 3 way switch is improperly wired. I recommend a licensed electrician repair or replace.

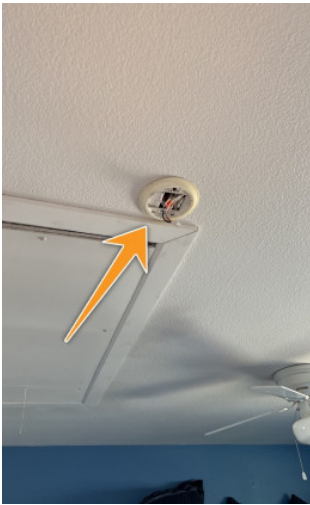
## DEFICIENCY 5.8

Missing - Smoke Detectors

Smoke detectors were missing at the time of inspection. I recommend installation.

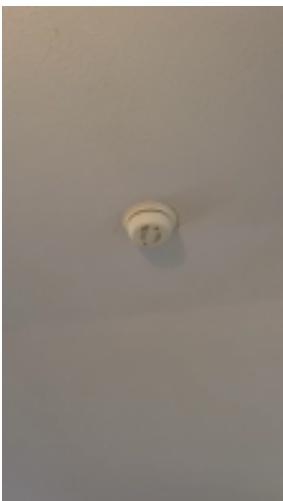
### DEFICIENCY 5.9

Expired - Smoke Detectors

The smoke detectors appeared older as evidenced by the yellowing of the plastic and may be expired. I recommend replacing every 10 years per manufacturers requirements.

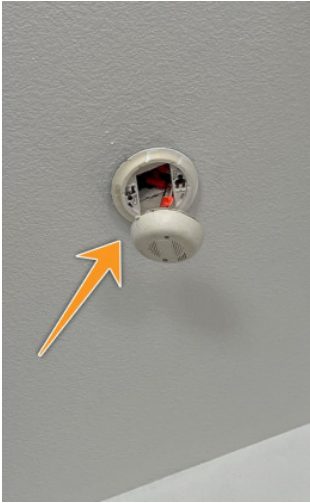
### DEFICIENCY 5.10

Hanging - Smoke Detector

One or more smoke detectors were hanging from the power wires at the time of the inspection. Recommend ensuring they work and properly installing them.

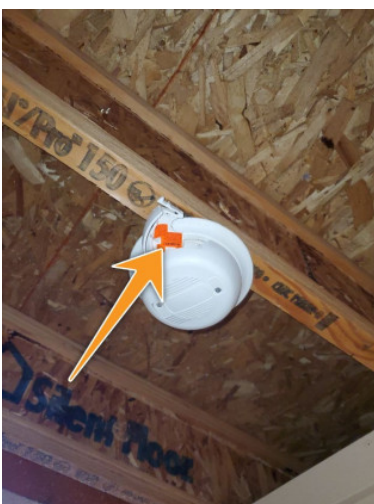
### DEFICIENCY 5.11

Battery Missing - Smoke Detector

One or more smoke detectors had the battery missing at the time of the inspection. Recommend replacement.

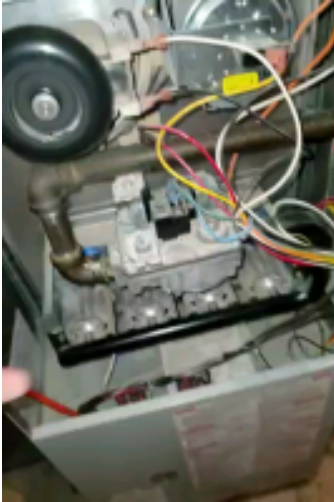
### DEFICIENCY 7.1

The furnace is dirty. I recommend servicing by a qualified HVAC technician.

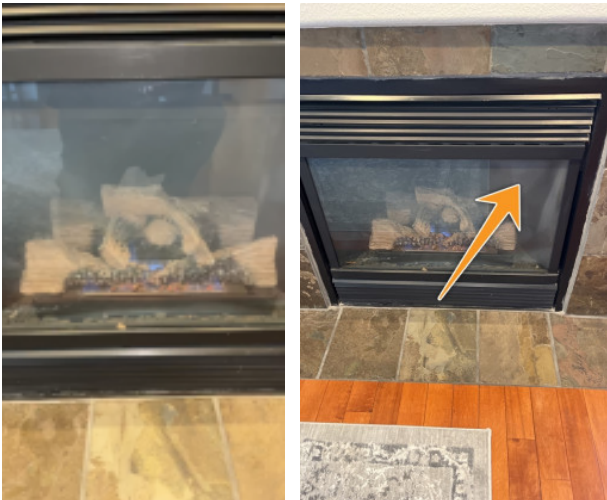
### DEFICIENCY 7.2

Foggy glass - Fireplace

The glass on the gas fireplace was foggy at the time of the inspection. Recommend cleaning of glass.

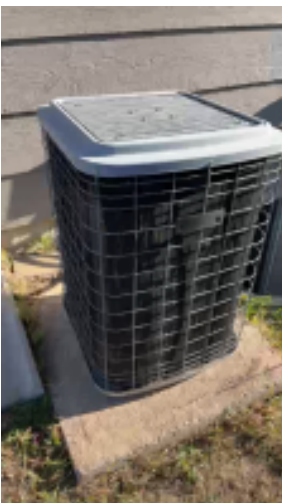
Unable to Test Functionality

Due to the temperature being below 65, or the condenser being covered, it could not be tested at the time of the inspection.

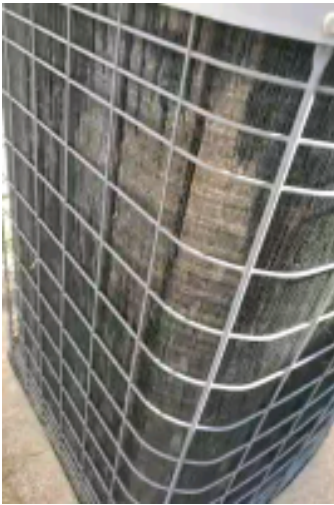
### DEFICIENCY 8.2

Corrosion - Exterior Condenser

There are signs of exterior wear and rust on the unit recommend an evaluation and repair if needed.

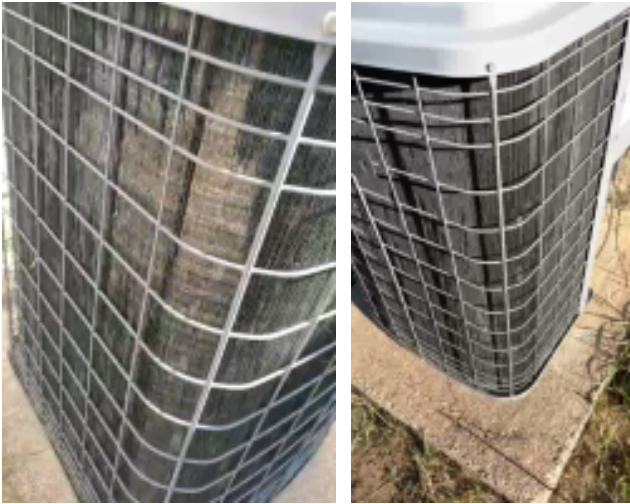
### DEFICIENCY 8.4

Damaged fins- Minor - Exterior Condenser

While inspecting the condenser, I found minor damage to the fins. This type of damage can typically be repaired by an HVAC technician by using a special comb to straighten the fins back out. I recommend having an HVAC do an evaluation and repair as necessary.

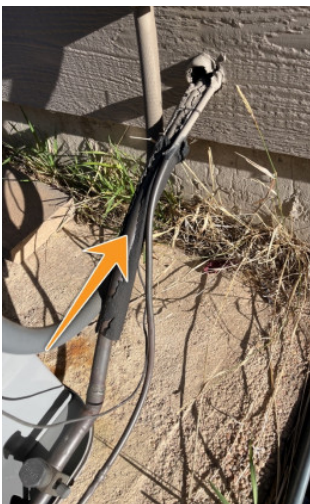
#### DEFICIENCY 8.5

Missing/Damaged - Insulation for A/C

Missing or damaged insulation on refrigerant line can cause energy loss and condensation. I recommend having condensate lines insulated to improve unit efficiency.

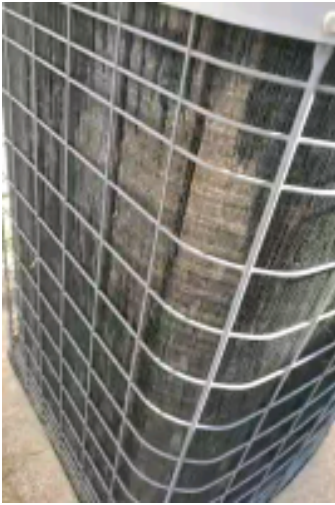
#### DEFICIENCY 8.6

## Dirty Fins - Exterior Condenser

Recommend cleaning fins to ensure proper airflow.

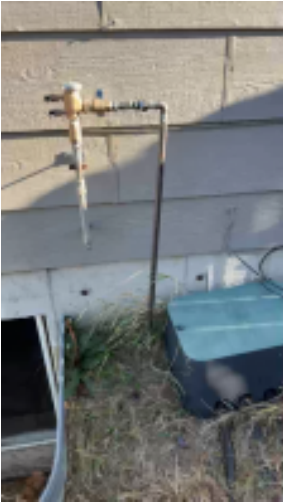
Not tested - Sprinkler System

Irrigation system not tested

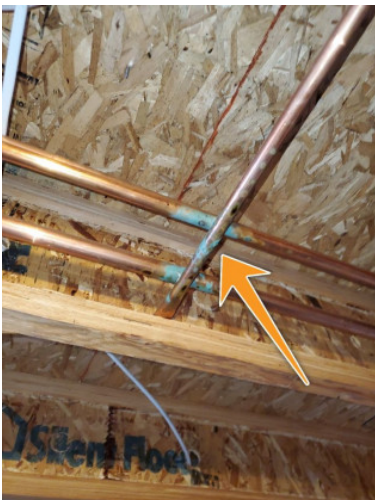
### DEFICIENCY 9.2

Corrosion - Supply Pipes

Pipe and/or fittings were observed to have corrosion. This can lead to a shortened lifespan.

Recommend a qualified plumber repair.

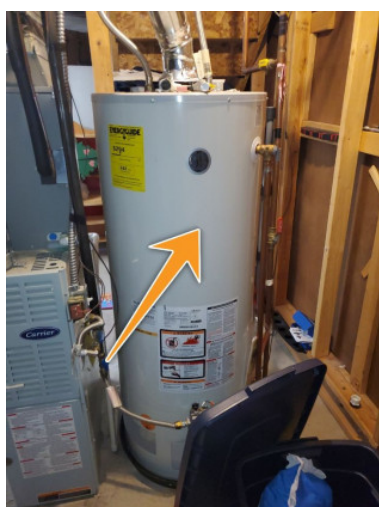
### DEFICIENCY 9.3

Dated Water Heater

The expected lifespan of a water heater is 8 to 12 years. One or more of the water heaters in the home fell within that range or past.

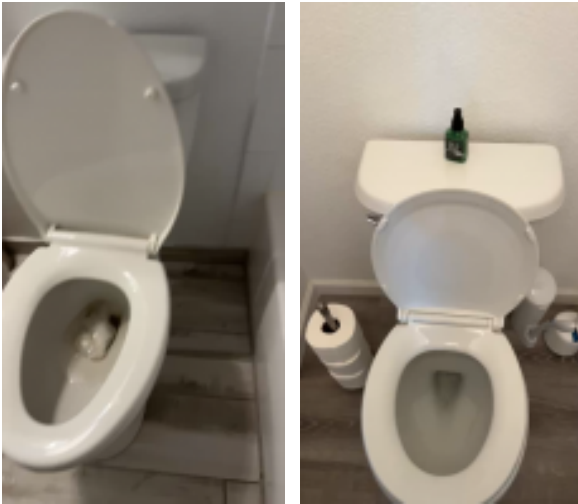
### DEFICIENCY 9.4

Loose - Toilet

The toilet was loose at the base. This may be from a damaged flange or a failed wax seal. In any case, this should be remedied before a leak occurs.

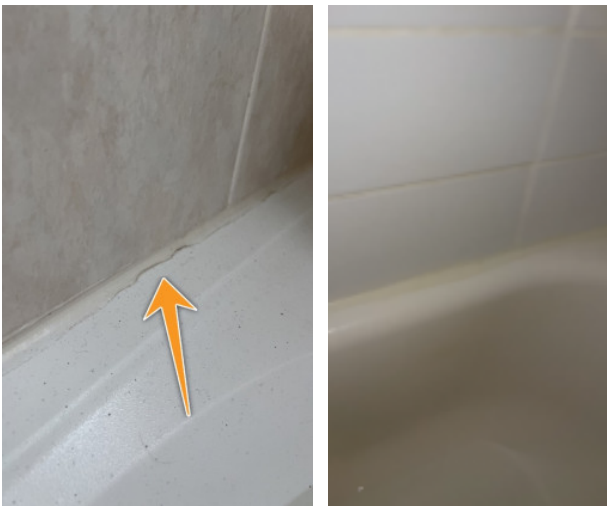
### DEFICIENCY 9.5

Maintain Caulking - Plumbing fixture

The caulking around the fixture was in need of repair and/or maintenance. Water intrusion can become a costly repair. I recommend sealing with a flexible caulk or silicone and then annual maintenance.

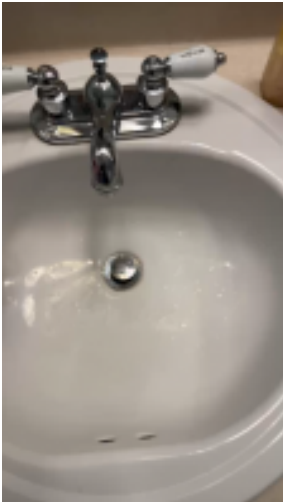
### DEFICIENCY 9.6

Not Functioning - Drain Assembly

The drain stopper at the fixture was missing or not functioning. Repair or replace.

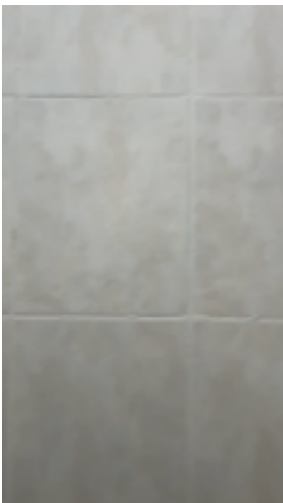
## DEFICIENCY 9.7

Grout Maintenance

Recommend re-grouting.

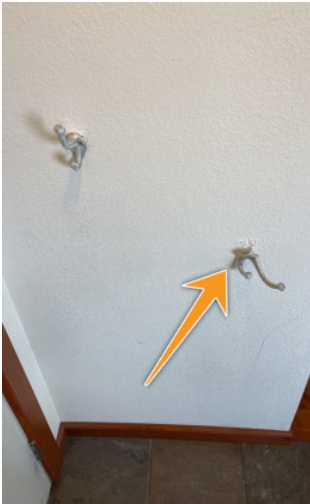
### DEFICIENCY 10.1

Damage drywall

minor drywall damage was present at time of inspection

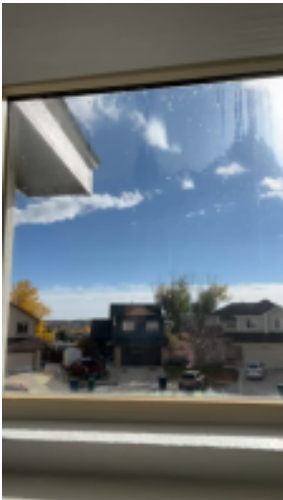
### DEFICIENCY 10.2

Failed Seal - Window

I observed condensation between the window panes, which indicates a failed seal. The windows have lost efficiency and have a cloudy look. I recommend having a qualified window contractor evaluate.

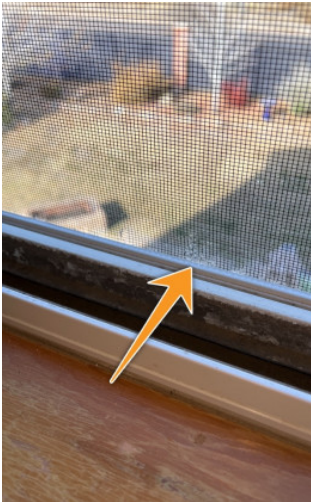
### DEFICIENCY 10.3

## Damaged Screen - Window

I recommend repair or replacement of the screen.

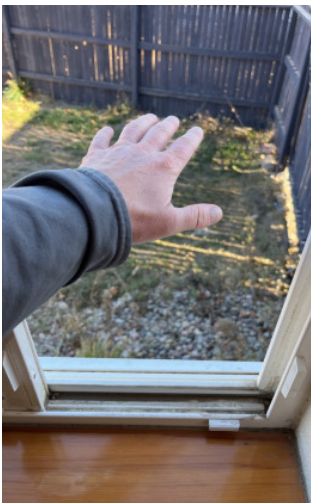
### DEFICIENCY 10.4

### Missing Screen - Window

When inspecting the windows, I did find that one or more of them did not have screens. I recommend replacing the missing screens.

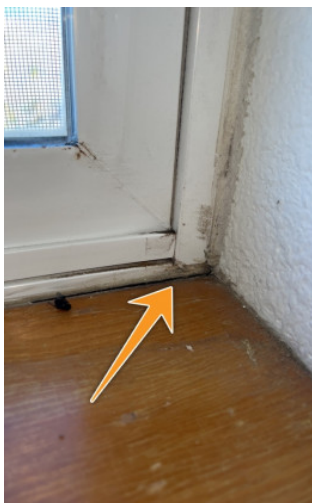
### DEFICIENCY 10.5

I did find one or more windows in the home that need to be caulked on the interior side. Caulking on the interior side is not only for cosmetic reasons, but also to weatherize the window. I recommend using a flexible and paintable caulking, and maintain over the years.

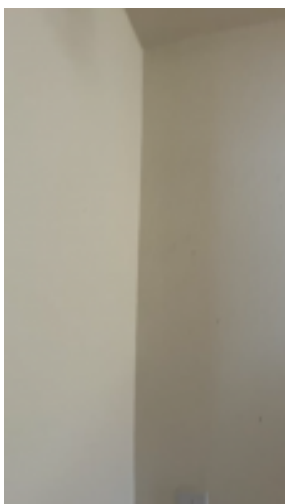
### DEFICIENCY 10.6

Paint touch up

At the time of inspection there were one or more locations that were in need of paint touch

up on the walls.

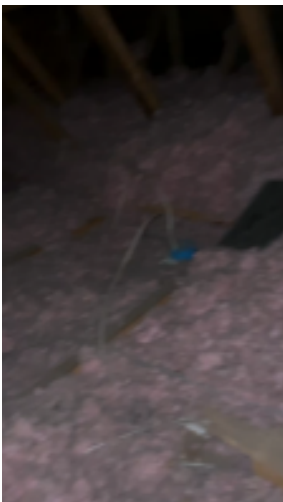
### DEFICIENCY 12.2

Uneven Insulation - Attic

Recommend leveling insulation for even insulating properties throughout the attic space.

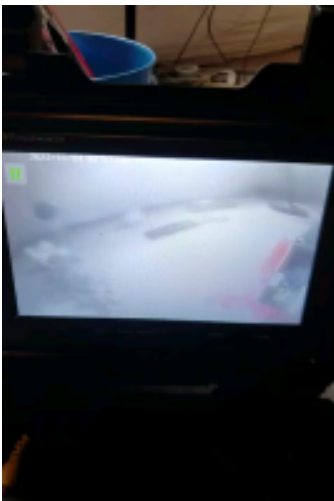
### DEFICIENCY 13.1

Blockage - Lateral Sewer Line

The lateral sewer line had major debris or blockage at the time of inspection. This is restricting sewage flow and will lead to a backup. Recommend cleaning and re-inspection of the lateral line by a qualified professional.

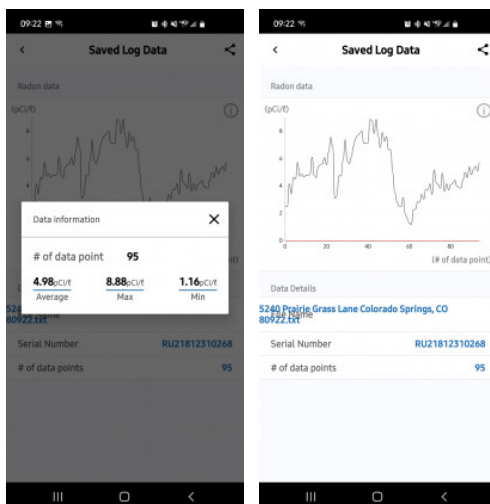
### DEFICIENCY 14.1

High Levels - Radon

Average radon levels of 4.98pCi/L exceeded the 4 pCi/l EPA threshold. I recommend a longer test, up to 90 days, or installation of a mitigation system in the home.
