Top Choice Inspectors

Residential Inspection Report

123 Sample Drive, Anytown, USA 54321

May 01, 2023 09:00 am

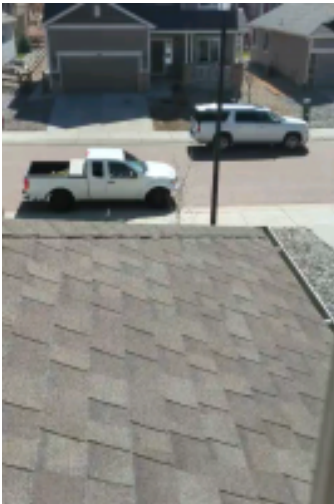
DEFICIENCY 2.1

Mechanical Damage - Coverings

Estimated Severity : ■ Minor/Maintenance

At the time of inspection there was some mechanical damage present on the roof covering. This is damage that's not attributed to a storm or hail. It is often the result of a contractor walking on the roof and scuffing the shingles. Mechanical damage typically does not affect the roof's ability to shed water. If there are further concerns I recommend having a licensed roofer evaluate.

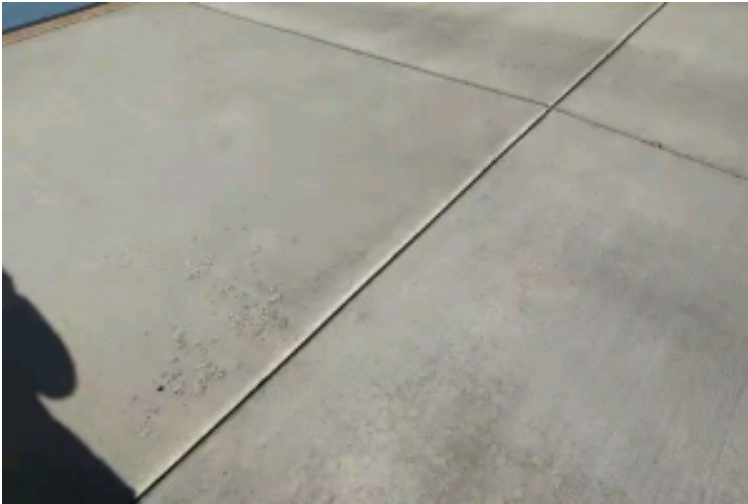
DEFICIENCY 3.1

Deterioration - Walkways Patios Driveways

Estimated Severity : Minor/Maintenance

Concrete surfaces are weathered and deteriorated. I recommend repair or replacement by concrete professional when the driveway or walkway loses its functionality.

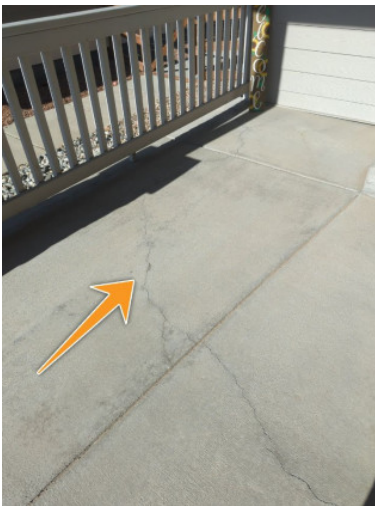
DEFICIENCY 3.2

Cracking/Settling - Minor - Walkways Patios Driveways

Estimated Severity : ■ □□ Repair

I observed some minor cracks in the cement. This is very typical due to soil movement. I would consider these cracks cosmetic, but I do recommend using a sealant to prevent water intrusion. Monitor and maintain as necessary.

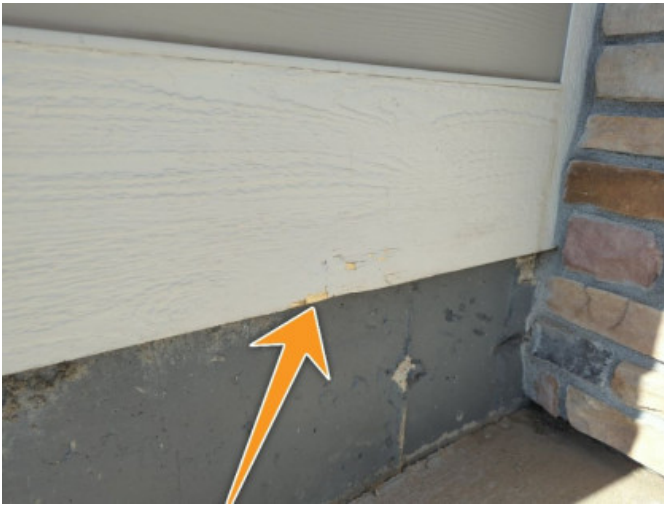
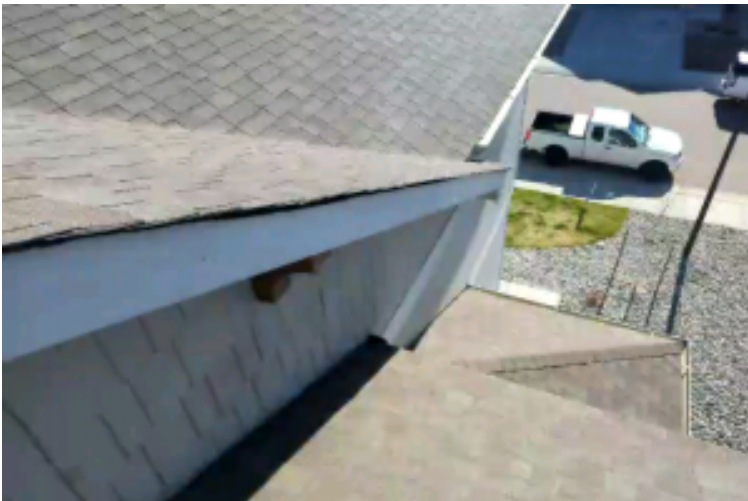
DEFICIENCY 3.3

Paint/caulk maintenance

Estimated Severity : ■ □□ Repair

At the time of inspection there were areas of the home that were in need of paint touch up and/or caulk maintenance to help seal the exterior siding and trim. Recommend performing exterior maintenance as needed to maintain the life of the siding.

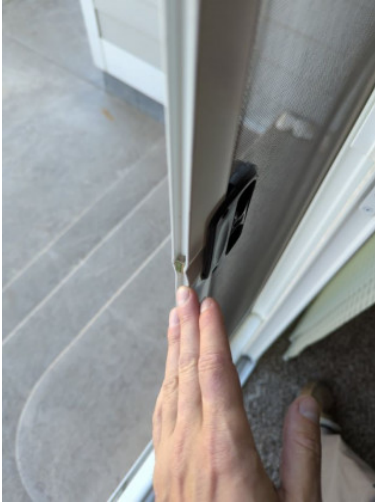
DEFICIENCY 3.4

Screen Damage - Exterior Doors

Estimated Severity : ■ Minor/Maintenance

The sliding glass door screen appears to be damaged. Recommend repair or replacement.

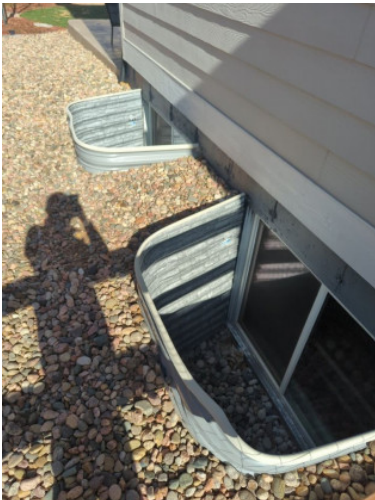
DEFICIENCY 3.5

Missing Window Well Covers

Estimated Severity : ■ □□ Repair

The basement window wells are missing there covering

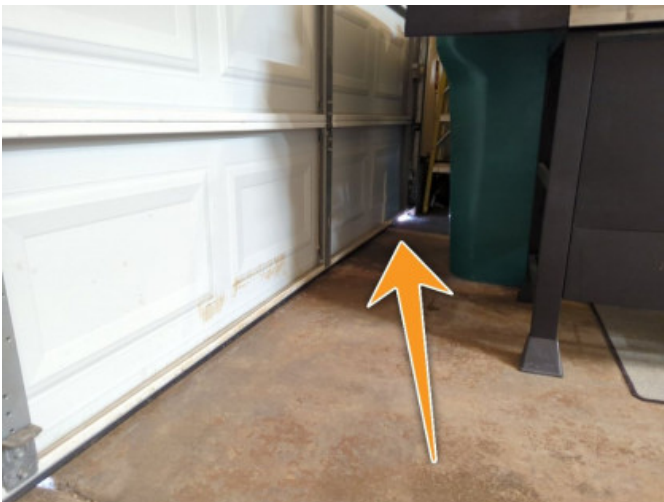
DEFICIENCY 4.2

Weatherstripping Damaged/missing - Garage Door

Estimated Severity : ■ □□ Repair

I recommend repair or replace.

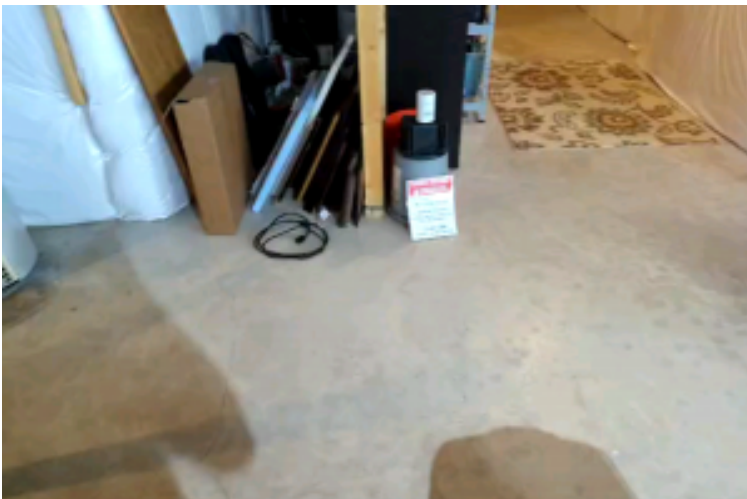
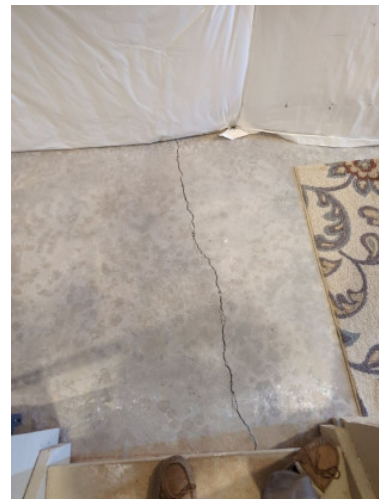
DEFICIENCY 6.2

Typical cracks - Slab

Estimated Severity : ■ ☐ Repair

There is evidence of typical cracking in the basement concrete slab. Recommend sealing the cracks and monitoring for further movement.

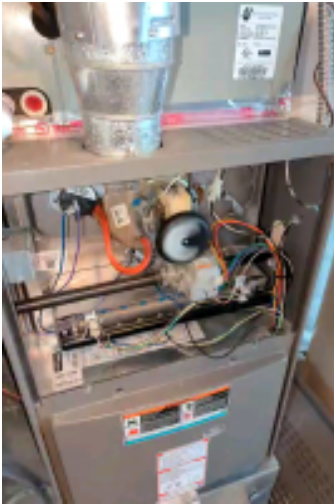
DEFICIENCY 7.1

Clean/Service - Furnace

The furnace is dirty. I recommend servicing by a qualified HVAC technician.

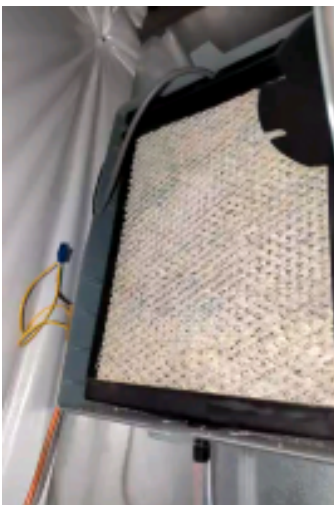
DEFICIENCY 7.2

Cleaning/maintenance - Humidifier

Estimated Severity : ■ □□ Repair

The humidifier had excessive mineral deposits at the time of the inspection. Recommend replacing the pad.

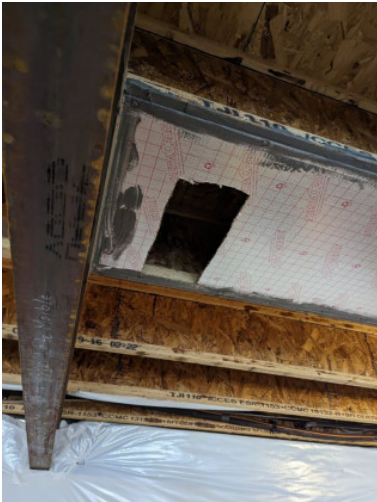
DEFICIENCY 7.3

Missing register cover

Estimated Severity : ■ Minor/Maintenance

Recommend replacement

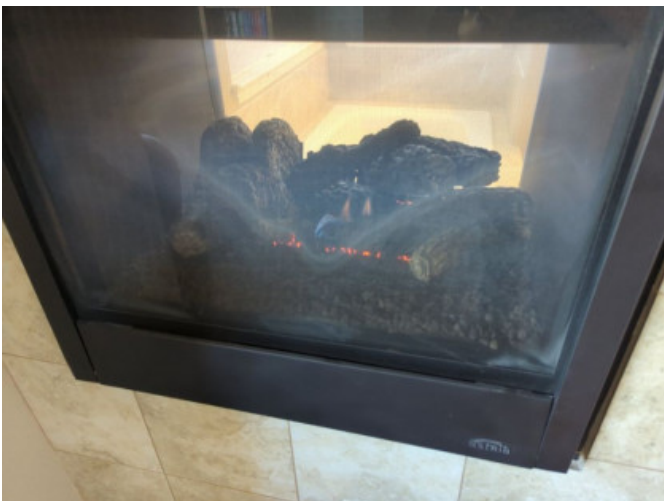
DEFICIENCY 7.4

Foggy glass - Fireplace

Estimated Severity : ■ Minor/Maintenance

The glass on the gas fireplace was foggy at the time of the inspection. Recommend cleaning of glass.

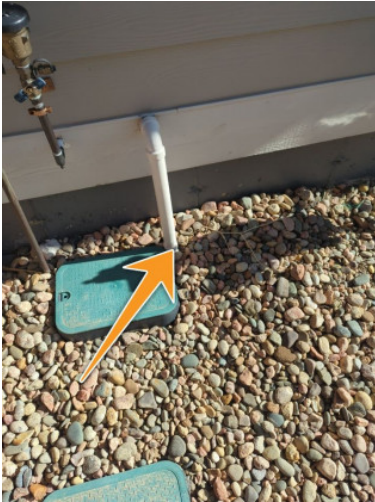
LIMITATION 9.1

Unable To Observe Sump Pump Discharge

I was unable to view where the sump pump discharge terminated. It is buried beneath the front porch and I was unable to find where it ends. Recommend asking seller pertinent information regarding sump pump discharge.

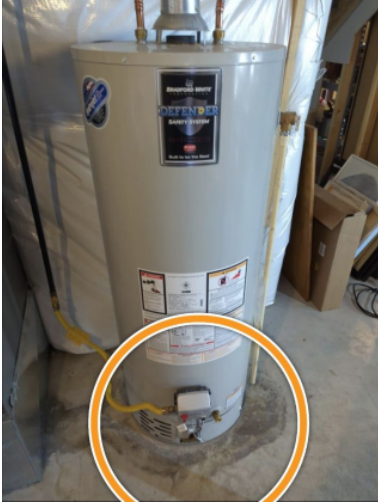
DEFICIENCY 9.2

Water Stains - Leakage - Water Heater

Estimated Severity : ■ <input type="checkbox"/> <input type="checkbox"/> Repair
--

Water stains were observed beneath water heater, indicating a past or present leak. Recommend further evaluation and repair by a qualified plumber if necessary.

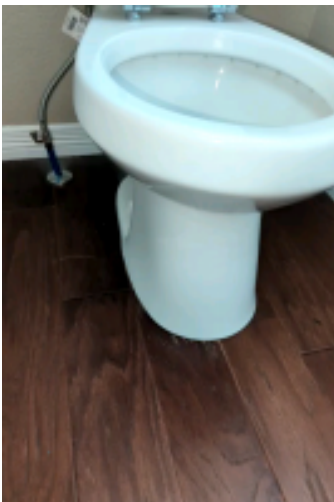
DEFICIENCY 9.3

Loose - Toilet

Estimated Severity : ■ □□ Repair

The toilet was loose at the base. This may be from a damaged flange or a failed wax seal. In any case, this should be remedied before a leak occurs.

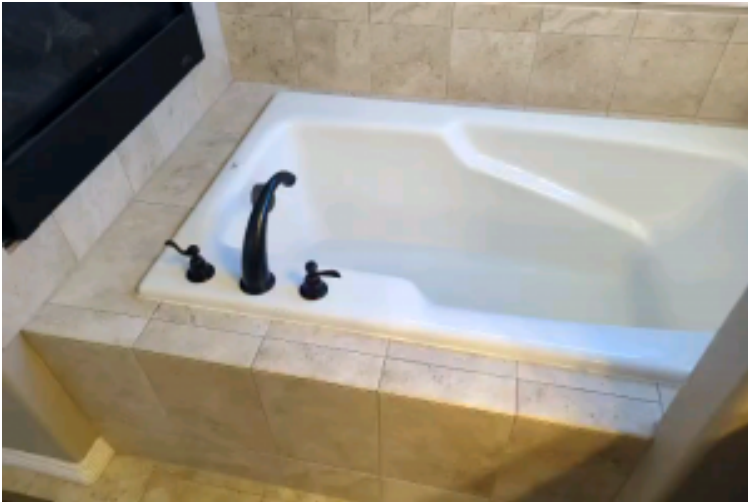
DEFICIENCY 9.4

Whistling Coming From Fixture

Estimated Severity : ■ Minor/Maintenance

At the time of inspection I observed a soft whistling noise coming from one of the fixtures in the home. This is typically the result of some air in the supply line. Sometimes it will work its way out on its own, but if the problem persists, I recommend evaluation by a licensed plumber in any repairs to be made.

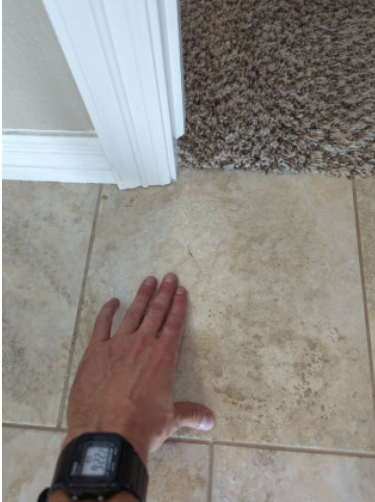
DEFICIENCY 10.1

Damaged - Tile

Minor/Maintenance
--

When inspecting the home's flooring, I found that one or more tiles in the home were damaged. I recommend having the damaged tiles replaced.

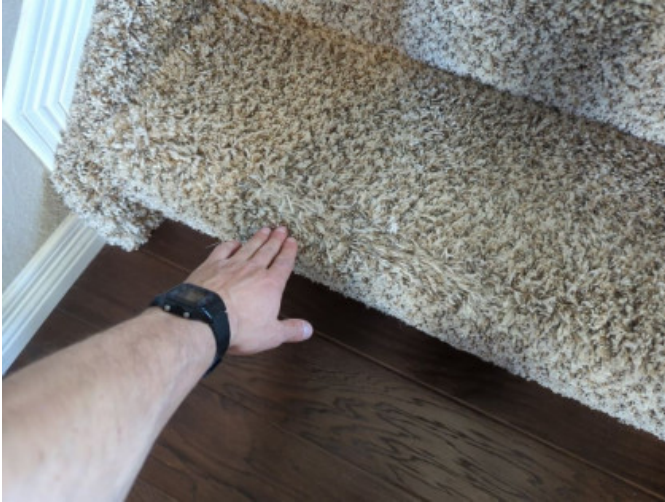
DEFICIENCY 10.3

Carpet - Typical Wear

Estimated Severity : ■ ☐ Repair

The carpet show signs of typical wear in the common areas and high traffic areas of the home.

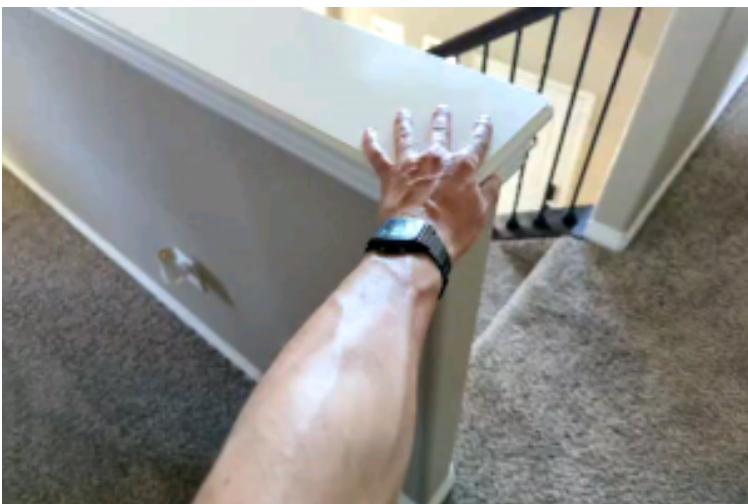
DEFICIENCY 10.4

Handrail Loose - Interior Staircase

Estimated Severity : ■ Minor/Maintenance

I recommend securing the handrail.

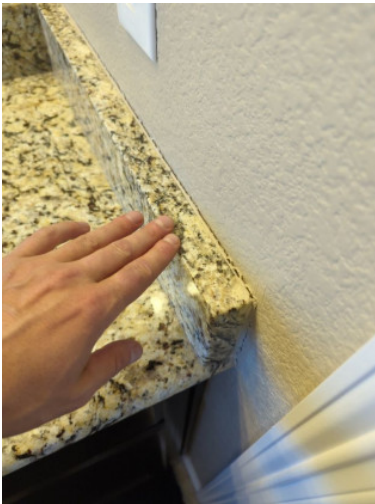
DEFICIENCY 10.5

Maintain Caulking - Countertop

Estimated Severity : ■ Minor/Maintenance

The countertop was missing sufficient caulk/sealant at the wall or sink. This can lead to water damage. I recommend adding sealant at sides and corners where counters touch walls and sinks. Here is a helpful DIY video on caulking gaps.

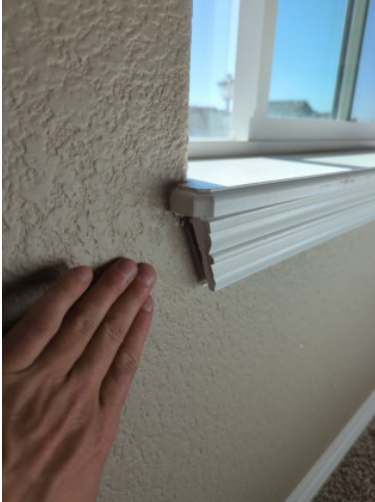
DEFICIENCY 10.6

Loose - Interior Trim

Estimated Severity : ■ Minor/Maintenance

One or more pieces of the interior trim appeared to be loose. I recommend having it re-secured to the wall.

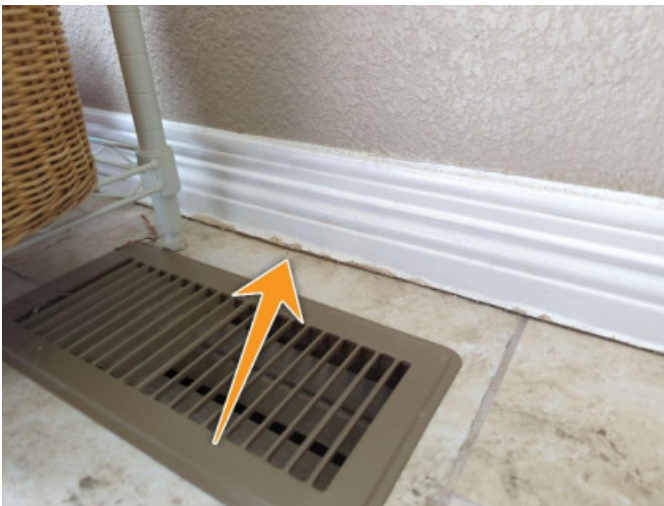
DEFICIENCY 10.7

Minor damage - Interior Trim

Estimated Severity : ■ Minor/Maintenance

There was minor damage to one or more pieces of trim at the time of the inspection. Recommend repair or replacement.
