# Top Choice Inspectors

## Residential Inspection Report

123 Sample Drive, Anytown, USA 54321

September 07, 2023 09:30 am

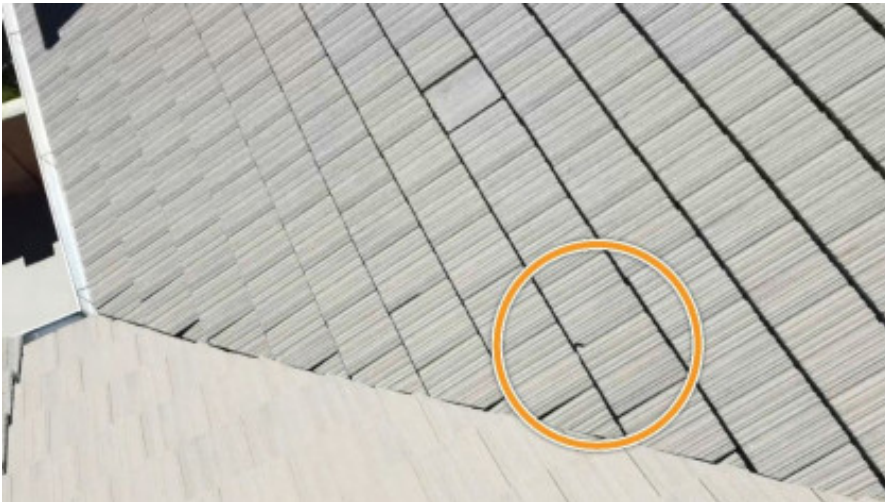
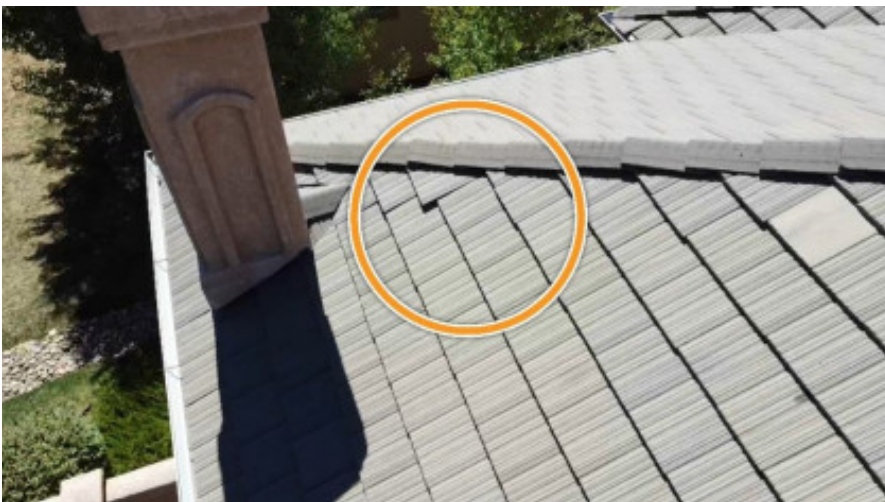
## DEFICIENCY 2.1

Chipped and Loose Tiles

Estimated Severity : ■ Minor/Maintenance

The roof had some chipped and loose tiles. I recommend a qualified roof contractor repair or replace to prevent moisture intrusion.

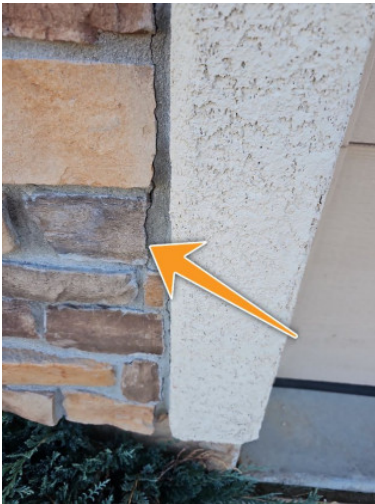
### DEFICIENCY 3.3

Cracking in stone veneer

Estimated Severity : ■   Repair

At the time of inspection, some cracking was noted in the stone veneer. This is not a structural component of the home. Recommend performing any necessary maintenance for the upkeep of the stone exterior..

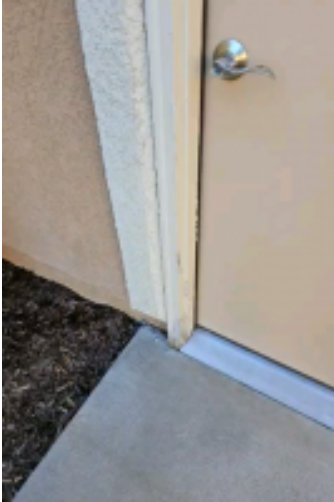
### DEFICIENCY 3.4

Paint / Finish Maintenance - Exterior Doors

Estimated Severity : ■   Repair

While inspecting the exterior door, it appeared to need the finish maintained. I recommend having the door properly finished in order to protect the door from sun and water damage.

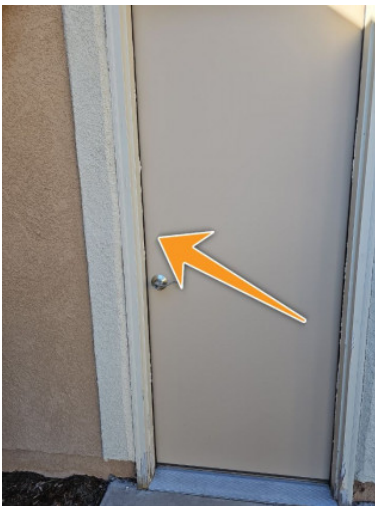
### DEFICIENCY 3.5

No deadbolt - Exterior Doors

Estimated Severity : ■  Repair

No dead bolt on the exterior door. I recommend installing for safety on all exterior doors.

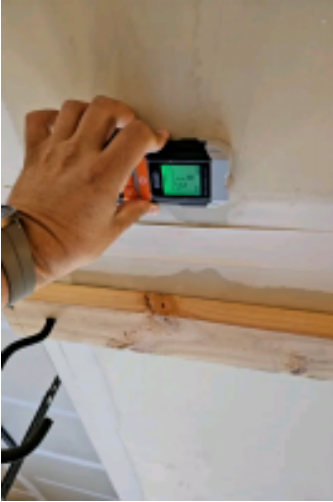
### DEFICIENCY 4.1

Water Stains - Non-Firewall Garage

Estimated Severity : ■ □□ Repair

Ceiling had water stains indicative of leaks or condensation. There are no active leaks as moisture levels were normal. Recommend monitoring.

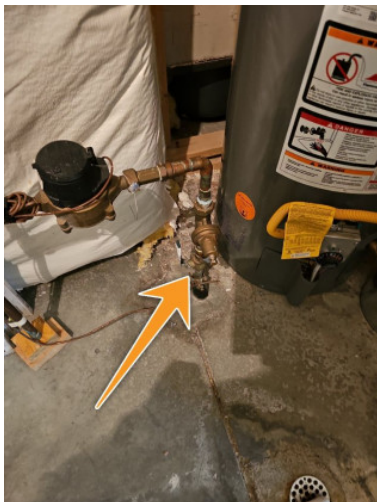
## CUSTOM 9.1

Main Water Shut-Off

This valve turns the water off to the whole house.

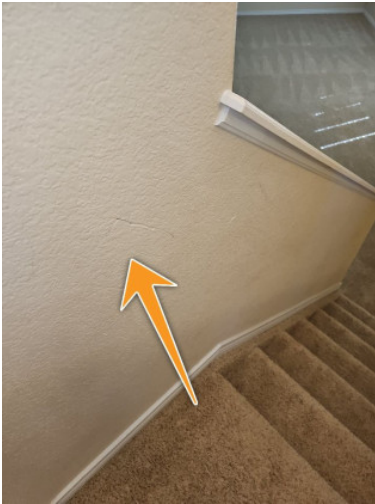
### DEFICIENCY 10.1

Damage drywall

Estimated Severity :    Repair

minor drywall damage was present at time of inspection

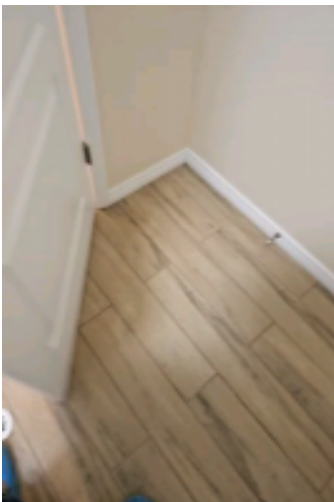
### DEFICIENCY 10.2

Sticks - Interior Door

Estimated Severity : ■ □□ Repair

I found one or more doors that stick and is difficult to open and close. I recommend adjustment of doors so they operate smoothly. Here is a helpful DIY article on how to fix a sticking door.

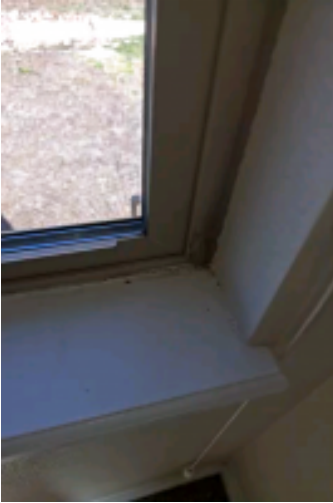
## DEFICIENCY 10.3

Caulk Maintenance - Window

Estimated Severity : ■ □□ Repair

I did find one or more windows in the home that need to be caulked on the interior side. Caulking on the interior side is not only for cosmetic reasons, but also to weatherize the window. I recommend using a flexible and paintable caulking, and maintain over the years.

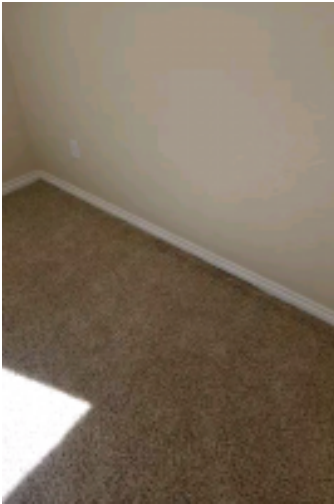
## DEFICIENCY 10.4

Stains - Carpet

Estimated Severity : ■ □□ Repair

When I inspected the home's flooring, I found areas of the carpet that appeared to have stains or some type of discoloration. I recommend a thorough steam clean by a qualified carpet cleaning company.

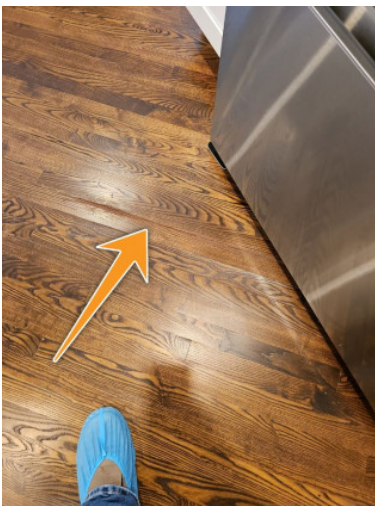
## DEFICIENCY 10.5

Moisture Damage - Flooring

Estimated Severity : ■  Repair

When inspecting the home's flooring, one or more areas had visible moisture damage. I recommend a qualified flooring contractor evaluate & repair areas of moisture.

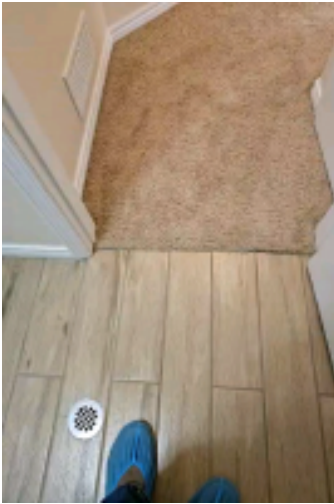
## DEFICIENCY 10.6

Re-stretch Carpet

Estimated Severity : ■ Minor/Maintenance

The carpet may need to be re stretched recommend repair as needed.

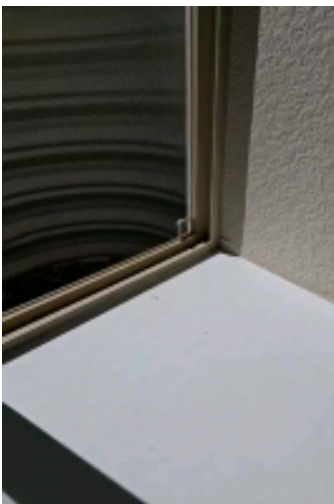
### DEFICIENCY 10.7

Moisture damage on walls

Estimated Severity : ■■■ Repair

There appears to be moisture damage on walls. Recommend further evaluation to correct the source of moisture and repair drywall

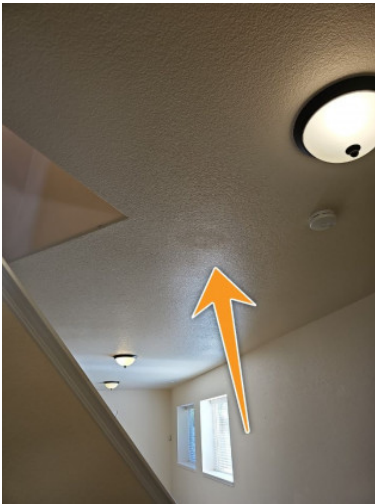
### DEFICIENCY 10.8

Patching - Ceiling

Estimated Severity : ■ □□ Repair

There appears to be some visible patching in the ceiling. Recommend asking the seller history as to why the patching was needed.

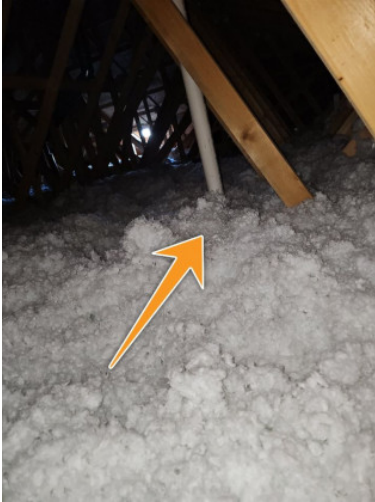
### DEFICIENCY 12.1

Aged Insulation - Attic

Estimated Severity :  ☐☐ Repair

Due to the age of the Insulation, and most likely the original install of the home, I recommend a insulation specialist to verify the quality and condition of the insulation. Overtime, insulation settles and compresses. I recommend further evaluation to determine if newer insulation is necessary to improve the efficiency of your home.
