# Precision Property Inspections

## Precision Residential

123 Sample Drive, Anytown, USA 54321

September 12, 2025 01:30 pm

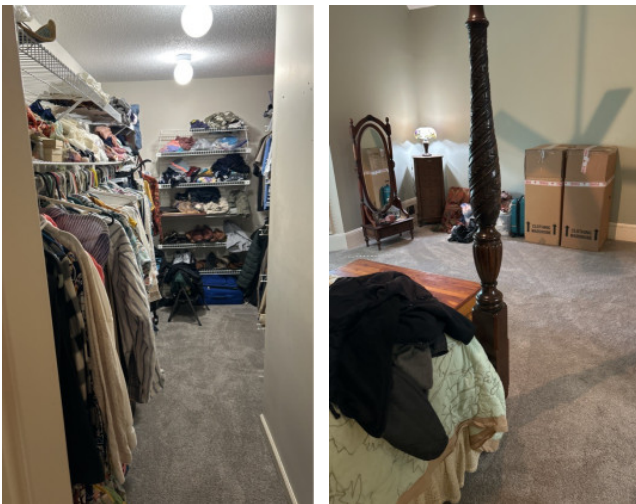
Occupied / Furnished Disclaimer

Due to the home being furnished at the time of inspection, not all floor and wall surfaces, countertops, windows, and electrical receptacles could be inspected or tested.

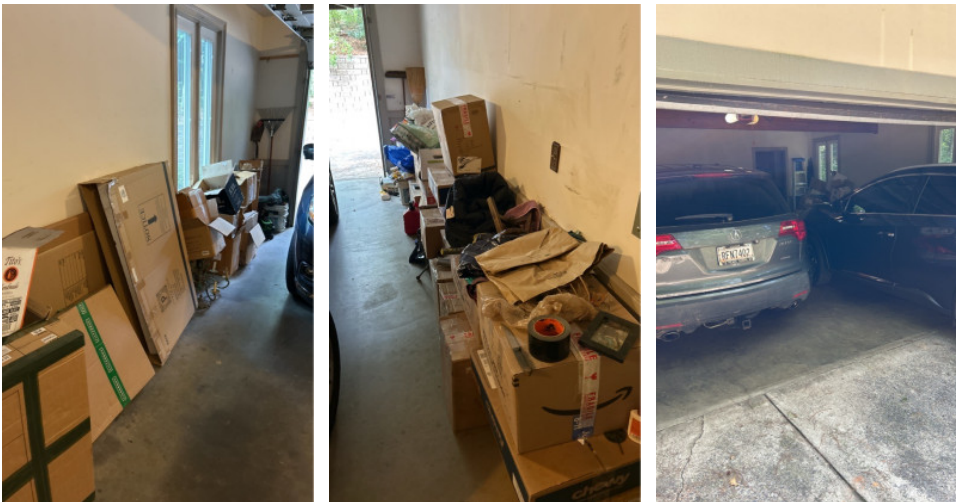
View Obstructed

Monitor: Stored items and/or vehicle(s) prevent full inspection of the floor and walls.  
Thoroughly inspect the area after items are removed.

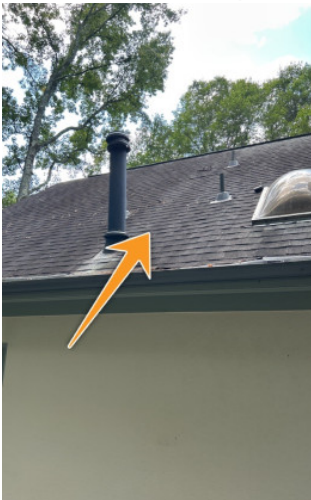
Roof Height / Slope Notice

Due to the steep slope and/or height of the roof structure, the roof could not be safely walked and was viewed from the ground only using binoculars or from a ladder at the eaves. Some sections of the roof could not be viewed.

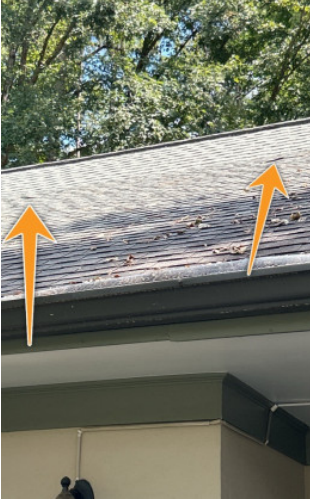
- DEFICIENCY 4.4 Structural Components- Structural: Floor Structure: Water Damage / Rot Noted - Repair
- DEFICIENCY 5.2 Roofing System- Roofing: Shingles / Membrane: Displaced Shingles Noted

Repair: Some shingles were observed lifting, displaced, or otherwise damaged. Damaged and displaced shingles can contribute to roof leakage. Have a qualified roofer provide further evaluation and replace all missing or defective components, ensuring proper operation of the roofing systems.

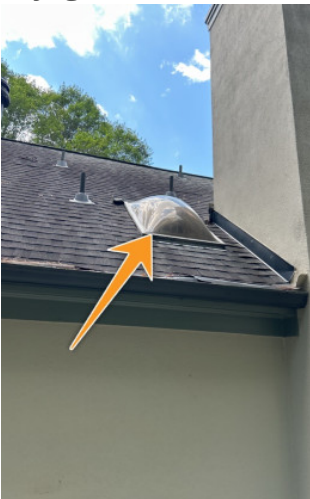
Skylight - Monitor

Monitor: The flashing components at the skylights should be carefully monitored, as these

areas are extremely vulnerable to leakage.

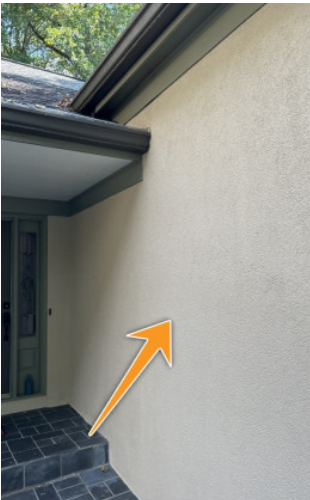
EIFS Warning

Monitor, Possible Concern: EIFS (Exterior Insulation and Finish System - sometimes referred to as "Synthetic Stucco"), as noted on this structure, has had moisture problems in the past with poor installations. It is important that these systems are kept well caulked and sealed to prevent moisture from infiltrating the structure, which can cause damage. All windows, doors, chimneys and intersecting roofs should be properly flashed. Consider having the entire veneer inspected by a stucco repair contractor for repairs and improvements that may be needed.

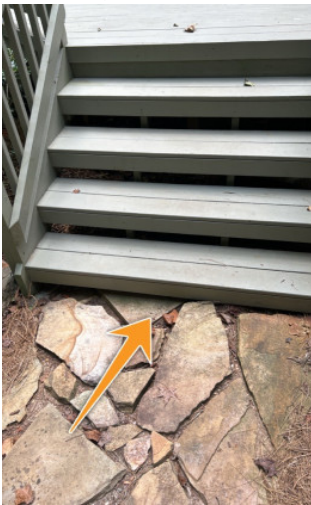
#### Landing Needed At Deck Stairs

Improve, Safety Issue: Deck stairs should terminate at a concrete landing to prevent tripping or falling. Consult a deck contractor or qualified handy person for installation of a landing.

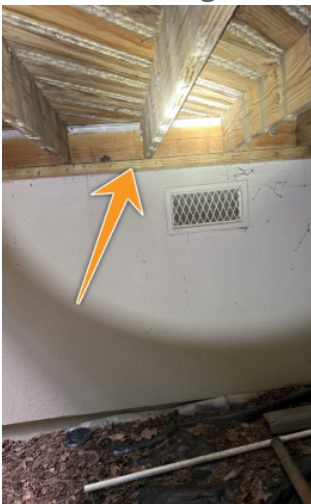
#### Deck 2x2" Ledger Warning

Improve: Until recently, a 2x2" wood ledger was deemed suitable as long as it was fastened below each joist with a minimum of three 16d nails. Recent changes in deck codes no longer recognize this as an adequate or safe connection. Consider evaluation by decking contractor for upgrades to the deck that may improve its longevity and safety. In many cases, the addition of simple hardware (such as joist hangers) can be done relatively easily and without great cost.

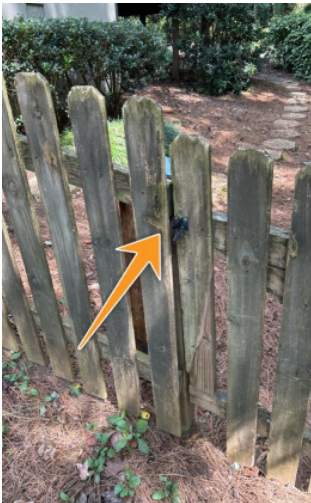
Adjust Gate / Latch

Improve: The gate and/or latch mechanism needs adjustment to function properly.

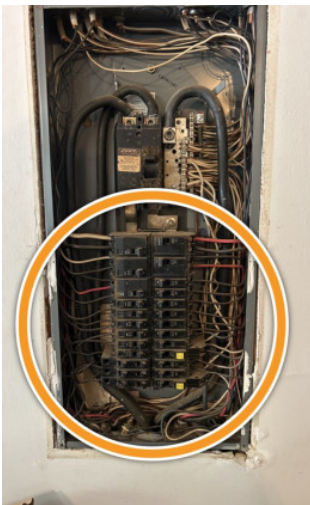
#### Panel Is Crowded

Improve: The main distribution panel is crowded with breakers. A larger panel, or an auxiliary panel, would be desirable, especially if electrical additions are planned.

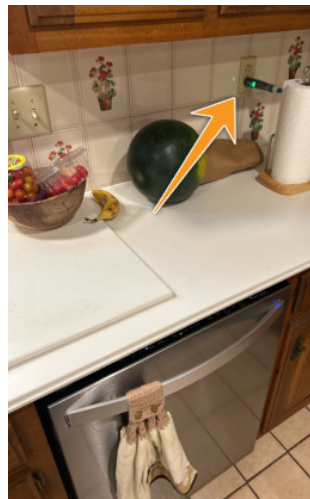
Loose Outlet

Repair: Loose outlet(s) as noted should be tightened to prevent the loosening of the wiring

connections in the future.

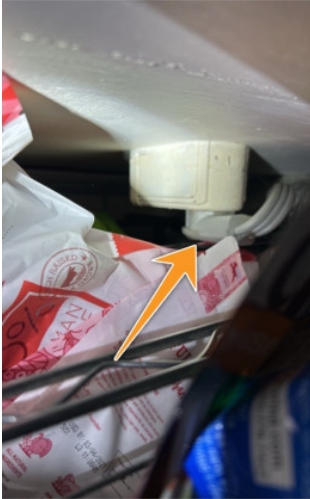
4 Prong Outlet Needed At Dryer (Improve)

Improve: A three-prong outlet was noted at the laundry, but newer dryers utilize a four-prong plug (although many do support replacing the cord with a three-prong version). Consult an electrician for replacement as necessary.

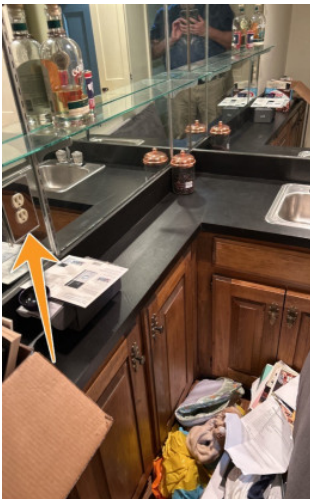
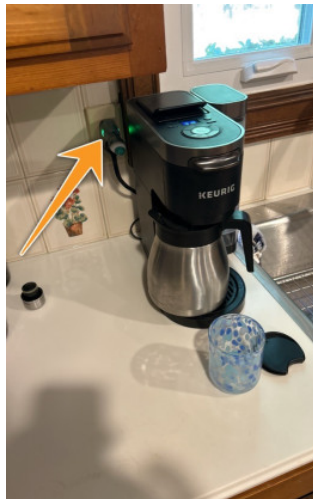
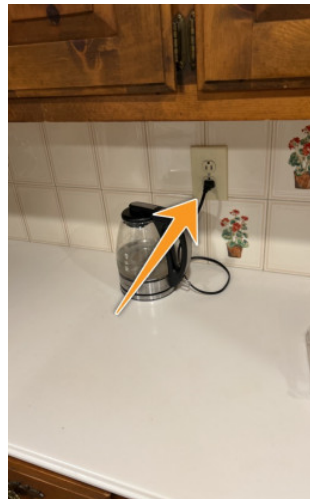
GFCI Recommended

Improve, Safety Issue: The installation of a ground fault circuit interrupter outlet(s) is recommended at the location(s) shown. A ground fault circuit interrupter (GFCI) offers increased protection from shock or electrocution. Up to date weatherproof covers should be installed at all exterior outlets.

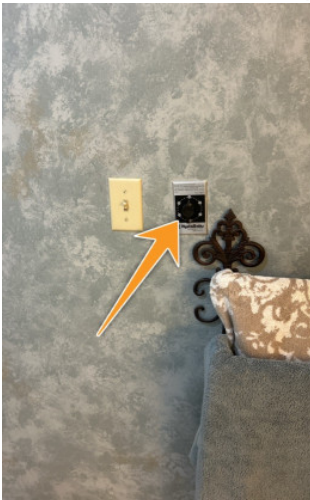
GFCI Needed At Whirlpool Bath

Possible Repair, Safety Issue: A ground fault circuit interrupter (GFCI) should be installed on the circuit for the whirlpool bathtub. The presence of this component could not be confirmed due to a lack of access under the tub (see "Plumbing" Section), and no labeled GFCI circuit breaker was noted in the main panel. A ground fault circuit interrupter offers protection from shock or electrocution.

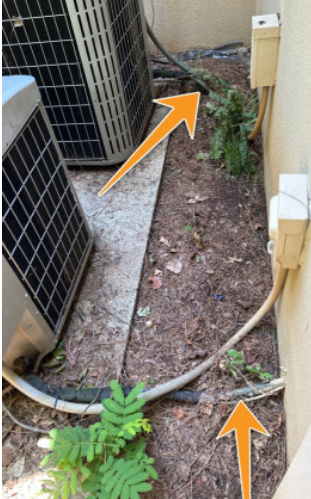
### Insulation Damage At Exterior Refrigerant Lines

Improve: Damaged and missing insulation on exterior refrigerant lines as noted should be repaired or replaced for proper efficiency and protection of the copper piping.

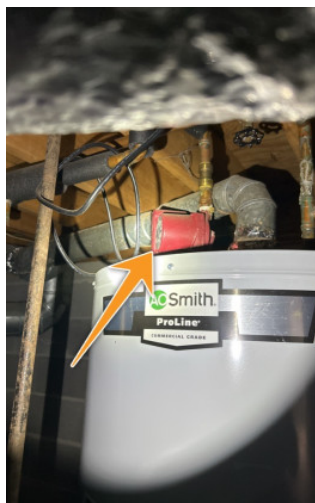
## Install Timer For Circulating Pump

Improve: Consider installing a timer on the hot water circulating pump to prevent heat loss in the walls when not in use (e.g. at night).

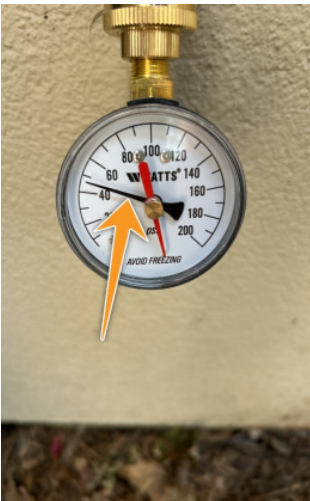
Water Pressure Normal

Water pressure measured between 40 and 80 PSI, considered normal. No action necessary,

FYI only.

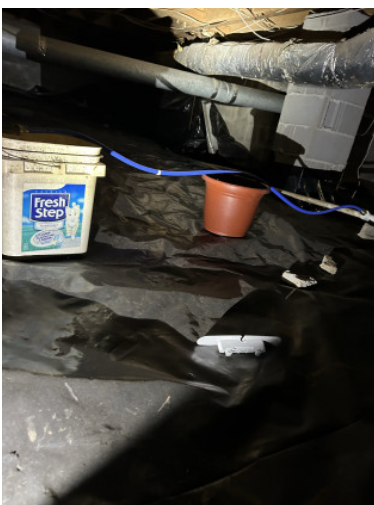
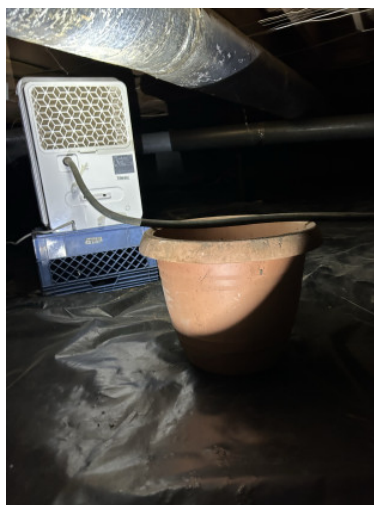
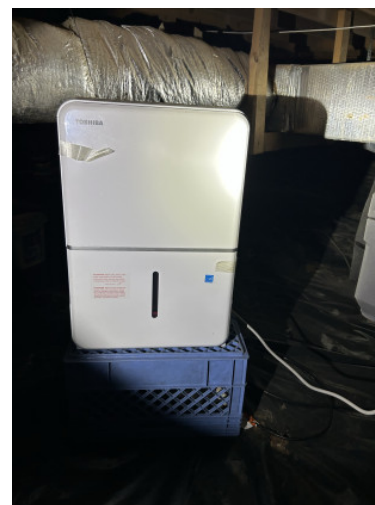
Dehumidifier Inoperative

Repair: The permanent dehumidifier installed in the crawlspace was not operative at the time of inspection and had been replaced with a light duty home/office unit. Consult the owner for details, or a waterproofing contractor for further evaluation and repair as necessary.

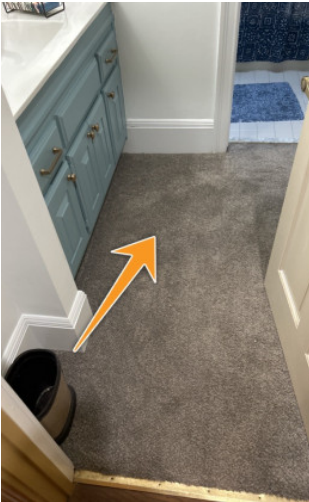
#### Uneven Floors

Monitor: Minor unevenness was observed in the floor structure. This condition is fairly common in older structures such as this and is typically caused by the framing design, installation methods, and aging of the building. There was no evidence of need for immediate repair, however the flooring system should be monitored for further movement. The rate of movement cannot be determined in a one-time inspection.

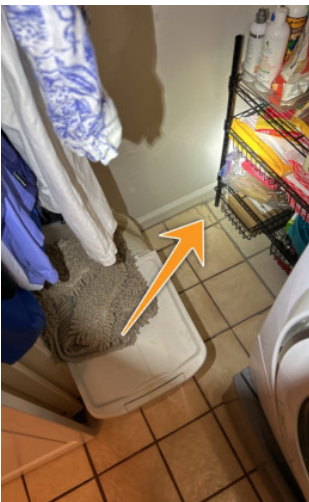
#### Floor Tiles Cracked

Repair: One or more floor tiles were cracked and are need of repair or replacement. Consult a contractor or qualified handy person for repair or replacement.

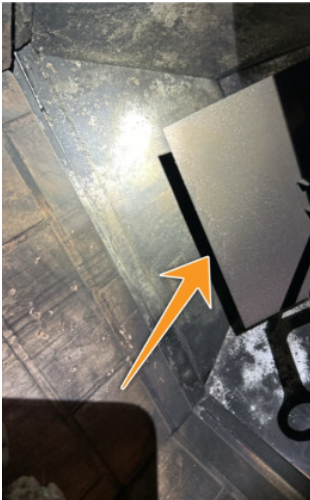
### Install Damper Clamp For Gas Logs

Improve, Safety Issue: There was no clamp installed at the metal damper above the gas logs in the fireplace, which could allow the damper to be closed during the operation of the gas logs. Consider installing this safety device or otherwise insure that the damper is left open when the gas logs are turned on. Also recommend installing a carbon monoxide alarm near the fireplace.
